**PiCUS Sonic Tomograph Test and Summary Report**

**Prepared for:** Jerry Hutter at the City of Kalamunda

**Date of Test:** 20 January 2021

**Site Details:** Kalamunda History Village (adj. toilet block)

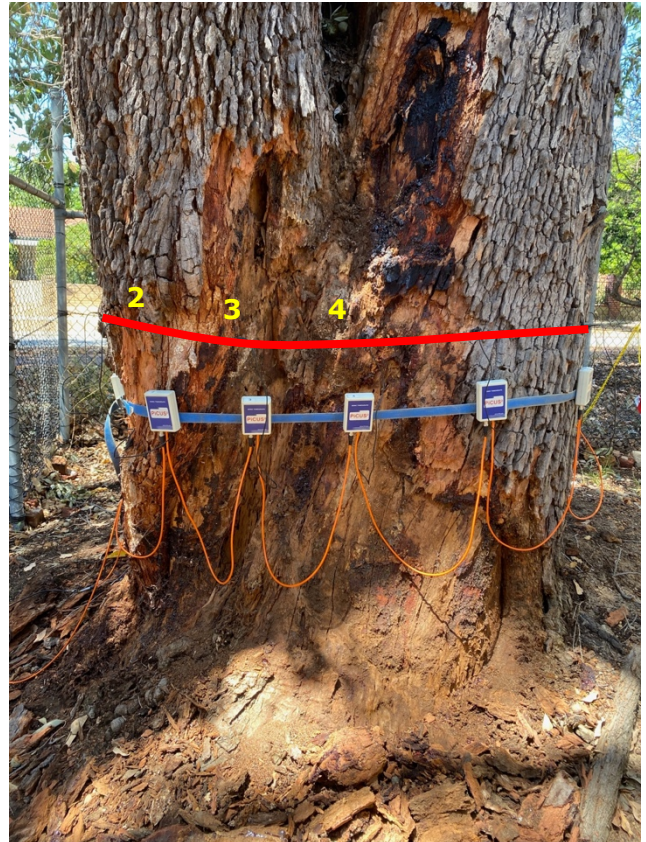
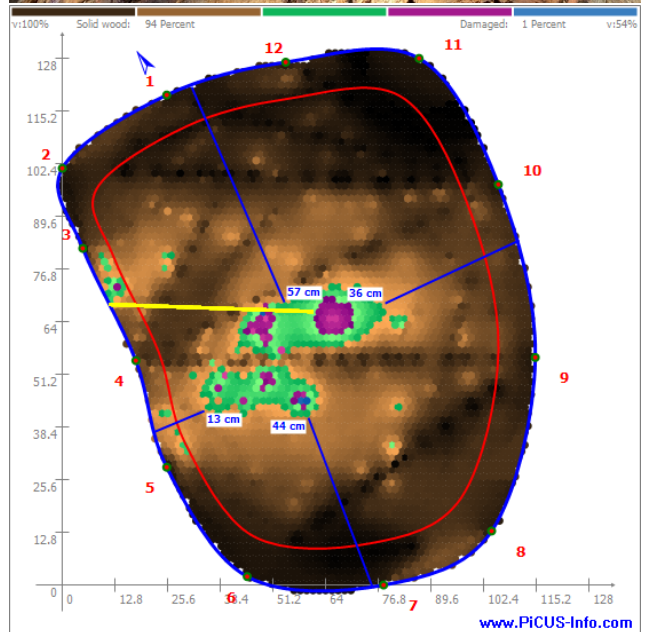
The PiCUS® Sonic Tomograph test result indicates 94% of the test area is solid (high density) wood. There is 5% incipient wood (wood being altered). The remaining 1% is active degradation (low density) wood, cracking or cavity.

The pest and/ or pathogen is likely to have entered the tree through the (fungal) canker wounds and/ or rootplate.

The radial amount of solid wood adjacent to sensor number 1 was measured at 57cm, adjacent to sensor 4 was measured at 13cm, adjacent to sensor 7 was measured at 44cm, and adjacent to sensor 10 was measured at 36cm.

It is observed that new wood growth increments are evident at all sensor numbers.

The test result provides evidence that the tree is still structurally sound at the test point and in excellent condition. Whilst response growth (new wood) is evident as part of self-optimisation and is maintaining an adequately-loaded structure at present, separation of connective tissue was revealed internally between sensor numbers 3 and 4.
