ASBESTOS MATERIALS REGISTER

Report ID: 28182r2 – supersedes
28182r1

Prepared for: City of Kalamunda

Building 7005 – Barton's Mill (Chapel, Shed and
Cell Block), 251 Pickering Brook Road, Pickering
Brook WA 6076

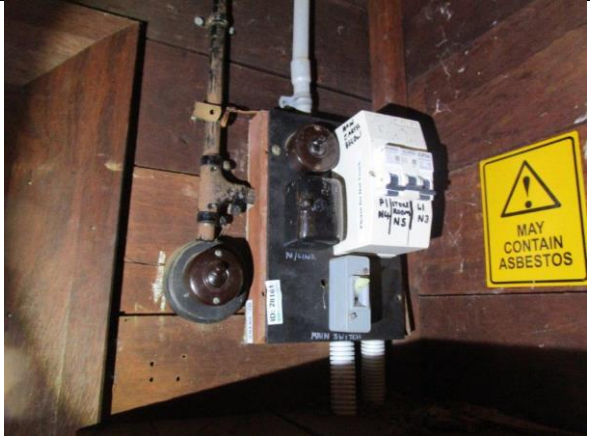
ID 1:- Chapel - Electrical Mounting Board (REMOVED)

Material	Chrysotile asbestos detected.	
Lab No.	Eurofins ARL Lab No. 21-10098-146.	
QED Sample No.	ID: 28161.	
Locations	Inside chapel building at far end	
Condition	N/A.	
Signage	N/A.	
Potential for Disturbance	N/A.	
Risk	REMOVED	
Management Actions	Material has been removed.	
References (See Appendices)	NOHSC 2018 (2005) Appendix C: Selection and use of Personal Protective Equipment (PPE). NOHSC 2018 (2005) Appendix H: Working on Electrical Mounting Boards (switchboards) Containing Asbestos. NOHSC 2002 (2005) Part 12 Section 12.5 Removal of Asbestos Switchboards or Meterboards.	
Service Record	Review in 12 Months – December 2022. Company: Hill Top Group Date: 13 th October 2022. Works: Removal of Electrical Mounting Board. Clearance certificate: Environmental Site Services – ENVSS_0012776_HAZ_VCC_01_20221013	
Further Details	All coal tar pitch boards should be presumed to contain asbestos Brand names include Zelemite, Miscolite and Lebah

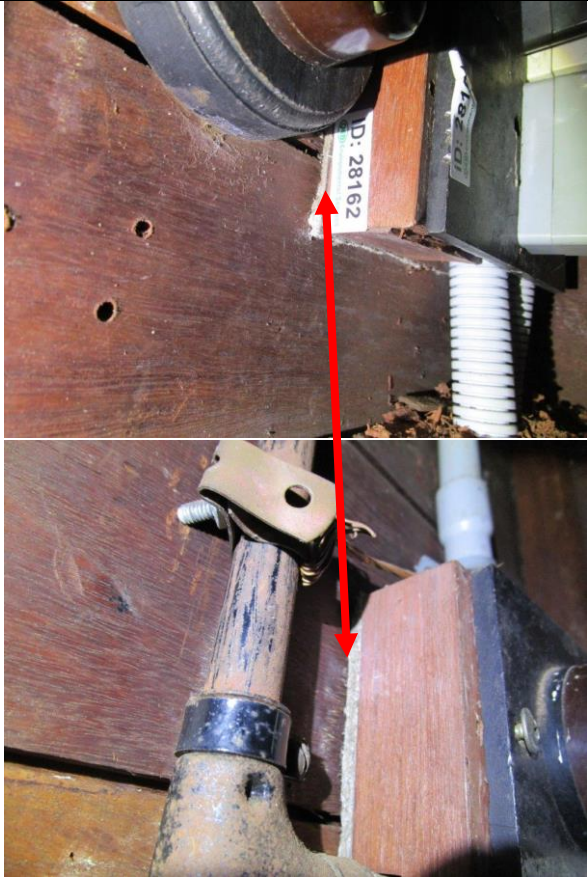
ID 2:- Chapel - EMB Backing Panel (Asbestos Detected)

Material	Chrysotile asbestos detected.	
Lab No.	Eurofins ARL Lab No. 21-10098-147	
QED Sample No.	ID: 28162	
Locations	Panel behind switch board	
Condition	Good, sealed, non-friable.	
Signage	Labelled on wall	
Potential for Disturbance	Low.	
Risk	<p>The ACM are not friable and are in stable condition. In accordance with [NOHSC: 2018 (2005)], ensure that they remain clearly labelled and regularly inspect to ensure they are not deteriorating or otherwise contributing to an unacceptable health risk.</p>	Photos from March 2021 inspection.
Management Actions	<p>May remain in-situ until replacement is required. Manage as per Asbestos Management Plan. Administrative – Follow safe work procedures during removal and maintenance. Personal protective equipment – P2 facemask and coveralls required when working on material.</p>	
References (See Appendices)	<p>NOHSC 2018 (2005) Appendix C: Selection and use of Personal Protective Equipment (PPE). NOHSC 2018 (2005) Appendix D: Drilling of Asbestos-containing Materials. NOHSC 2018 (2005) Appendix E: Sealing, Painting, Coating and Cleaning of Asbestos Cement Products. NOHSC 2002 (2005) Part 12 Section 12.1 Removal of Asbestos Cement Products.</p>

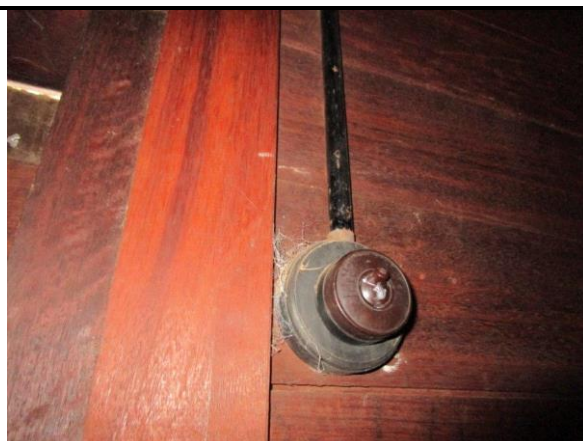
ID 3:- Chapel - Bakelite Switches (Suspected Asbestos Containing Material)	
Material	Suspected asbestos containing material.
Lab No.	N/A
QED Sample No.	N/A. – Unable to sample (live)
Locations	Switches throughout.
Condition	Good, non-friable.
Signage	Building entrance labelled.
Potential for Disturbance	Low to Medium.
Risk	The ACM are not friable and are in stable condition. In accordance with [NOHSC: 2018 (2005)], ensure that they remain clearly labelled and regularly inspect to ensure they are not deteriorating or otherwise contributing to an unacceptable health risk.
Management Actions	May remain in-situ until replacement is required. Manage as per Asbestos Management Plan. Administrative – Follow safe work procedures during removal and maintenance. Personal protective equipment – P2 facemask and coveralls required when working on material.
References (See Appendices)	NOHSC 2018 (2005) Appendix C: Selection and use of Personal Protective Equipment (PPE). NOHSC 2018 (2005) Appendix D: Drilling of Asbestos-containing Materials. NOHSC 2018 (2005) Appendix E: Sealing, Painting, Coating and Cleaning of Asbestos Cement Products. NOHSC 2002 (2005) Part 12 Section 12.1 Removal of Asbestos Cement Products.

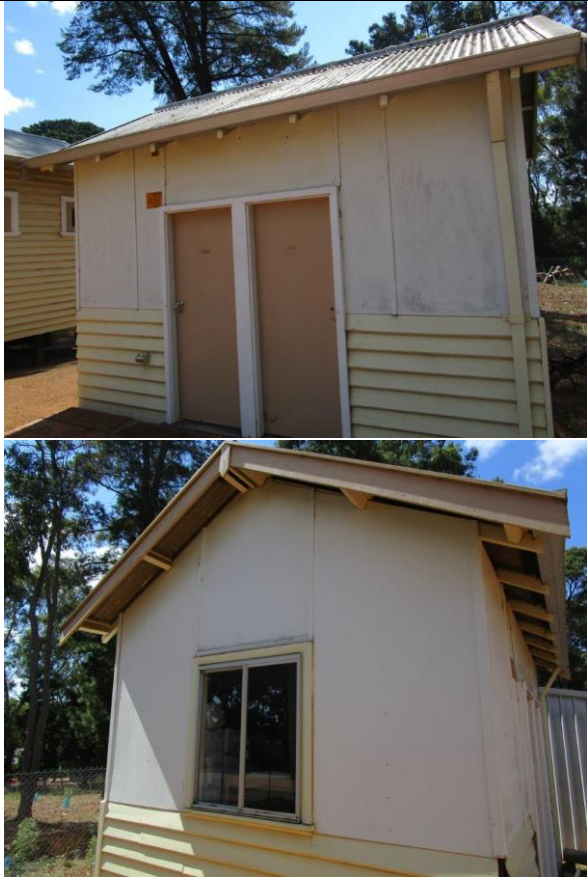
ID 4:- Cell Block - External Panelling and Batons (Asbestos Detected)

Material	Chrysotile asbestos detected.	
Lab No.	Eurofins ARL Lab No. 21-10098-148	
QED Sample No.	ID: 28163	
Locations	External panels and batons to cell block building.	
Condition	Good to fair, some small areas of damaged, typically sealed, non-friable.	
Signage	Labelled.	
Potential for Disturbance	Low to medium.	
Risk	<p>The ACM are not friable and are in stable condition. In accordance with [NOHSC: 2018 (2005)], ensure that they remain clearly labelled and regularly inspect to ensure they are not deteriorating or otherwise contributing to an unacceptable health risk.</p>	Photos from March 2021 inspection.
Management Actions	<p>Ideally, the panelling should be replaced, however, if removal is not practicable, the damaged areas should be encapsulated to improve the condition of the material. Manage as per Asbestos Management Plan. Administrative – Follow safe work procedures during removal and maintenance. Personal protective equipment – P2 facemask and coveralls required when working on material.</p>

References (See Appendices)	<p>NOHSC 2018 (2005) Appendix C: Selection and use of Personal Protective Equipment (PPE). NOHSC 2018 (2005) Appendix D: Drilling of Asbestos-containing Materials. NOHSC 2018 (2005) Appendix E: Sealing, Painting, Coating and Cleaning of Asbestos Cement Products. NOHSC 2002 (2005) Part 12 Section 12.1 Removal of Asbestos Cement Products.</p>	
Service Record	<p>Review in 12 Months – December 2022. Company: Date: Works: Clearance certificate:</p>

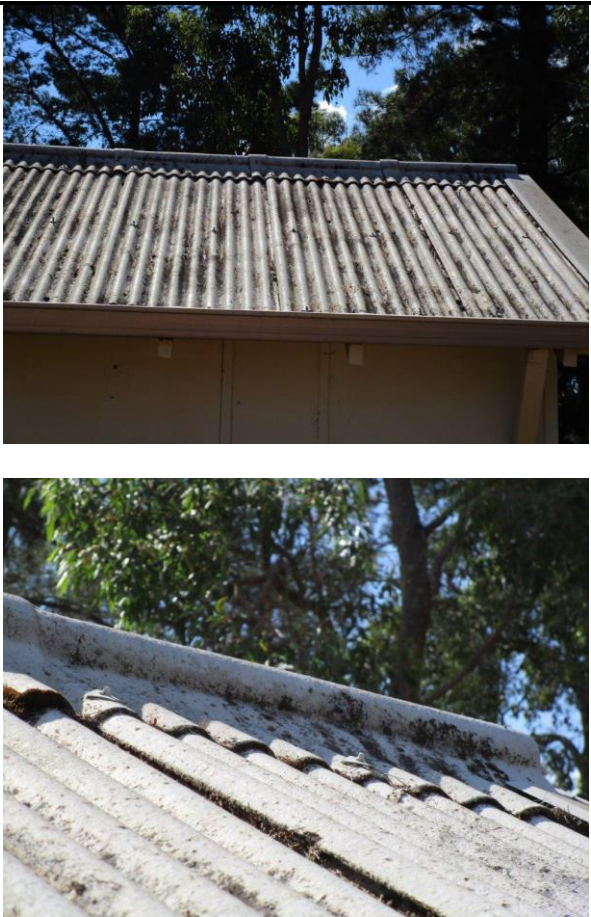
ID 5:- Cell Block - Roof Sheeting & Capping (REMOVED)

Material	Chrysotile asbestos detected.	
Lab No.	Eurofins ARL Lab No. 21-10098-150	
QED Sample No.	ID: 28165	
Locations	Roof of cell block	
Condition	N/A.	
Signage	N/A.	
Potential for Disturbance	N/A.	
Risk	REMOVED	Photos from March 2021 inspection.
Management Actions	Material has been removed.	
References (See Appendices)	NOHSC 2018 (2005) Appendix C: Selection and use of Personal Protective Equipment (PPE). NOHSC 2018 (2005) Appendix D: Drilling of Asbestos-containing Materials. NOHSC 2018 (2005) Appendix E: Sealing, Painting, Coating and Cleaning of Asbestos Cement Products. NOHSC 2018 (2005) Appendix F: Cleaning leaf litter from the gutters of asbestos cement roofs. NOHSC 2002 (2005) Part 12 Section 12.1 Removal of Asbestos Cement Products.	
Service Record	Company: Hill Top Group Date: 13 th October 2022. Works: Removal of Roof sheeting. Clearance certificate: Environmental Site Services – ENVSS_0012776_HAZ_VCC_01_20221013

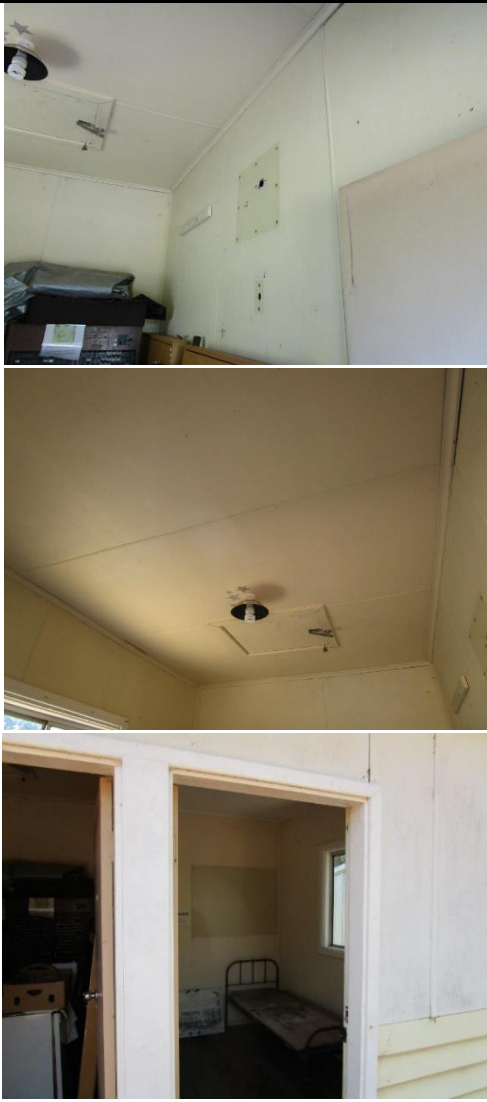
ID 6:- Cell Block - Internal Wall & Ceiling Panels (REMOVED)

<p>Photos from March 2021 inspection.</p>
Material	Chrysotile asbestos detected.	
Lab No.	Eurofins ARL Lab No. 21-10098-149	
QED Sample No.	ID: 28164	
Locations	Internal panels to cell block.	
Condition	N/A.	
Signage	N/A.	
Potential for Disturbance	N/A.	
Risk	REMOVED	
Management Actions	Material has been removed.	
References (See Appendices)	NOHSC 2018 (2005) Appendix C: Selection and use of Personal Protective Equipment (PPE). NOHSC 2018 (2005) Appendix D: Drilling of Asbestos-containing Materials. NOHSC 2018 (2005) Appendix E: Sealing, Painting, Coating and Cleaning of Asbestos Cement Products. NOHSC 2002 (2005) Part 12 Section 12.1 Removal of Asbestos Cement Products.	
Service Record	Review in 12 Months – December 2022. Company: Hill Top Group Date: 13 th October 2022. Works: Removal of Electrical Mounting Board. Clearance certificate: Environmental Site Services – ENVSS_0012776_HAZ_VCC_01_20221013
