ASBESTOS MATERIALS REGISTER

Report ID: 28183r2 – Supersedes
28183r1

Prepared for: City of Kalamunda

**Building 7010 – Carmel Hall, 152 Carmel Road,
Carmel WA 6076**

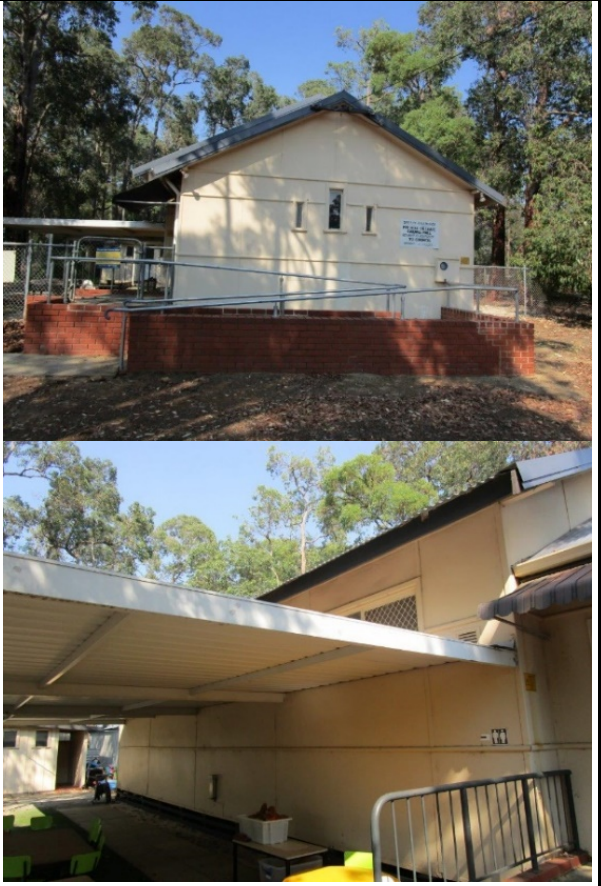
ID 1:- External Wall Panelling (Demolished)	
Material	Chrysotile, amosite and crocidolite asbestos detected.
Lab No.	Eurofins ARL Lab No. 21-10098-216
QED Sample No.	ID: 28145
Locations	External panels surrounding the building including angled corner moulds and gables.
Condition	N/A.
Signage	N/A.
Potential for Disturbance	N/A.
Risk	N/A.
Management Actions	N/A.
References (See Appendices)	N/A.
Service Record	Building Demolished. Company: Hill Top Group Date: May 2022 Works: Demolition and removal of old house with ACM walls Clearance certificate: Environmental Site Services (ENVSS) - ENVSS_0012202_HAZ_VCC_01_2022517

Photos from March 2021 inspection.

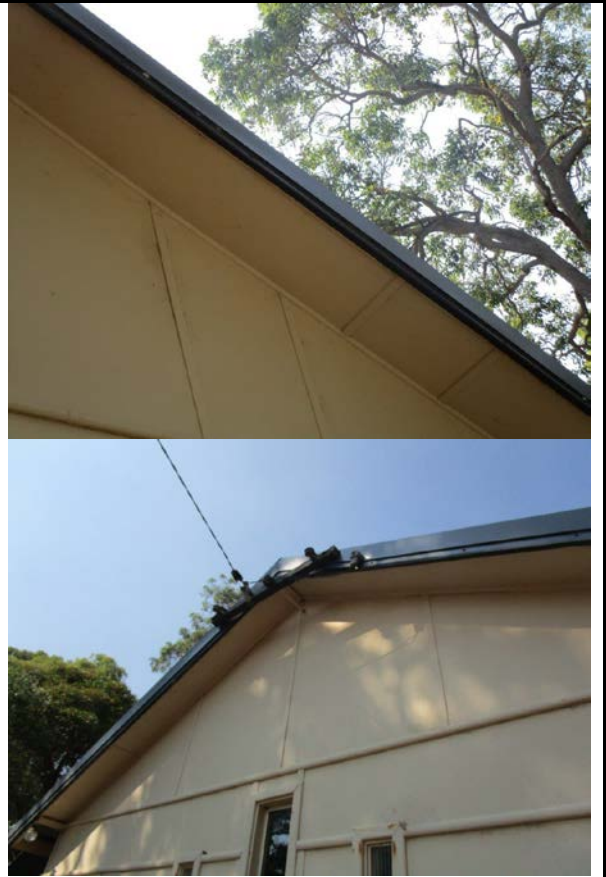
ID 2:- Eave Panelling (Demolished)	
Material	Chrysotile, amosite and crocidolite asbestos detected.
Lab No.	As per Eurofins ARL Lab No. 21-10098-216
QED Sample No.	ID: 28145
Locations	External eaves surrounding the building.
Condition	N/A.
Signage	N/A.
Potential for Disturbance	N/A.
Risk	N/A.
Management Actions	N/A.
References (See Appendices)	N/A.
Service Record	Building Demolished. Company: Hill Top Group Date: May 2022 Works: Demolition and removal of old house with ACM walls Clearance certificate: Environmental Site Services (ENVSS) - ENVSS_0012202_HAZ_VCC_01_2022517

Photos from March 2021 inspection.

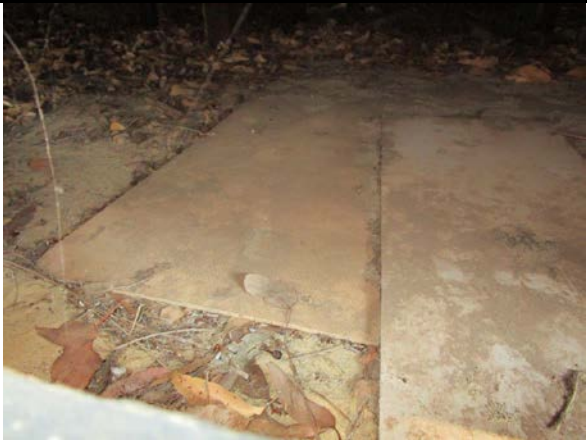
ID 3:- Loose Fibre Cement Panelling (Demolished)	
Material	Suspected asbestos containing material.
Lab No.	Unable to obtain suitable sample (material under building).
QED Sample No.	N/A.
Locations	Under building near entrance.
Condition	N/A.
Signage	N/A.
Potential for Disturbance	N/A.
Risk	N/A.
Management Actions	N/A.
References (See Appendices)	N/A.
Service Record	Building Demolished. Company: Hill Top Group Date: May 2022 Works: Demolition and removal of old house with ACM walls Clearance certificate: Environmental Site Services (ENVSS) - ENVSS_0012202_HAZ_VCC_01_2022517

Photos from March 2021 inspection.

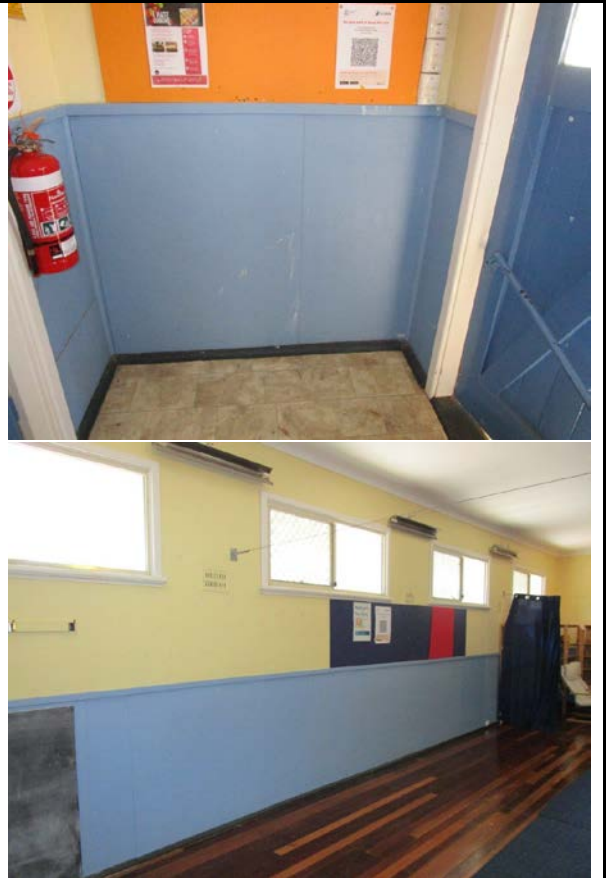
ID 4:- Interior Blue Lower Wall Panelling (Demolished)	
Material	Chrysotile and amosite asbestos detected.
Lab No.	Eurofins ARL Lab No. 21-10098-217
QED Sample No.	ID: 28146
Locations	Interior lower panels (blue) of the hall and entrance.
Condition	N/A.
Signage	N/A.
Potential for Disturbance	N/A.
Risk	N/A.

<p>Photos from March 2021 inspection.</p>
Management Actions	N/A.
References (See Appendices)	N/A.
Service Record	Building Demolished. Company: Hill Top Group Date: May 2022 Works: Demolition and removal of old house with ACM walls Clearance certificate: Environmental Site Services (ENVSS) - ENVSS_0012202_HAZ_VCC_01_2022517

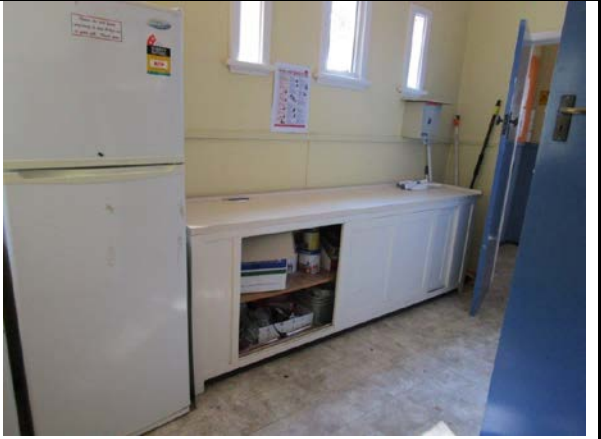
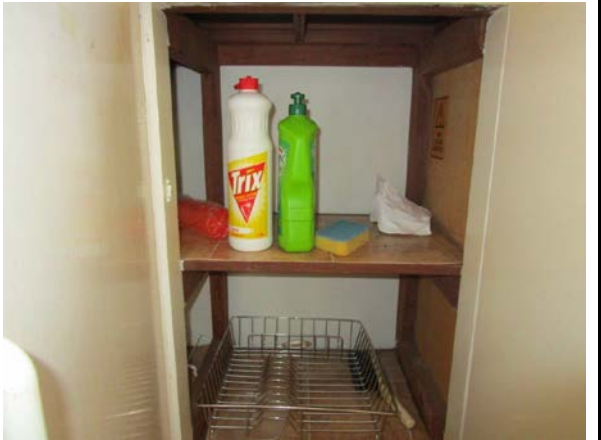
ID 5:- Kitchen Wall Panelling (Demolished)

Material	Chrysotile, amosite asbestos detected.	
Lab No.	Eurofins ARL Lab No. 21-10098-217	
QED Sample No.	ID: 28146	
Locations	Lower wall panels in the kitchen including behind cupboard.	
Condition	N/A.	
Signage	N/A.	
Potential for Disturbance	N/A.	
Risk	N/A.

<p>Photos from March 2021 inspection.</p>
Management Actions	N/A.	
References (See Appendices)	N/A.	
Service Record	Building Demolished. Company: Hill Top Group Date: May 2022 Works: Demolition and removal of old house with ACM walls Clearance certificate: Environmental Site Services (ENVSS) - ENVSS_0012202_HAZ_VCC_01_2022517

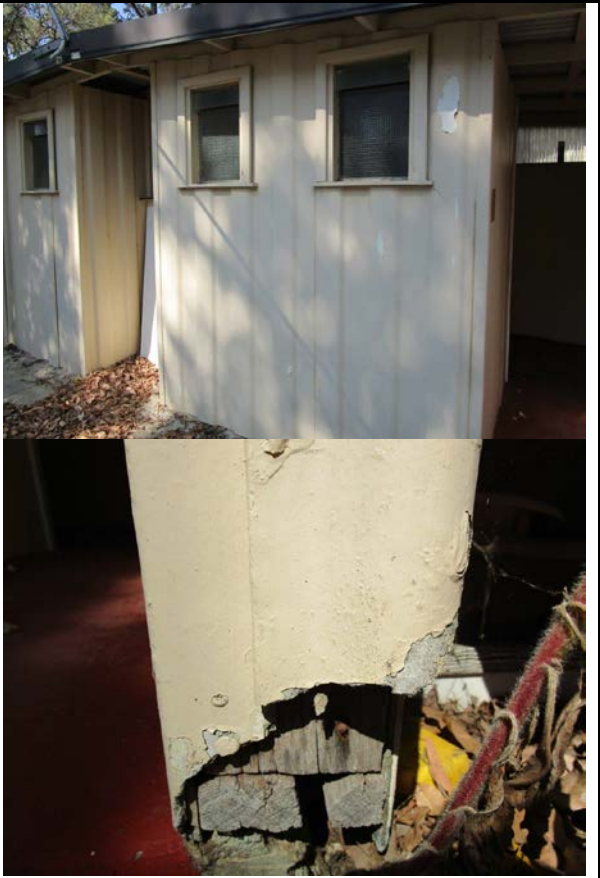
ID 6:- External Toilet Panelling (Demolished)	
Material	Chrysotile and amosite asbestos detected.
Lab No.	Eurofins ARL Lab No. 21-10098-220
QED Sample No.	ID: 28150
Locations	Panels surrounding external toilet block.
Condition	N/A.
Signage	N/A.
Potential for Disturbance	N/A.
Risk	N/A.
Management Actions	N/A.
References (See Appendices)	N/A.
Service Record	Building Demolished. Company: Hill Top Group Date: May 2022 Works: Demolition and removal of old house with ACM walls Clearance certificate: Environmental Site Services (ENVSS) - ENVSS_0012202_HAZ_VCC_01_2022517

Photos from March 2021 inspection.

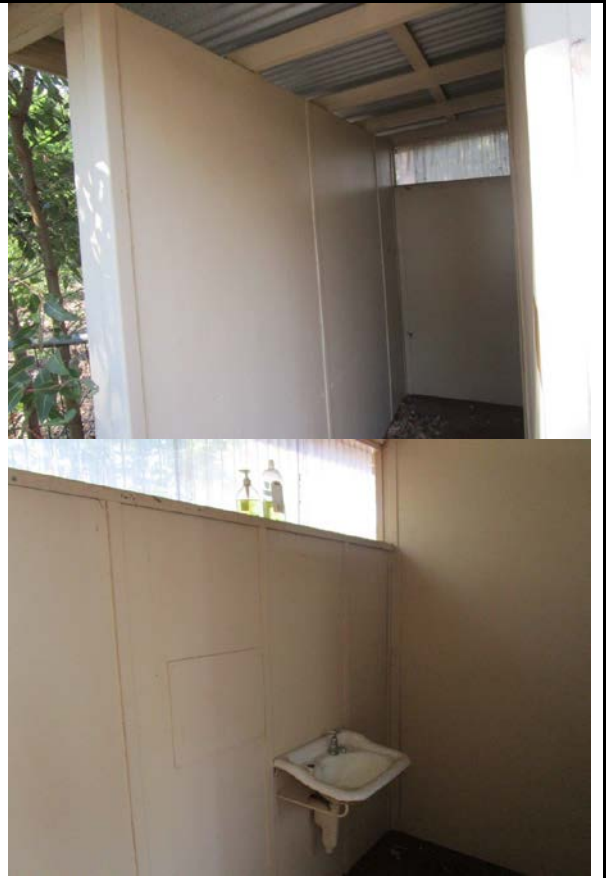
ID 7:- Internal Toilet Panelling (Demolished)

Material	Chrysotile and amosite asbestos detected.	
Lab No.	Eurofins ARL Lab No. 21-10098-220	
QED Sample No.	ID: 28151	
Locations	Internal panels to toilet block.	
Condition	N/A.	
Signage	N/A.	
Potential for Disturbance	N/A.	
Risk	N/A.	<p>Photos from March 2021 inspection.</p>
Management Actions	N/A.	
References (See Appendices)	N/A.	
Service Record	Building Demolished. Company: Hill Top Group Date: May 2022 Works: Demolition and removal of old house with ACM walls Clearance certificate: Environmental Site Services (ENVSS) - ENVSS_0012202_HAZ_VCC_01_2022517

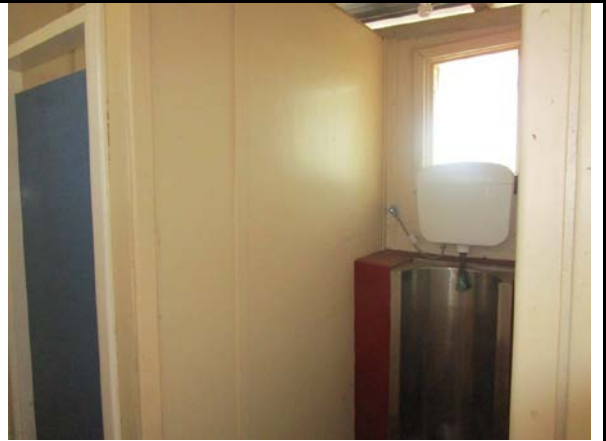
ID 8:- Urinal Backing Membrane (Demolished)	
Material	Suspected asbestos containing material.
Lab No.	Unable to sample (encapsulated)
QED Sample No.	N/A.
Locations	Male toilets
Condition	N/A.
Signage	N/A.
Potential for Disturbance	N/A.
Risk	N/A.
Management Actions	N/A.
References (See Appendices)	N/A.
Service Record	Building Demolished. Company: Hill Top Group Date: May 2022 Works: Demolition and removal of old house with ACM walls Clearance certificate: Environmental Site Services (ENVSS) - ENVSS_0012202_HAZ_VCC_01_2022517

Photos from March 2021 inspection.
