ASBESTOS MATERIALS REGISTER

Report ID: 28188r1 – Supersedes
28188r0

Prepared for: City of Kalamunda

Building 7016 – Depot, 10 Raymond Rd,
Walliston WA 6076

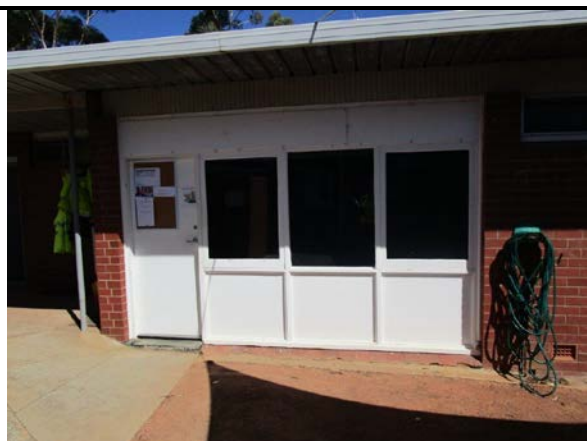
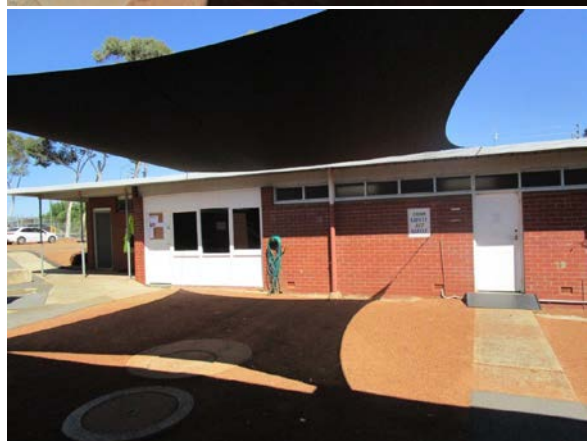
Photos from March 2021 inspection.

ID 1:- Clerical Stock Store - Window Infill Panelling (Asbestos Detected)	
Material	Chrysotile and crocidolite asbestos detected.
Lab No.	Eurofins ARL Lab No. 21-10098-125
QED Sample No.	ID: 28116
Locations	Window infill panelling.
Condition	Good, sealed, non-friable.
Signage	Labelled.
Potential for Disturbance	Low.
Risk	<p>The ACM are not friable and are in stable condition. In accordance with [NOHSC: 2018 (2005)], ensure that they remain clearly labelled and regularly inspect to ensure they are not deteriorating or otherwise contributing to an unacceptable health risk.</p>
Management Actions	<p>May remain in-situ until replacement is required. Manage as per Asbestos Management Plan. Administrative – Follow safe work procedures during removal and maintenance. Personal protective equipment – P2 facemask and coveralls required when working on material.</p>
References (See Appendices)	<p>NOHSC 2018 (2005) Appendix C: Selection and use of Personal Protective Equipment (PPE). NOHSC 2018 (2005) Appendix D: Drilling of Asbestos-containing Materials. NOHSC 2018 (2005) Appendix E: Sealing, Painting, Coating and Cleaning of Asbestos Cement Products. NOHSC 2002 (2005) Part 12 Section 12.1 Removal of Asbestos Cement Products.</p>

Service Record	<p>Review in 12 Months – December 2022. Company: Date: Works: Clearance certificate:</p>

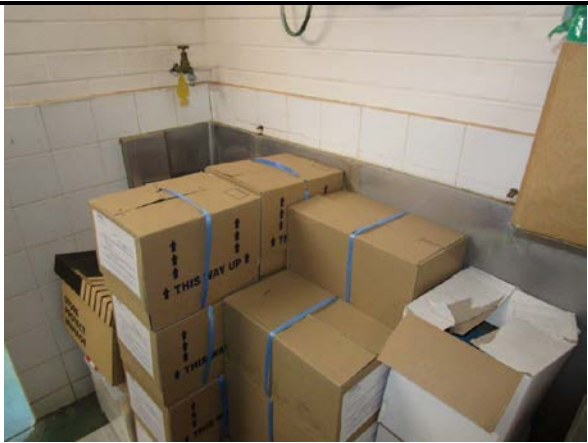
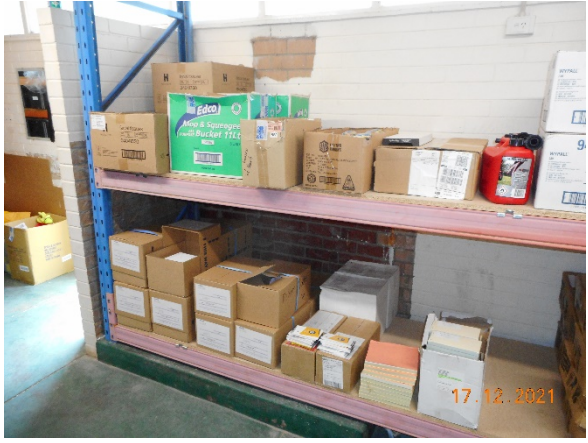
ID 2:- Clerical Stock Store - Urinal Backing Membrane (Removed)

<p>December 2021</p>
Material	Suspected asbestos containing material.	
Lab No.	Unable to sample (encapsulated)	
QED Sample No.	N/A.	
Locations	Male toilets	
Condition	N/A.	
Signage	N/A.	
Potential for Disturbance	N/A.	
Risk	N/A.	
Management Actions	N/A.	
References (See Appendices)	N/A.	
Service Record	Removal details Company: Unknown Date: November 2021 Works: Refurbishment of Store Clearance certificate: None

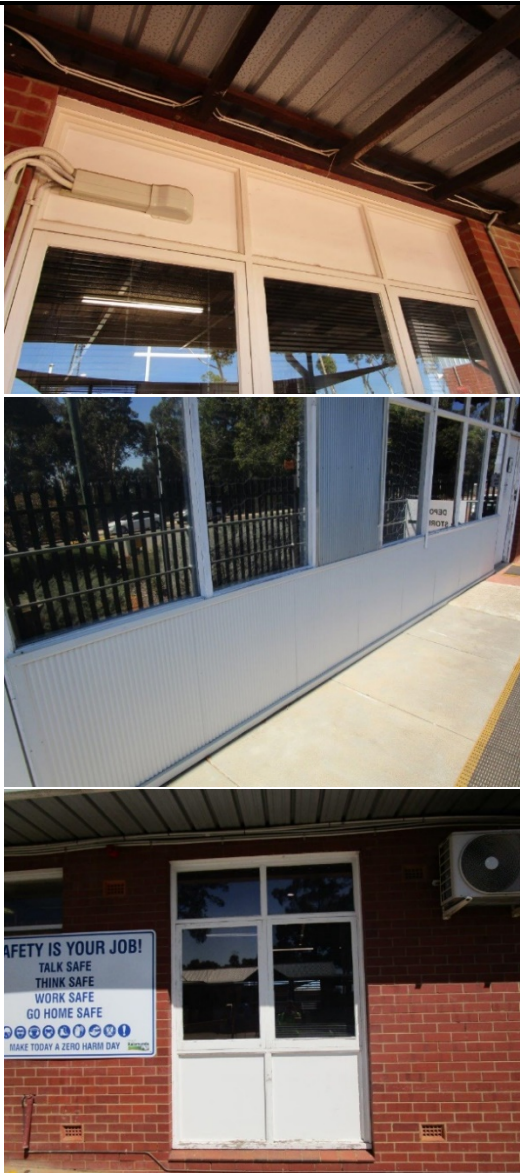
ID 3:- Clerical Stock Office - Window Infill Panelling (Asbestos Detected)

Material	Chrysotile and crocidolite asbestos detected.	
Lab No.	Eurofins ARL Lab No. 21-10098-125.	
QED Sample No.	ID: 28116.	
Locations	Window infill panels throughout the building, including encapsulated under the corrugated metal panelling on the west side of the building.	
Condition	Good, sealed, non-friable.	
Signage	Labelled.	
Potential for Disturbance	Low.	
Risk	<p>The ACM are not friable and are in stable condition. In accordance with [NOHSC: 2018 (2005)], ensure that they remain clearly labelled and regularly inspect to ensure they are not deteriorating or otherwise contributing to an unacceptable health risk.</p>	<p>Photos from March 2021 inspection.</p>
Management Actions	<p>May remain in-situ until replacement is required. Manage as per Asbestos Management Plan. Administrative – Follow safe work procedures during removal and maintenance. Personal protective equipment – P2 facemask and coveralls required when working on material.</p>

References (See Appendices)	<p>NOHSC 2018 (2005) Appendix C: Selection and use of Personal Protective Equipment (PPE). NOHSC 2018 (2005) Appendix D: Drilling of Asbestos-containing Materials. NOHSC 2018 (2005) Appendix E: Sealing, Painting, Coating and Cleaning of Asbestos Cement Products. NOHSC 2002 (2005) Part 12 Section 12.1 Removal of Asbestos Cement Products.</p>	
Service Record	<p>Review in 12 Months – December 2022. Company: Date: Works: Clearance certificate:</p>

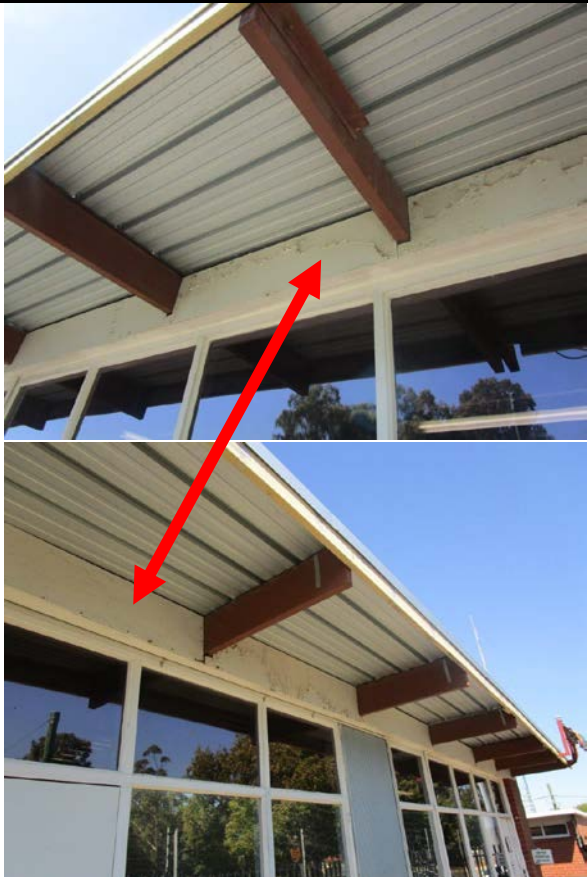
ID 4:- Clerical Stock Office - Fascia Panels (Asbestos Detected)

Material	Chrysotile, amosite and crocidolite asbestos detected.	
Lab No.	Eurofins ARL Lab No. 21-10098-122.	
QED Sample No.	ID: 28119.	
Locations	Panels between top of windows and roof.	
Condition	Good to fair, paint peeling, non-friable.	
Signage	Labelled.	
Potential for Disturbance	Low.	
Risk	<p>The ACM are not friable and are in stable condition. In accordance with [NOHSC: 2018 (2005)], ensure that they remain clearly labelled and regularly inspect to ensure they are not deteriorating or otherwise contributing to an unacceptable health risk.</p>	Photos from March 2021 inspection.
Management Actions	<p>May remain in-situ until replacement is required. Manage as per Asbestos Management Plan. Administrative – Follow safe work procedures during removal and maintenance. Personal protective equipment – P2 facemask and coveralls required when working on material.</p>

References (See Appendices)	<p>NOHSC 2018 (2005) Appendix C: Selection and use of Personal Protective Equipment (PPE). NOHSC 2018 (2005) Appendix D: Drilling of Asbestos-containing Materials. NOHSC 2018 (2005) Appendix E: Sealing, Painting, Coating and Cleaning of Asbestos Cement Products. NOHSC 2002 (2005) Part 12 Section 12.1 Removal of Asbestos Cement Products.</p>	
Service Record	<p>Review in 12 Months – December 2022. Company: Date: Works: Clearance certificate:</p>

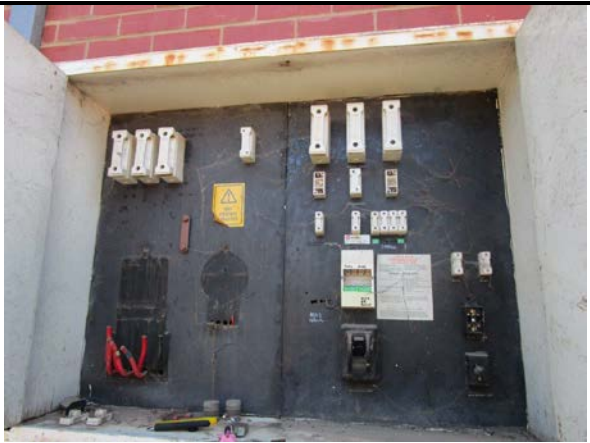
ID 5:- Clerical Stock Office - Electrical Mounting Board (Asbestos Detected)

<p>Photos from March 2021 inspection.</p>
Material	Chrysotile asbestos detected.	
Lab No.	Eurofins ARL Lab No. 21-10098-126.	
QED Sample No.	ID: 28115.	
Locations	Meter box, rear south wall.	
Condition	Good, non-friable.	
Signage	Labelled.	
Potential for Disturbance	Low to Medium.	
Risk	<p>The ACM are not friable and are in stable condition. In accordance with [NOHSC: 2018 (2005)], ensure that they remain clearly labelled and regularly inspect to ensure they are not deteriorating or otherwise contributing to an unacceptable health risk.</p>	
Management Actions	<p>It is understood that the board is redundant. Plans should be made for the removal of the board and fuse packers. Manage as per Asbestos Management Plan. Administrative – Follow safe work procedures during removal and maintenance. Personal protective equipment – P2 facemask and coveralls required when working on material.</p>

References (See Appendices)	<p>NOHSC 2018 (2005) Appendix C: Selection and use of Personal Protective Equipment (PPE). NOHSC 2018 (2005) Appendix H: Working on Electrical Mounting Boards (switchboards) Containing Asbestos. NOHSC 2002 (2005) Part 12 Section 12.5 Removal of Asbestos Switchboards or Meterboards.</p>	
Service Record	<p>Review in 12 Months – December 2022. Company: Date: Works: Clearance certificate:</p>	
Further Details	<p>All coal tar pitch boards should be presumed to contain asbestos Brand names include Zelemite, Miscolite and Lebah</p>

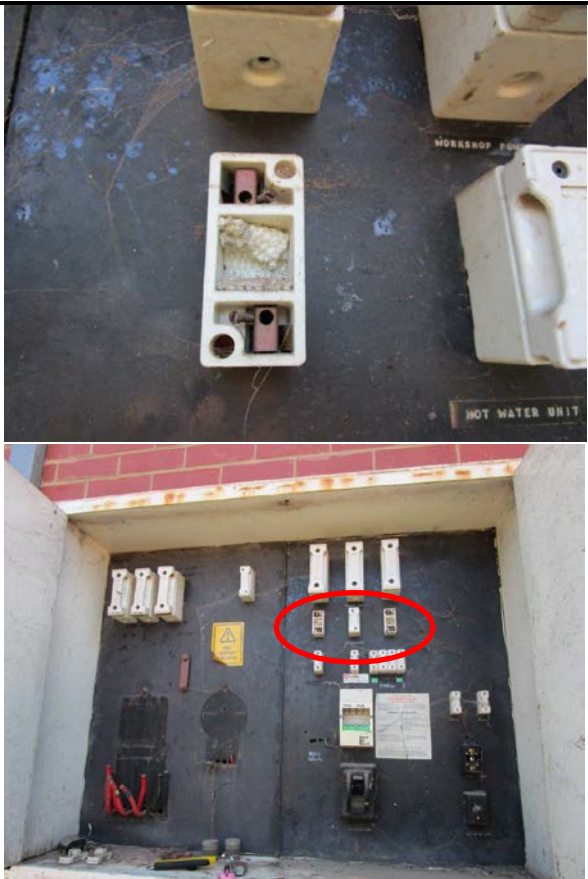
ID 6:- Clerical Stock Office - Electrical Fuse Packer (Suspected Asbestos Containing Material)

Material	Suspected asbestos containing material.	
Lab No.	Observed.	
QED Sample No.	N/A.	
Locations	Within the ceramic fuse holders mounted on the electrical mounting board on the rear wall.	
Condition	Fair, intact, friable	
Signage	Labelled on mounting board.	
Potential for Disturbance	Low.	
Risk	<p>The ACM are friable however intact with a low potential for disturbance. In accordance with [NOHSC: 2002 (2005)], they should be removed by an appropriately licensed asbestos removalist as soon as is practicable.</p>	Photos from March 2021 inspection.
Management Actions	<p>In accordance with [NOHSC: 2002 (2005)], the fuse packer should be removed by an appropriately licensed asbestos removalist as soon as is practicable</p> <p>Manage as per Asbestos Management Plan.</p> <p>Administrative – Follow safe work procedures during removal and maintenance.</p> <p>Personal protective equipment – P2 facemask and coveralls required when working on material.</p>

References	<p>NOHSC: 2018(2005) Appendix C: Selection and Use of Personal Protective Equipment (PPE).</p> <p>NOHSC: 2018(2005) Part 11.11 Waste Removal and Disposal.</p>	
Service Record	<p>Review in 12 Months – December 2022.</p> <p>Company:</p> <p>Date:</p> <p>Works:</p> <p>Clearance certificate:</p>

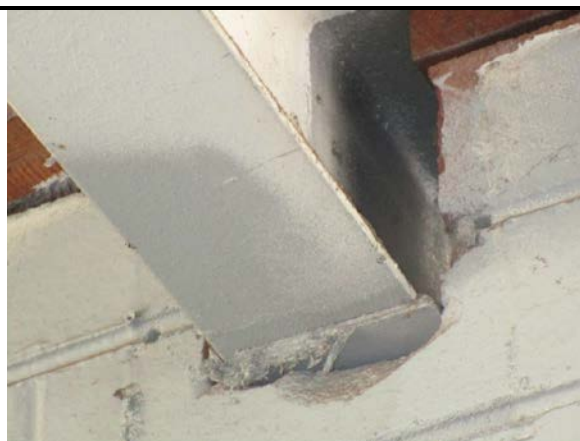
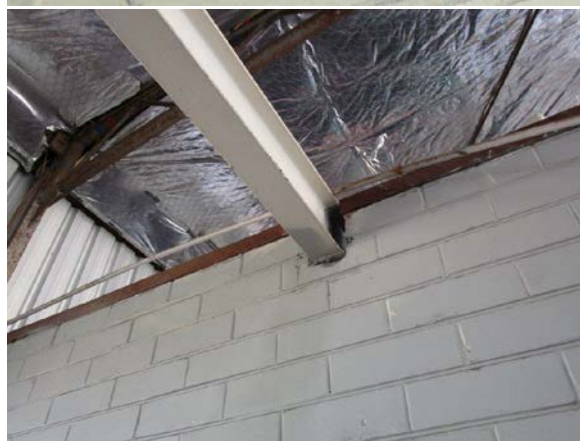
Photos from March 2021 inspection.

ID 7:- Workshop – Beam Packer (Asbestos Detected)	
Material	Chrysotile asbestos detected.
Lab No.	Eurofins ARL Lab No. 21-10098-123.
QED Sample No.	ID: 28117.
Locations	Underneath the low beam in the workshop.
Condition	Good to fair, edge damaged, sealed, non-friable.
Signage	None.
Potential for Disturbance	Low.
Risk	<p>The ACM are not friable and are in stable condition. In accordance with [NOHSC: 2018 (2005)], ensure that they remain clearly labelled and regularly inspect to ensure they are not deteriorating or otherwise contributing to an unacceptable health risk.</p>
Management Actions	<p>Requires labelling. May remain in-situ until replacement is required. Manage as per Asbestos Management Plan. Administrative – Follow safe work procedures during removal and maintenance. Personal protective equipment – P2 facemask and coveralls required when working on material.</p>
References (See Appendices)	<p>NOHSC 2018 (2005) Appendix C: Selection and use of Personal Protective Equipment (PPE). NOHSC 2018 (2005) Appendix D: Drilling of Asbestos-containing Materials. NOHSC 2018 (2005) Appendix E: Sealing, Painting, Coating and Cleaning of Asbestos Cement Products. NOHSC 2002 (2005) Part 12 Section 12.1 Removal of Asbestos Cement Products.</p>

Service Record	<p>Review in 12 Months – December 2022. Company: Date: Works: Clearance certificate:</p>
