ASBESTOS MATERIALS REGISTER

Report ID: 28226r1 – supersedes
28226r0

Building 7223 – Forrestfield Library, 3 Salix Road,
Forrestfield WA 6058

Reinspection conducted by City of Kalamunda

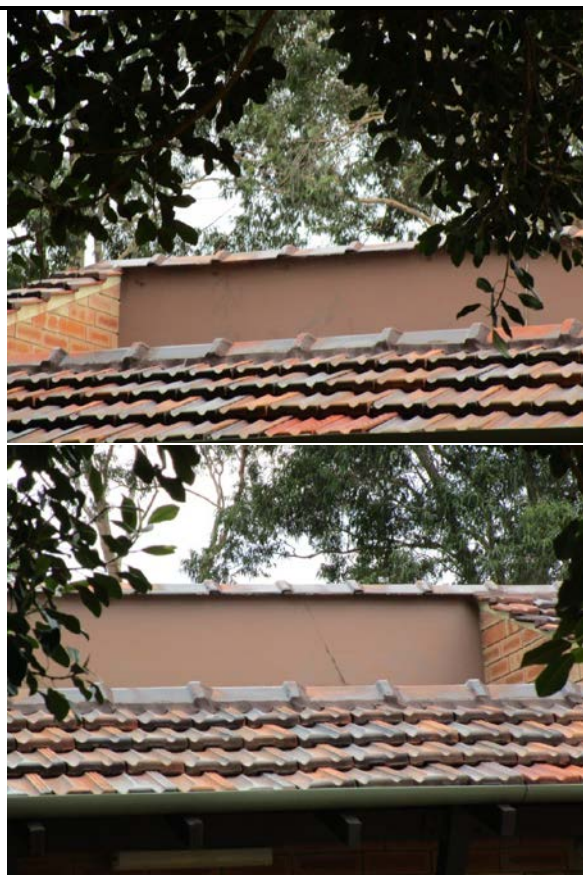
ID 1:- Fascia Panelling (Asbestos Detected)	
Material	Chrysotile and amosite asbestos detected.
Lab No.	ARL Lab No. 20-07224-8 and 9.
QED Sample No.	Sampled by City of Kalamunda and Hill Top Group in April 2020.
Locations	Roof area above the windows.
Condition	Good, sealed, non-friable.
Signage	None.
Potential for Disturbance	Low to medium.
Risk	<p style="text-align: center;">The ACM are not friable and are in stable condition. In accordance with [NOHSC: 2018 (2005)], ensure that they remain clearly labelled and regularly inspect to ensure they are not deteriorating or otherwise contributing to an unacceptable health risk.</p>
Management Actions	<p>Requires labelling. May remain in-situ until replacement is required. Manage as per Asbestos Management Plan. Administrative – Follow safe work procedures during removal and maintenance. Personal protective equipment – P2 facemask and coveralls required when working on material.</p>

Photos from April 2021 inspection.

References (See Appendices)	<p>NOHSC 2018 (2005) Appendix C: Selection and use of Personal Protective Equipment (PPE). NOHSC 2018 (2005) Appendix D: Drilling of Asbestos-containing Materials. NOHSC 2018 (2005) Appendix E: Sealing, Painting, Coating and Cleaning of Asbestos Cement Products. NOHSC 2002 (2005) Part 12 Section 12.1 Removal of Asbestos Cement Products.</p>
Service Record	<p>Review in 12 Months – December 2022. Company: Date: Works: Clearance certificate:</p>

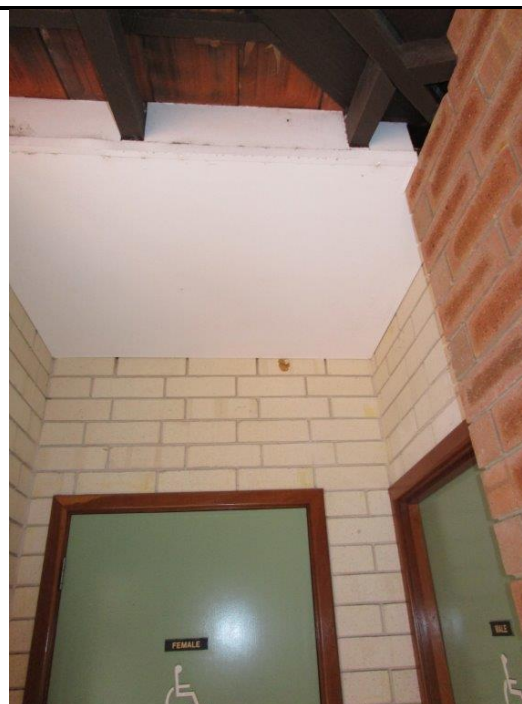
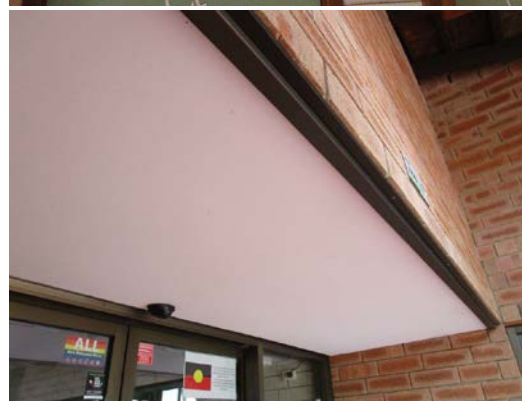
ID 2:- External Ceiling Panelling (Asbestos Detected)	
Material	Chrysotile and amosite asbestos detected.
Lab No.	ARL Lab No. 20-07224-5.
QED Sample No.	Sampled by City of Kalamunda and Hill Top Group in April 2020.
Locations	Main entrance ceiling and entrance to the toilets in the courtyard.
Condition	Good, sealed, non-friable.
Signage	Entrance ceiling labelled, toilet entrance ceiling none.
Potential for Disturbance	Low to medium.
Risk	<p>The ACM are not friable and are in stable condition. In accordance with [NOHSC: 2018 (2005)], ensure that they remain clearly labelled and regularly inspect to ensure they are not deteriorating or otherwise contributing to an unacceptable health risk.</p>
Management Actions	<p>Toilet entrance requires labelling. May remain in-situ until replacement is required. Manage as per Asbestos Management Plan. Administrative – Follow safe work procedures during removal and maintenance. Personal protective equipment – P2 facemask and coveralls required when working on material.</p>

Photos from April 2021 inspection.

References (See Appendices)	<p>NOHSC 2018 (2005) Appendix C: Selection and use of Personal Protective Equipment (PPE). NOHSC 2018 (2005) Appendix D: Drilling of Asbestos-containing Materials. NOHSC 2018 (2005) Appendix E: Sealing, Painting, Coating and Cleaning of Asbestos Cement Products. NOHSC 2002 (2005) Part 12 Section 12.1 Removal of Asbestos Cement Products.</p>
Service Record	<p>Review in 12 Months – December 2022. Company: Date: Works: Clearance certificate:</p>

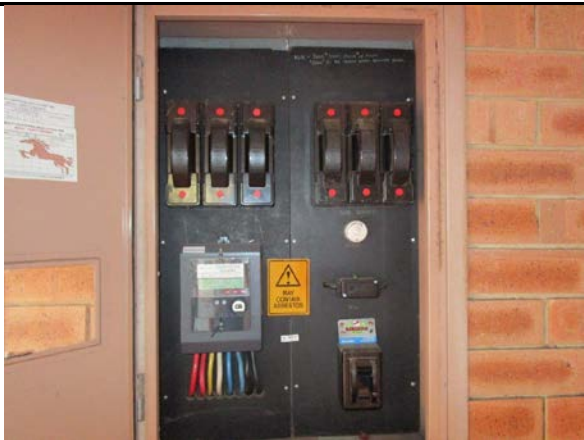
ID 3:- Electrical Mounting Board (Asbestos Detected)

Material	Chrysotile asbestos detected.	
Lab No.	Eurofins ARL Lab No. 21-10098-107.	
QED Sample No.	ID: 28239.	
Locations	Main meter board cabinet left of entry.	
Condition	Good, non-friable.	
Signage	Labelled.	
Potential for Disturbance	Low to Medium.	
Risk	<p>The ACM are not friable and are in stable condition. In accordance with [NOHSC: 2018 (2005)], ensure that they remain clearly labelled and regularly inspect to ensure they are not deteriorating or otherwise contributing to an unacceptable health risk.</p>	Photos from April 2021 inspection.
Management Actions	<p>May remain in-situ until replacement is required. Manage as per Asbestos Management Plan. Administrative – Follow safe work procedures during removal and maintenance. Personal protective equipment – P2 facemask and coveralls required when working on material.</p>	
References (See Appendices)	<p>NOHSC 2018 (2005) Appendix C: Selection and use of Personal Protective Equipment (PPE). NOHSC 2018 (2005) Appendix H: Working on Electrical Mounting Boards (switchboards) Containing Asbestos. NOHSC 2002 (2005) Part 12 Section 12.5 Removal of Asbestos Switchboards or Meterboards.</p>

Service Record	<p>Review in 12 Months – December 2022. Company: Date: Works: Clearance certificate:</p>	
Further Details	<p>All coal tar pitch boards should be presumed to contain asbestos Brand names include Zelemite, Miscolite and Lebah</p>

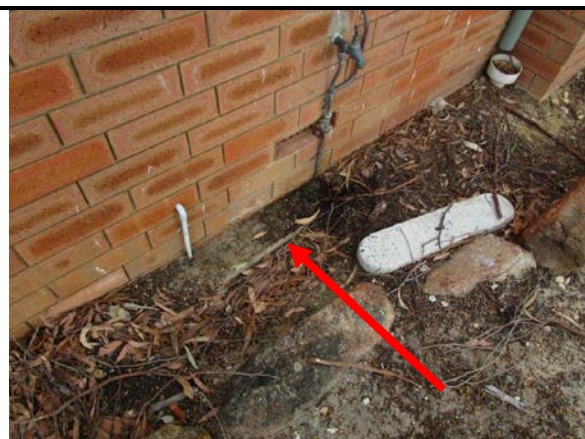
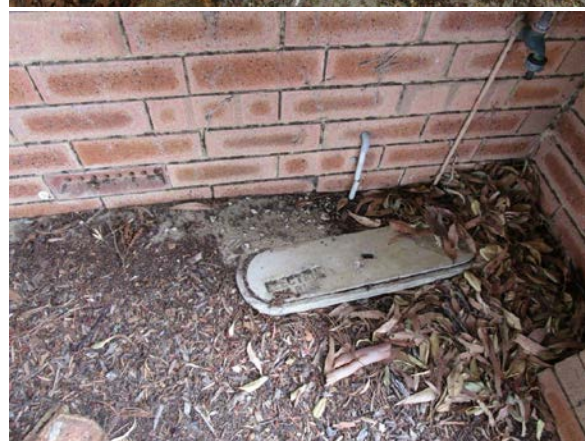
ID 4:- Cable Pit Surrounds (Asbestos Detected)	
Material	Chrysotile and amosite asbestos detected.
Lab No.	ARL Lab No. 20-07224-6 and 7.
QED Sample No.	Sampled by City of Kalamunda and Hill Top Group in April 2020.
Locations	West and south sides of the building under the eaves.
Condition	Good, intact, non-friable.
Signage	Labelling not practical.
Potential for Disturbance	Medium.
Risk	<p style="background-color: yellow; text-align: center;"> The ACM are not friable and are in stable condition. In accordance with [NOHSC: 2018 (2005)], ensure that they remain clearly labelled and regularly inspect to ensure they are not deteriorating or otherwise contributing to an unacceptable health risk. </p>
Management Actions	<p>May remain in-situ until replacement is required.</p> <p>Manage as per Asbestos Management Plan.</p> <p>Administrative – Follow safe work procedures during removal and maintenance.</p> <p>Personal protective equipment – P2 facemask and coveralls required when working on material.</p>

Photos from April 2021 inspection.

References (See Appendices)	<p>NOHSC 2018 (2005) Appendix C: Selection and use of Personal Protective Equipment (PPE).</p> <p>NOHSC 2018 (2005) Appendix D: Drilling of Asbestos Containing Materials.</p> <p>NOHSC 2018 (2005) Appendix E: Sealing, Painting, Coating and Cleaning of Asbestos Cement Products.</p> <p>NOHSC 2018 (2005) Appendix G: Replacing Cabling in Asbestos Cement Conduits or Boxes.</p> <p>NOHSC 2002 (2005) Part 12 Section 12.1 Removal of Asbestos Cement Products.</p>
Service Record	<p>Review in 12 Months – December 2022.</p> <p>Company:</p> <p>Date:</p> <p>Works:</p> <p>Clearance certificate:</p>

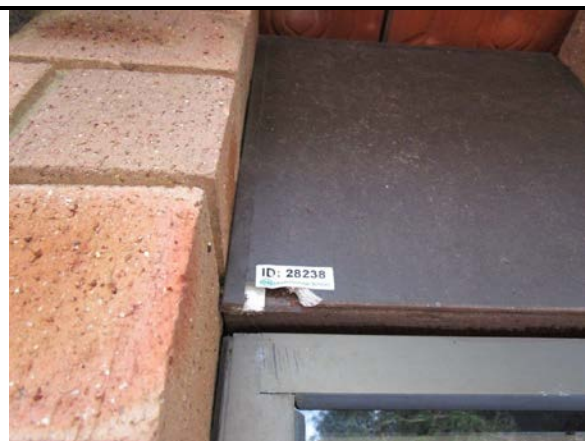
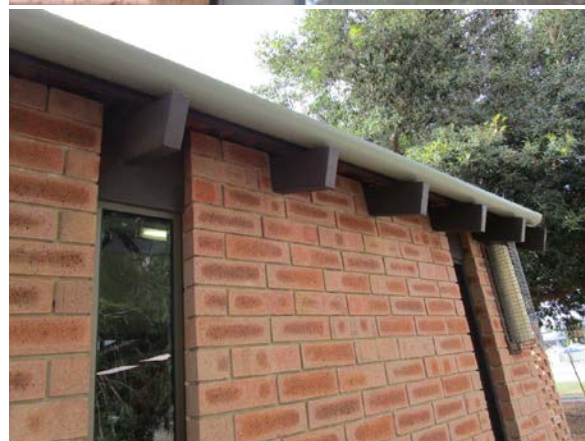
ID 5:- Window Panelling (Asbestos Detected)	
Material	Chrysotile asbestos detected.
Lab No.	Eurofins ARL Lab No. 21-10098-106.
QED Sample No.	ID: 28238.
Locations	Above the low-level windows.
Condition	Good to fair, typically sealed, small areas of damage, non-friable.
Signage	None.
Potential for Disturbance	Low to medium.
Risk	<p>The ACM are not friable and are in stable condition. In accordance with [NOHSC: 2018 (2005)], ensure that they remain clearly labelled and regularly inspect to ensure they are not deteriorating or otherwise contributing to an unacceptable health risk.</p>
Management Actions	<p>Requires labelling. May remain in-situ until replacement is required. Manage as per Asbestos Management Plan. Administrative – Follow safe work procedures during removal and maintenance. Personal protective equipment – P2 facemask and coveralls required when working on material.</p>
References (See Appendices)	<p>NOHSC 2018 (2005) Appendix C: Selection and use of Personal Protective Equipment (PPE). NOHSC 2018 (2005) Appendix D: Drilling of Asbestos-containing Materials. NOHSC 2018 (2005) Appendix E: Sealing, Painting, Coating and Cleaning of Asbestos Cement Products. NOHSC 2002 (2005) Part 12 Section 12.1 Removal of Asbestos Cement Products.</p>

Photos from April 2021 inspection.

Service Record	<p>Review in 12 Months – December 2022. Company: Date: Works: Clearance certificate:</p>

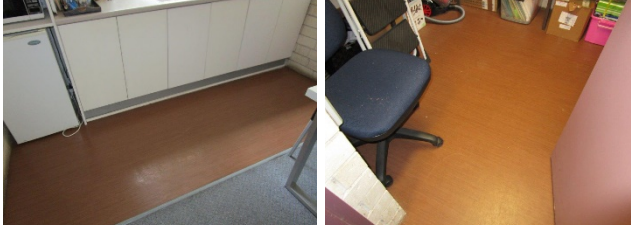
Item Description	Lab No.	Location		Comments
Vinyl floor sheeting.	Greencap Report No. 42333. QED ID: 28240.	Storeroom, kitchen and cleaners' room.

No asbestos detected.
