# ASBESTOS MATERIALS REGISTER

Report ID: 28211r3 – supersedes  
28211r2

**Building 7078 – Pat Moran Pavilion (Kostera), 3  
Recreation Rd, Kalamunda WA 6076**

**Reinspection conducted by City of Kalamunda**

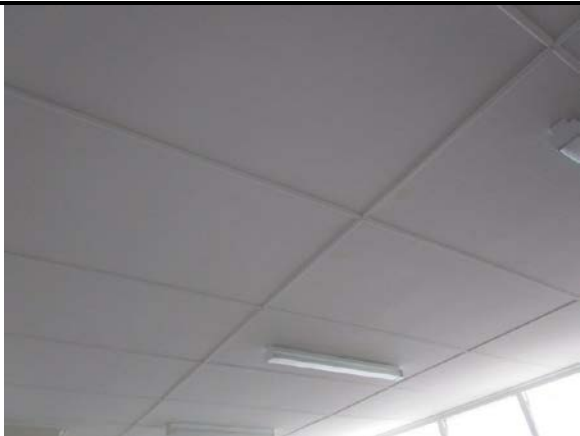
<b>ID 1:- Ceiling Panelling (Removed)</b>	
Material	Chrysotile and amosite asbestos detected.
Lab No.	Eurofins ARL Lab No. 21-10098-68.
QED Sample No.	ID: 32463.
Locations	Removed from Visitors #1 & Visitors #2 Auskick ceiling – no asbestos detected
Condition	N/A.
Signage	N/A.
Potential for Disturbance	N/A.
<b>Risk</b>	N/A.
Management Actions	N/A.
References (See Appendices)	N/A.
Service Record	Company: Rapid Asbestos Removal Date: 16/03/2022 Works: Removal of visitor 1 and visitor 2 Changeroom Panels Clearance certificate: Peter Shades – 16/03/2022

Photos from March 2021 inspection.

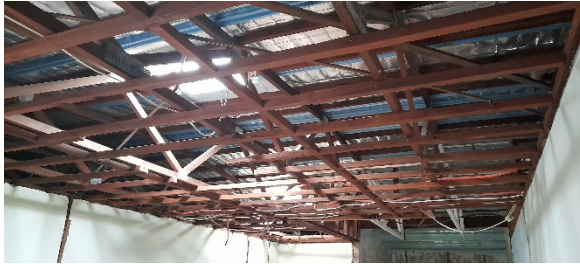
16 March 2022 - changeroom

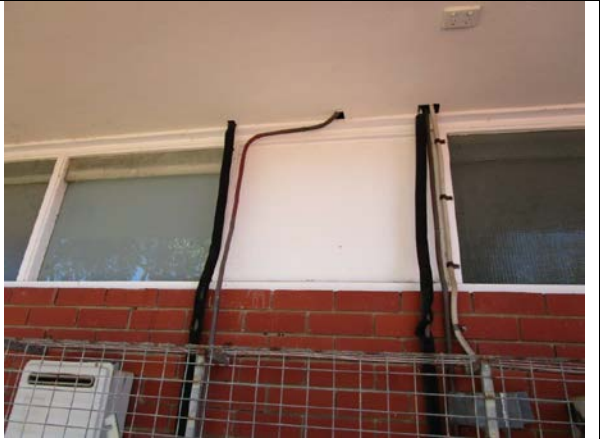
<b>ID 2:- Window Infill Panelling (Removed)</b>

<p>Photos from March 2021 inspection.</p>

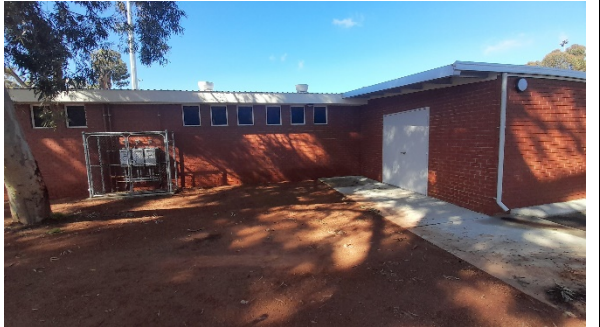
<p>27 July 2022 – photo supplied by City of Kalamunda</p>
Material	Chrysotile asbestos detected.	
Lab No.	Eurofins ARL Lab No. 21-10098-73.	
QED Sample No.	ID: 32468.	
Locations	Window panelling at the rear of the building.	
Condition	N/A.	
Signage	N/A.	
Potential for Disturbance	N/A.	
<b>Risk</b>	N/A.	
Management Actions	N/A.	
References (See Appendices)	N/A.	
Service Record	<p>Company: Unknown  Date: Between March 2021 and 27 July 2022  Works: external window infill panelling has been removed during the recent renovations at Pat Moran Pavilion  Clearance certificate: None.</p>
