Proposed Garden Centre, 720 Welshpool Road East, Wattle Grove Preliminary Design Stage (Stage 2) Road Safety Audit

PREPARED FOR:
Peritas Group

November 2022

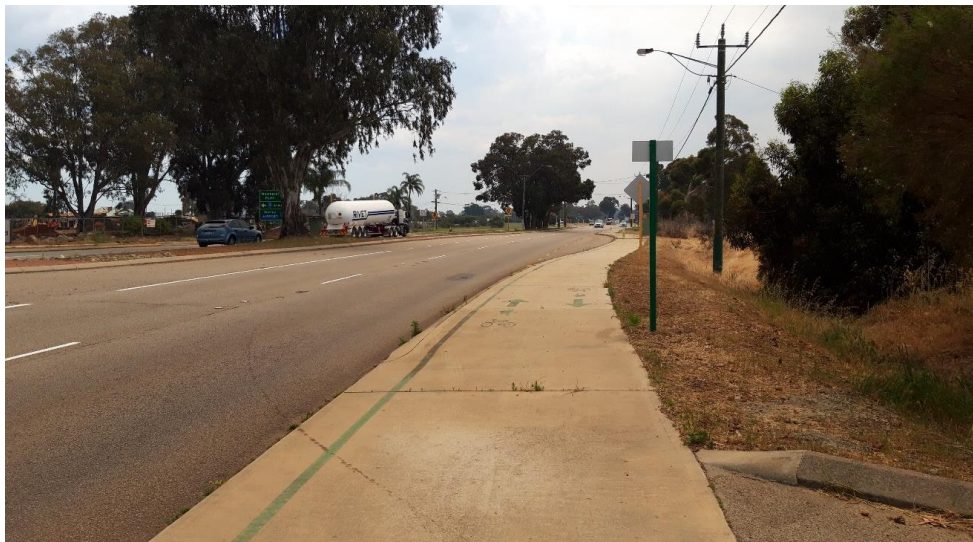
Figure 2: Westbound view along Welshpool Road East in the vicinity of the subject site

Welshpool Road East in the vicinity of the subject site is a four-lane dual carriageway road with a kerbed and landscaped central median. Each carriageway is approximately 7.4m wide and the median varies in width from approximately 4.5m near the western property boundary to approximately 8.5m wide near the eastern property boundary. Median breaks and turn pockets are provided at multiple locations in this vicinity. These turn pockets are not compliant with respect to the requirements of Austroads Guidelines as it relates to deceleration length requirements. A pedestrian footpath on the southern and a shared path on the northern side of Welshpool Road East is in place in the vicinity of the subject site.

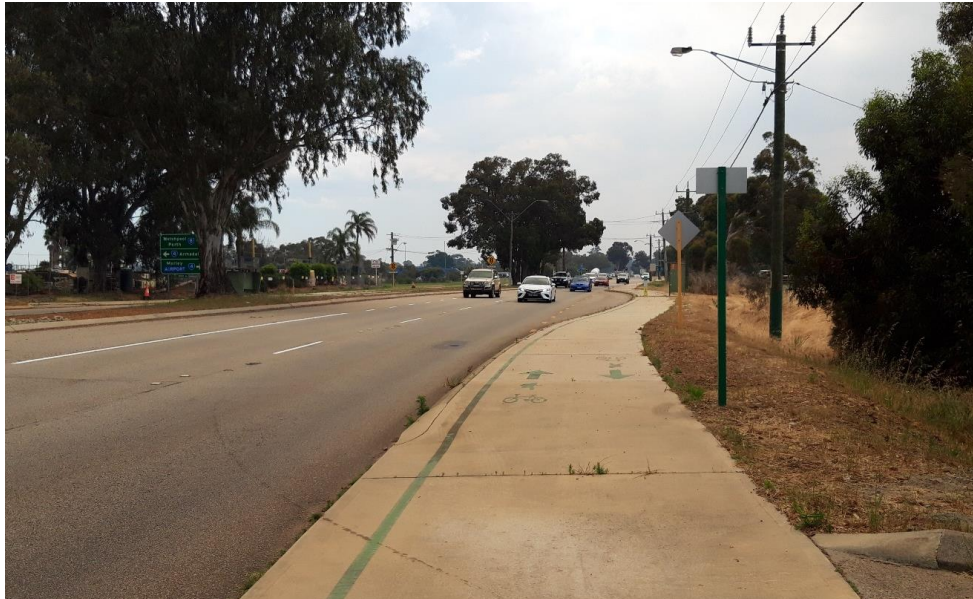
Figure 4: Westbound view along Welshpool Road East in the vicinity of the future garden centre crossover

The proposed left-turn deceleration facility for the new garden centre crossover incorporates an existing bus stop embayment. A bus parked within the embayment may impact on the sightlines to the Welshpool Road East traffic incoming from the west. Refer **Figure 4** for illustration.

This situation is potentially undesirable and can lead to drivers undertaking unsafe egress movements from the site as a result of restricted/inhibited sightlines.

Investigate sight lines at the proposed crossover when a bus is parked within the turn lane in accordance with AS2890.1 for a crossover/driveway. If the sight line is not adequate investigate the feasibility of relocation of the existing bus stop further east and downstream of the existing location or deeper within the verge through liaison with PTA in order to avoid impact on sightlines at the proposed garden centre crossover.
