# Revegetation within the NW corner of Lot 150 Welshpool Road East, Wattle Grove, West Australia

## Plantation and Landcare Services Pty Ltd

### Revegetation within the NW corner of lot 150 Welshpool Road East, Wattle Grove

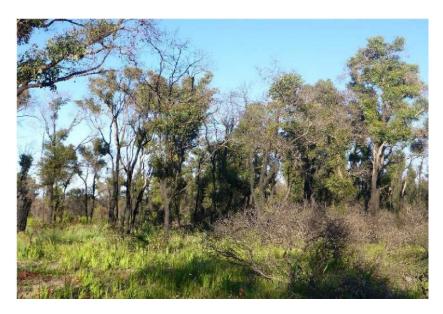
Pic 1; Although the trees (jarrah/marri) are recovering from the fire their form and health is very poor.

As a result of the very poor hygiene and form of these trees they were pushed up by the current owner.

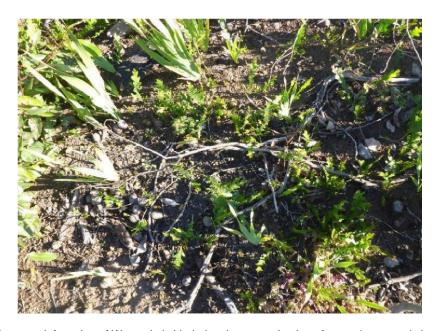
Pic 2: A severe infestation of Watsonia is hindering the regermination of groundcover and shrubs

The current owner's foresight in his quest to rehabilitate the site include an extensive spraying program to eradicate the Watsonia. This has been carried out at the owners expense.

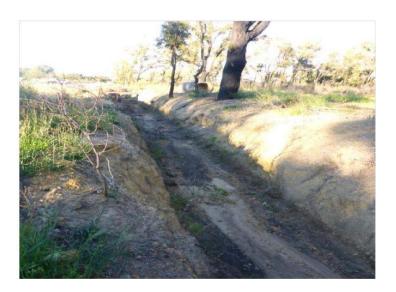
Pic 3 Photo taken October 2016. No water is evident in this channel which was built to contain overflow from the severe weather/rainfall events

The western channel has been constructed to take the <u>overflow</u> from the main channel in the serve rainfall events.

It is envisaged that the secondary channel was constructed to concentrate and contain the peak water flows from spreading across the neighbouring farmland. The secondary channel is situated outside the boundary of Lot 150.

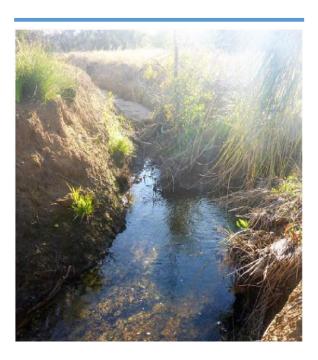
Pic4: The general condition of the main channel. Weeds will be sprayed and the batter slopes revegetated with sedges and rushes as per species list

Within Lot 150 Welshpool Road East the river flows in a channel set approximately 1.5 to 2.5 metres below the surrounding topography. The elevation at the top of the river bank is approximately 26.5 to 27.5 m AHD and the river floor is set at about 24 m AHD. At the time of inspection on 11 October 2016, the river width varied from 1.0 meters to 1.5 meters.

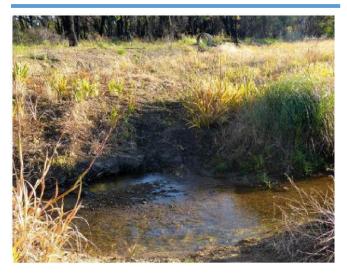
Pic 5 : The only crossing onto the main area which will be revegetated. This crossing will be used for access to the main area

A small crossover/ford is position in the southern corner of the main channel. This should be left as is to help within access both through the revegetation phase and maintenance. It will help with fire access if required

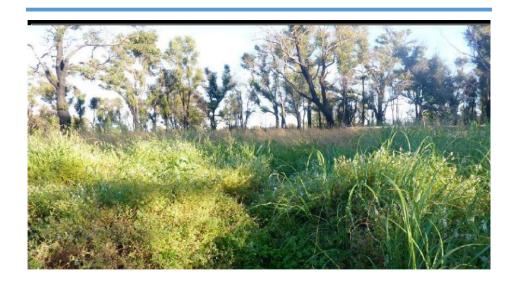
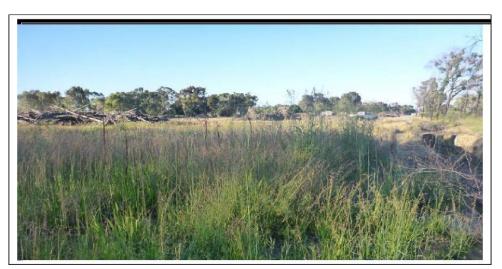
Intensive weed control program has commenced. Continual spraying and control of weeds will be the key to this project It is recommended that the weeds be mechanically removed and disposed of to ensure the site is clean of weeds prior to site preparation
