ASBESTOS REGISTER

Carmel School (Scouts), 101 Carmel Road, Carmel, WA

Report ID: **34725Br0**

Prepared for: **City of Kalamunda**

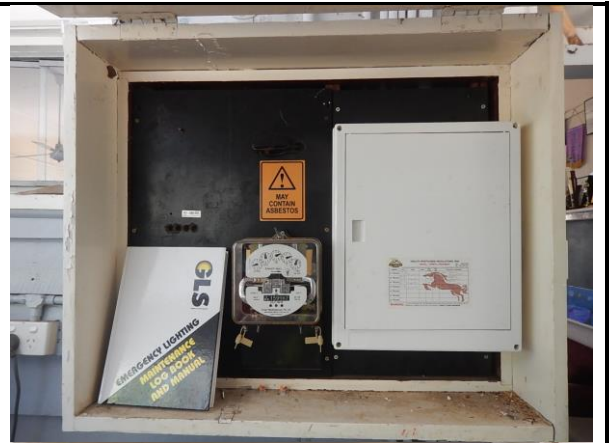
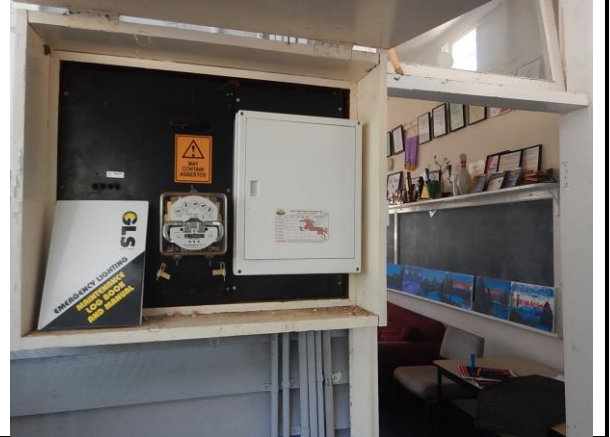
ID 3:- Electrical Mounting Board (Asbestos Detected)	
Material	Chrysotile asbestos detected.
Lab No.	Eurofins ARL Lab No. 21-10098-29.
QED Sample No.	ID: 28155.
Locations	Internal – Kitchen electrical cabinet.
Condition	Good, non-friable.
Signage	Labelled.
Potential for Disturbance	Low.
Risk	<p>The ACM are not friable and are in stable condition. Ensure that they remain clearly labelled and regularly inspect to ensure they are not deteriorating or otherwise contributing to an unacceptable health risk.</p>
Management Actions	<p>May remain in-situ until replacement is required. Manage as per Asbestos Management Plan. Administrative – Follow safe work procedures during removal and maintenance. Personal protective equipment – P2 facemask and coveralls required when working on material.</p>
References (See Appendices)	<p>Safe Work Australia, Code of Practice: How to Manage and Control Asbestos in the Workplace. WHS Appendix G—Recommended safe working practices Safe work practice 5—Working on electrical mounting boards (switchboards) containing asbestos Safe Work Australia, Code of Practice: How to Safely Remove Asbestos Appendix E—Examples of asbestos removal work Asbestos cement products</p>

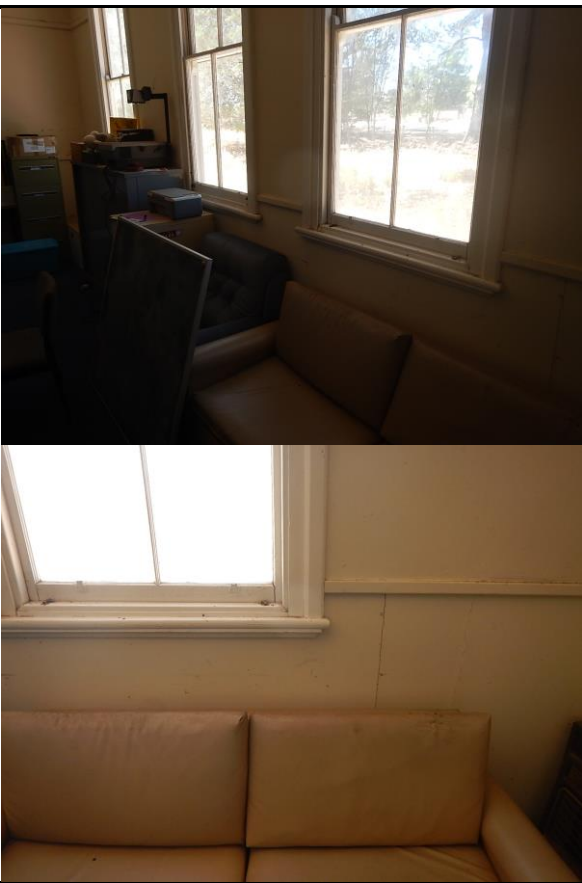
ID 4:- Fibre Cement Panelling –Wall Panelling (Asbestos Detected)

Material	Chrysotile and crocidolite asbestos detected.	
Lab No.	Eurofins ARL Lab No. 21-10098-37.	
QED Sample No.	ID: 28157.	
Locations	Internal – Large/main Classroom, wall panels (below windows).	
Condition	Good, sealed, non-friable.	
Signage	Labelled.	
Potential for Disturbance	Low.	
Risk	<p>The ACM are not friable and are in stable condition. Ensure that they remain clearly labelled and regularly inspect to ensure they are not deteriorating or otherwise contributing to an unacceptable health risk.</p>	
Management Actions	<p>May remain in-situ until replacement is required. Manage as per Asbestos Management Plan. Administrative – Follow safe work procedures during removal and maintenance. Personal protective equipment – P2 facemask and coveralls required when working on material.</p>	
References (See Appendices)	<p>Safe Work Australia, Code of Practice: How to Manage and Control Asbestos in the Workplace. WHS Appendix G—Recommended safe working practices Safe work practice 1—Drilling of ACM Safe work practice 2—Sealing, painting, coating and cleaning of asbestos cement products Safe Work Australia, Code of Practice: How to Safely Remove Asbestos Appendix E—Examples of asbestos removal work Asbestos cement products</p>

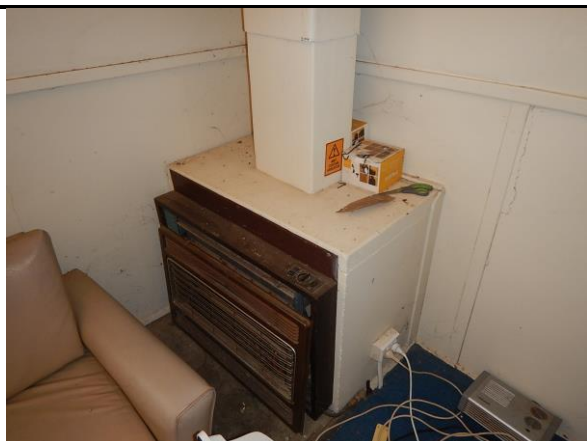
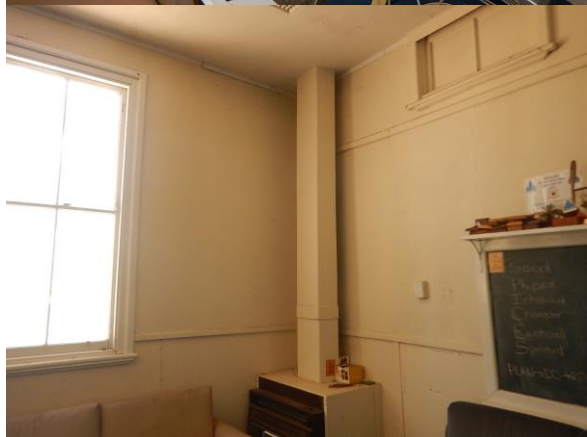
ID 5:- Classroom Heating Unit Flue Pipe (Asbestos Detected)	
Material	Chrysotile and amosite asbestos detected.
Lab No.	Eurofins ARL Lab No. 21-10098-35.
QED Sample No.	ID: 28158.
Locations	Internal – Large/main Classroom, heating unit exhaust pipe.
Condition	Good, sealed, non-friable.
Signage	Labelled.
Potential for Disturbance	Low.
Risk	<p>The ACM are not friable and are in stable condition. Ensure that they remain clearly labelled and regularly inspect to ensure they are not deteriorating or otherwise contributing to an unacceptable health risk.</p>
Management Actions	<p>May remain in-situ until replacement is required. Manage as per Asbestos Management Plan. Administrative – Follow safe work procedures during removal and maintenance. Personal protective equipment – P2 facemask and coveralls required when working on material. Conduit has been sealed in wall, use caution when drilling through walls.</p>

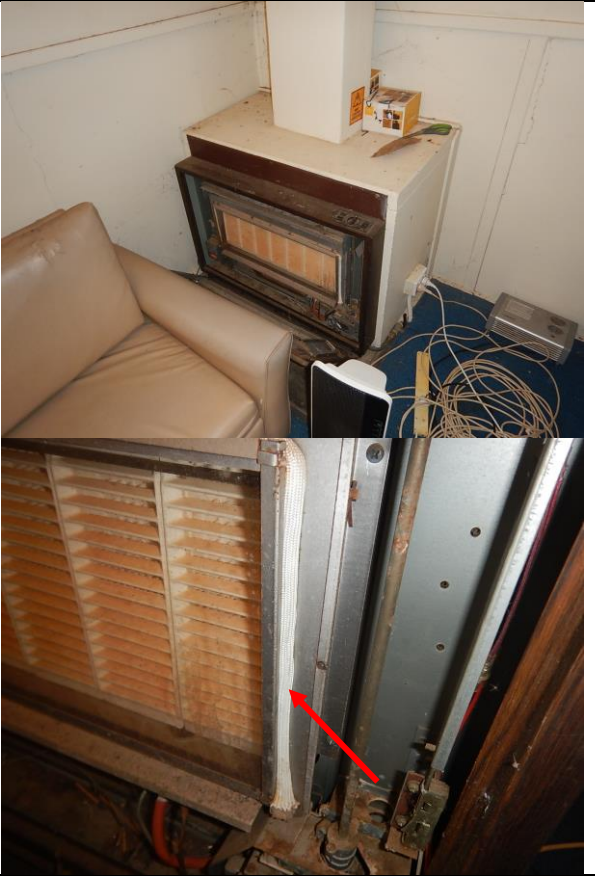
ID 6:- Electrical Heating Unit – Textile Seal (Suspected Asbestos Containing Material)

Material	Suspected asbestos containing material.	
Lab No.	Unable to obtain suitable sample (Live).	
QED Sample No.	ID: N/A.	
Locations	Internal – Large/main Classroom, heating unit textile seal to access hatch.	
Condition	Unsealed, non-friable.	
Signage	None.	
Potential for Disturbance	Low to medium.	
Risk	<p>The ACM are not friable and are in stable condition. Ensure that they remain clearly labelled and regularly inspect to ensure they are not deteriorating or otherwise contributing to an unacceptable health risk.</p>	
Management Actions	<p>Label when practical. If works are planned on material, ensure a sample is taken prior to confirm asbestos presence/non-presence. May remain in-situ until replacement is required. Manage as per Asbestos Management Plan. Administrative – Follow safe work procedures during removal and maintenance. Personal protective equipment – P2 facemask and coveralls required when working on material.</p>

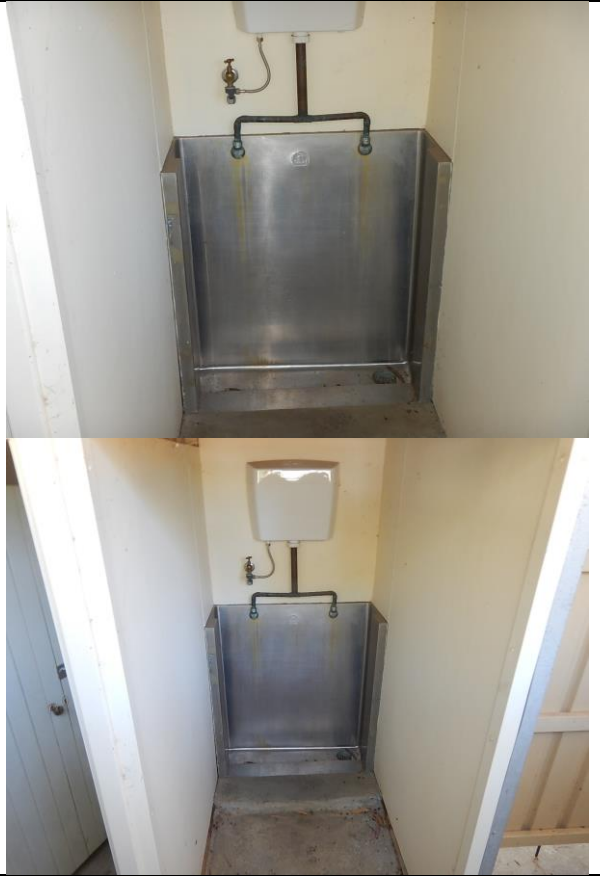
ID 7:- Urinal Backing Membrane (Suspected Asbestos Containing Material)

Material	Suspected asbestos containing material.	
Lab No.	Unable to sample (encapsulated)	
QED Sample No.	ID: N/A.	
Locations	External Toilet - Urinal.	
Condition	Encased, intact, non-friable.	
Signage	Unable to adequately label.	
Potential for Disturbance	Low.	
Risk	<p>The ACM are not friable and are in stable condition. Ensure that they are regularly inspected to ensure they are not deteriorating or otherwise contributing to an unacceptable health risk.</p>	
Management Actions	<p>May remain in-situ until replacement is required. Manage as per Asbestos Management Plan. Administrative – Follow safe work procedures during removal and maintenance. Personal protective equipment – P2 facemask and coveralls required when working on material.</p>	
References (See Appendices)	<p>Safe Work Australia, Code of Practice: How to Manage and Control Asbestos in the Workplace. Safe Work Australia, Code of Practice: How to Safely Remove Asbestos Appendix E—Examples of asbestos removal work Removing bituminous (malthoid) products</p>

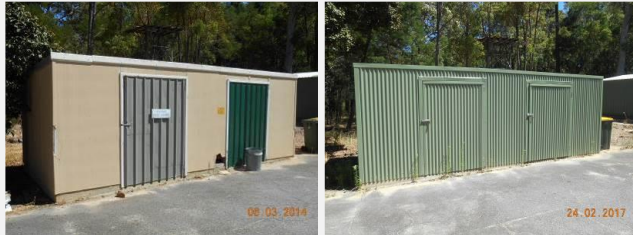
Item Description	Lab No.	Location	Photo	Comments
External storage shed	Removed	External storage shed

<p style="text-align: center;">2014 2017</p>	<p>Removed 2017.</p> <p>Information taken from the City of Kalamunda register:</p> <p>Building: Carmel School</p> <p>Asset ID: BD_5011-00 to BD_5011-04</p> <p>Date Inspected: 09-Dec-2019</p>
Toilet wall panelling: external walls, Dividing walls between M & F	Removed between 2015 and 2016 audits	Rear toilet block

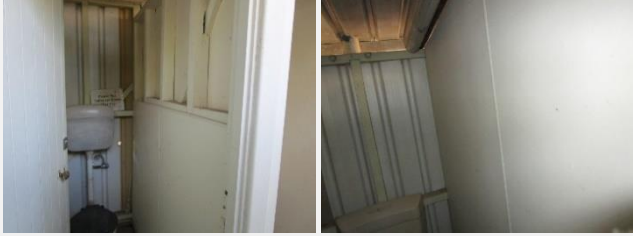
No asbestos detected. Organic fibres detected.
Toilet wall panels	Eurofins ARL Lab No. 21-10098-33 QED ID: 28160	External toilet block

No asbestos detected. Organic fibres detected.
Window Mastic	Eurofins ARL Lab No. 21-10098-34 QED ID: 28159	Windows throughout the building.
