# ASBESTOS REGISTER

Dome Café (Old Police Station), 31 Canning Road, Kalamunda, WA

Report ID: **34744Br0**

Prepared for: **City of Kalamunda**

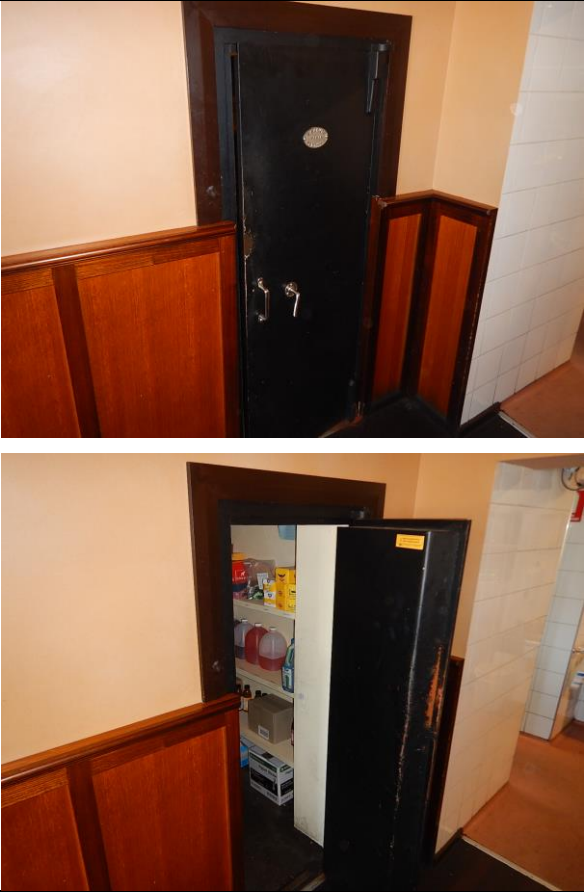
<b>ID 1:- Safe Internal Insulation (Suspected Asbestos Containing Material)</b>

Material	Suspected asbestos containing material.	
Lab No.	N/A.	
QED Sample No.	ID: Observed.	
Locations	Internal – Small storeroom adjacent order counter/kitchen entry door.	
Condition	Encased, sealed, friable.	
Signage	Labelled.	
Potential for Disturbance	Low.	
<b>Risk</b>	<p><b>The ACM are friable but are encapsulated within the door skins. Ensure that they remain clearly labelled and regularly inspect to ensure they are not deteriorating or otherwise contributing to an unacceptable health risk.</b></p>	
Management Actions	<p>Asbestos thermal insulation may only be disturbed by a contractor holding a Class A Asbestos Removal License.                  May remain in-situ until replacement is required.                  Manage as per <b>Asbestos Management Plan</b>.                  Administrative – Follow safe work procedures during removal and maintenance.                  Personal protective equipment – P3 full face powered air respirator and coveralls required during removal of material.</p>

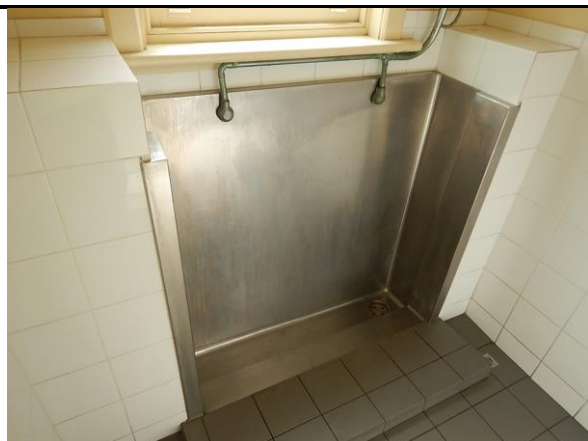
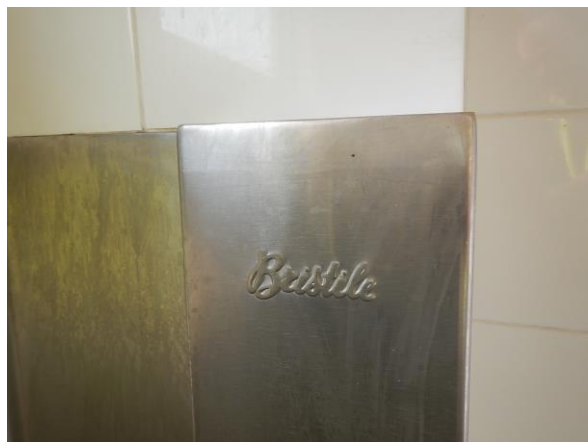
<b>ID 2:- Urinal Backing Membrane (Suspected Asbestos Containing Material)</b>	
Material	Suspected asbestos containing material.
Lab No.	Unable to sample (encapsulated)
QED Sample No.	ID: N/A.
Locations	Internal - Male toilets, urinal.
Condition	Encased, non-friable.
Signage	Unable to adequately label.
Potential for Disturbance	Low.
<b>Risk</b>	<p><b>The ACM are not friable and are in stable condition. Ensure that they are regularly inspected to ensure they are not deteriorating or otherwise contributing to an unacceptable health risk.</b></p>
Management Actions	<p>May remain in-situ until replacement is required.                  Manage as per <b>Asbestos Management Plan</b>.                  Administrative – Follow safe work procedures during removal and maintenance.                  Personal protective equipment – P2 facemask and coveralls required when working on material.</p>
References (See Appendices)	<p><b>Safe Work Australia, Code of Practice: How to Manage and Control Asbestos in the Workplace.</b>  <b>Safe Work Australia, Code of Practice: How to Safely Remove Asbestos</b>  <b>Appendix E—Examples of asbestos removal work</b>                  Removing bituminous (malthoid) products</p>

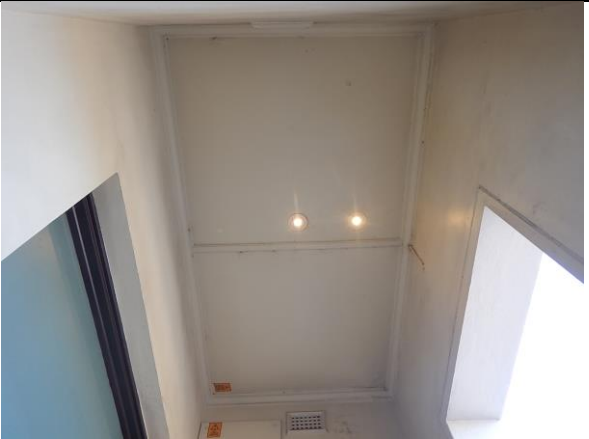
<b>ID 3:- Fibre Cement Ceiling Panelling (Suspected Asbestos Containing Material)</b>

Material	Suspected asbestos containing material.	
Lab No.	Unable to obtain suitable sample [height/public in area].	
QED Sample No.	ID: Observed.	
Locations	External – Entry walkway into Café (Canning Road entry).	
Condition	Good, sealed, non-friable.	
Signage	Labelled.	
Potential for Disturbance	Low.	
<b>Risk</b>	<p><b>The ACM are not friable and are in stable condition. Ensure that they remain clearly labelled and regularly inspect to ensure they are not deteriorating or otherwise contributing to an unacceptable health risk.</b></p>	
Management Actions	<p>May remain in-situ until replacement is required.                  Manage as per <b>Asbestos Management Plan</b>.                  Administrative – Follow safe work procedures during removal and maintenance.                  Personal protective equipment – P2 facemask and coveralls required when working on material.</p>

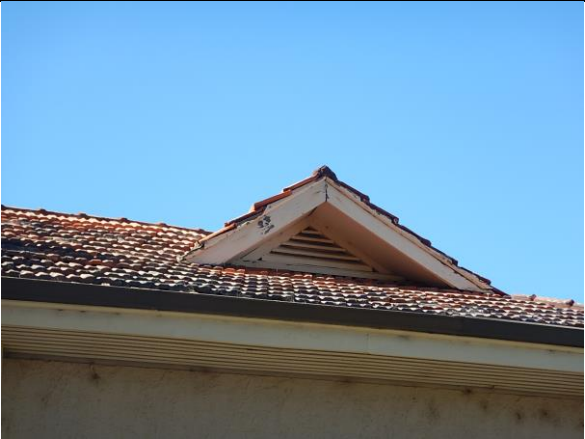
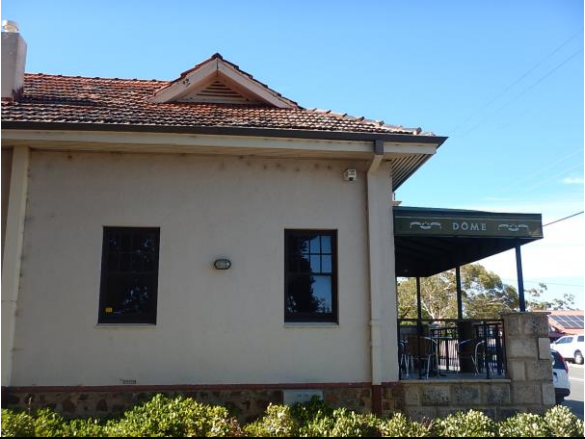
<b>ID 4:- Fibre Cement Eave Panelling (Suspected Asbestos Containing Material)</b>

Material	Suspected asbestos containing material.	
Lab No.	Unable to obtain suitable sample [height/public in area].	
QED Sample No.	ID: Observed.	
Locations	External – Roof gable ends, eave linings.	
Condition	Good, sealed, non-friable.	
Signage	Unable to label.	
Potential for Disturbance	Low.	
<b>Risk</b>	<p><b>The ACM are not friable and are in stable condition. Ensure that they remain clearly labelled and regularly inspect to ensure they are not deteriorating or otherwise contributing to an unacceptable health risk.</b></p>	
Management Actions	<p>Label material if/when practical.            May remain in-situ until replacement is required.            Manage as per <b>Asbestos Management Plan</b>.            Administrative – Follow safe work procedures during removal and maintenance.            Personal protective equipment – P2 facemask and coveralls required when working on material.</p>

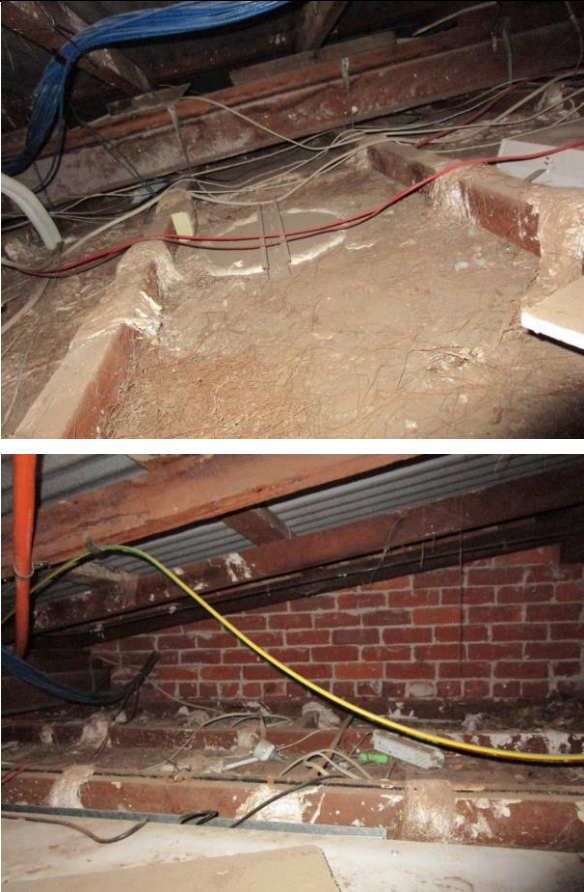
<b>ID 6:- Asbestos Containing Dust and Debris (ACD) (Asbestos Detected)</b>

Material	Chrysotile, amosite and crocidolite asbestos detected.	
Lab No.	Eurofins ARL Lab No. 21-10098-186.	
QED Sample No.	ID: 32461.	
Locations	Internal – Ceiling space (observed in man hole adjacent offices/toilets).	
Condition	Poor, minor contamination considered friable.	
Signage	None.	
Potential for Disturbance	Low to medium (due to restricted access).	
<b>Risk</b>	<p align="center"><b>IMMEDIATE ACTION REQUIRED.</b>  <b>The ACM are friable and not in a stable condition, and there is a risk to health from exposure. Ensure that they are removed by an appropriately licensed asbestos removalist as soon as is practicable.</b></p>	2021 Photographs.
Management Actions	<p>Unable to access during 2023 inspections (publicly occupied). When/if practical, it is recommended to conduct an inspection of the ceiling space to detail the extent of contamination, then have this material removed.</p> <p>QED Environmental Services must be consulted prior to commencement of any works that require access to the ceiling space to develop controls that will prevent dust from the ceiling space entering the occupied areas of the building.</p> <p>Access to the ceiling space should be restricted, and if access is required, minimum asbestos PPE is required (overalls Type 5/6, P2 mask, gloves, etc).</p> <p>QED strongly recommends appointing a Class A asbestos removal license holder to complete the decontamination. Restrict access to the enclosure until area is remediated.</p>

ID #	Product	Location
6	Asbestos Containing Dust and Debris.	Internal – Ceiling space (observed in manhole adjacent offices/toilets).
<i>Recommendations:</i> It is recommended to conduct an inspection of the ceiling space to detail the extent of contamination, then have this/these material/s removed.

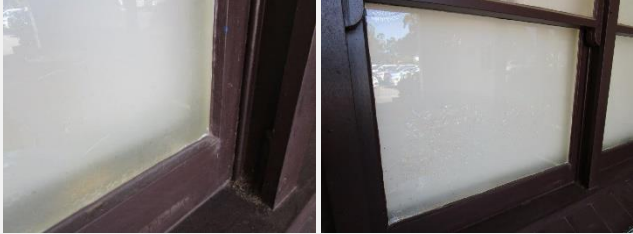
No asbestos detected.
<b>Window Mastic.</b>	Eurofins ARL Lab No. 21-10098-184.  QED ID: 32459.	Window frames throughout the buildings.

No asbestos detected.
