ASBESTOS REGISTER

Forrestfield Tennis Club, Morrison Road, Forrestfield, WA

Report ID: **34729Br0**

Prepared for: **City of Kalamunda**

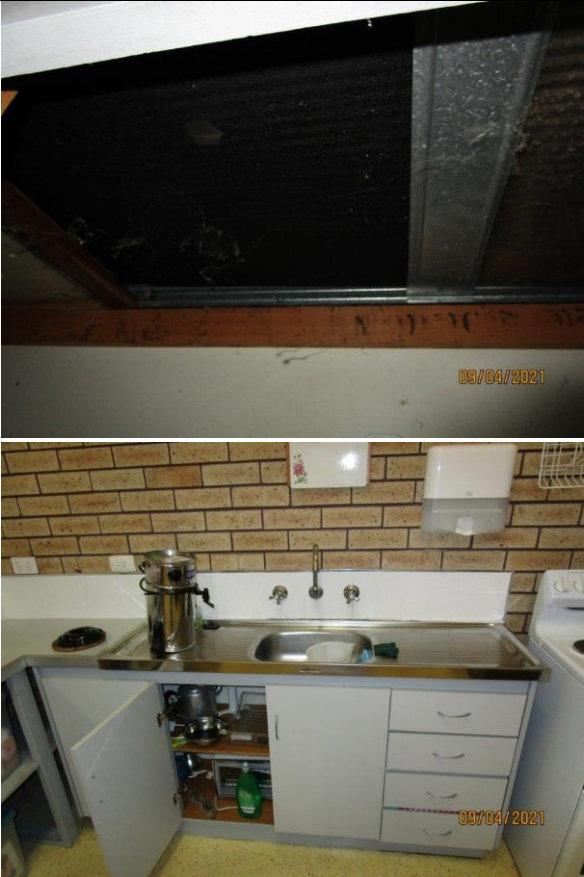
ID 1:- Under Sink Membrane (Asbestos Detected)

Material	Chrysotile asbestos detected.	
Lab No.	Eurofins ARL Lab no. 21-10098-178.	
QED Sample No.	ID: 28260.	
Locations	Internal – Kitchen, sink unit.	
Condition	Good, intact, non-friable.	
Signage	None.	
Potential for Disturbance	Low.	
Risk	<p>The ACM are not friable and are in stable condition. Ensure that they remain clearly labelled and regularly inspect to ensure they are not deteriorating or otherwise contributing to an unacceptable health risk.</p>	
Management Actions	<p>Label when practical. May remain in-situ until replacement is required. Manage as per Asbestos Management Plan. Administrative – Follow safe work procedures during removal and maintenance. Personal protective equipment – P2 facemask and coveralls required when working on material.</p>	
References (See Appendices)	<p>Safe Work Australia, Code of Practice: How to Manage and Control Asbestos in the Workplace. Safe Work Australia, Code of Practice: How to Safely Remove Asbestos Appendix E—Examples of asbestos removal work Removing bituminous (malthoid) products</p>

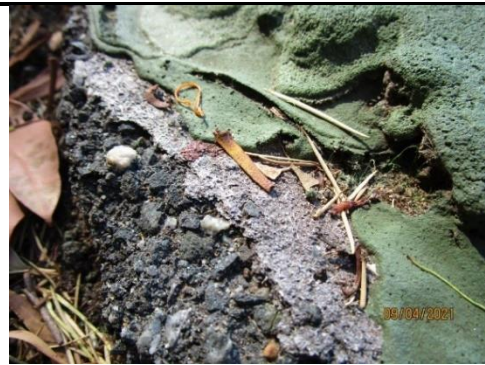
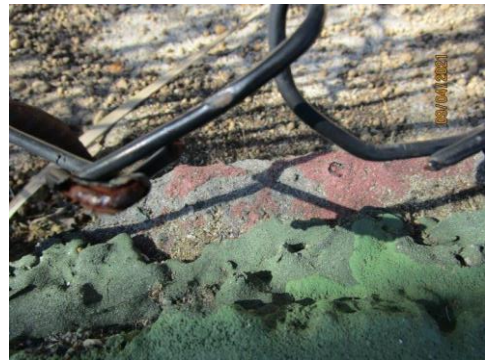
Photos from April 2021 inspection.

ID 2:- Tennis Court Woven Material (Asbestos Detected)	
Material	Chrysotile asbestos detected.
Lab No.	SERS Lab No. 157570.
QED Sample No.	ID: Sample taken by City of Kalamunda (28/06/2019).
Locations	Original red surface layer underneath current green surface as pictured opposite. Core samples have also identified asbestos at 75mm deep.
Condition	Typically good, and encapsulated. Some areas are exposed at the edges, potentially friable.
Signage	Unable to adequately label
Potential for Disturbance	Medium.
Risk	<p>The ACM are not friable and are in stable condition. Ensure that they remain clearly labelled and regularly inspect to ensure they are not deteriorating or otherwise contributing to an unacceptable health risk.</p>
Management Actions	<p>Exposed areas should be encapsulated to improve the condition of the material. May remain in-situ until replacement is required. Manage as per Asbestos Management Plan. Administrative – Follow safe work procedures during removal and maintenance. Personal protective equipment – P2 facemask and coveralls required when working on material.</p>

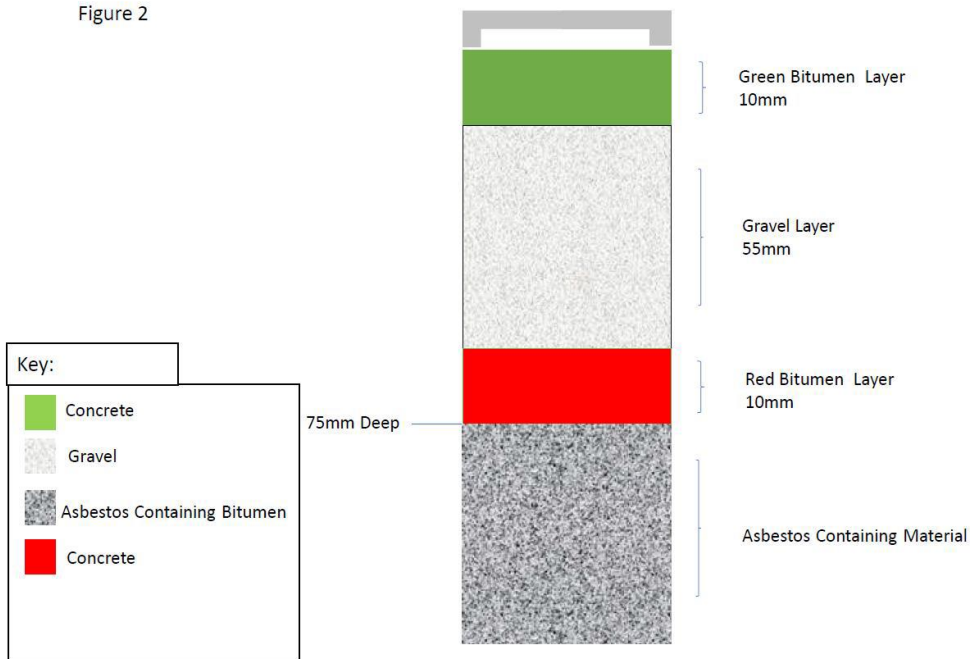
It was found that ACM was present at 75mm below the surface. The 2 resurfaced layers of the court as outlined in Figure 2 show there to be no asbestos present.

It was found that at 75mm there was asbestos fibres present, therefore when restoration of the court takes place SERS recommends that the material underneath 70mm deep is not disturbed unless the adequate precautions are taken.

Crack restoration can take place without disturbing asbestos as the cracks throughout the court are expected to only be surface cracks.
