ASBESTOS REGISTER

Gooseberry Hill Hall & CHC, Ledger Road, Gooseberry Hill, WA

Report ID: **34736Br0**

Prepared for: **City of Kalamunda**

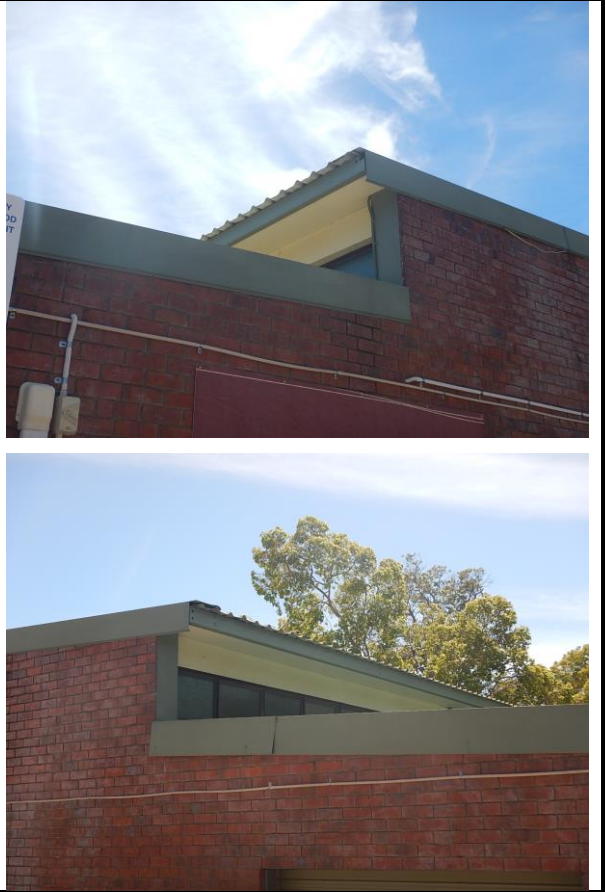
ID 1:- Fibre Cement Eaves and Fascia Panelling (Suspected Asbestos Containing Material)

Material	Suspected asbestos containing material.	
Lab No.	Unable to obtain suitable sample [height].	
QED Sample No.	ID: Observed.	
Locations	External – Eaves and fascia surrounding windows (skillion roof section).	
Condition	Good, sealed, non-friable.	
Signage	None.	
Potential for Disturbance	Low.	
Risk	<p>The ACM are not friable and are in stable condition. Ensure that they remain clearly labelled and regularly inspect to ensure they are not deteriorating or otherwise contributing to an unacceptable health risk.</p>	
Management Actions	<p>Label when practicable. May remain in-situ until replacement is required. Manage as per Asbestos Management Plan. Administrative – Follow safe work procedures during removal and maintenance. Personal protective equipment – P2 facemask and coveralls required when working on material.</p>

References (See Appendices)	<p>Safe Work Australia, Code of Practice: How to Manage and Control Asbestos in the Workplace. WHS Appendix G—Recommended safe working practices Safe work practice 1—Drilling of ACM Safe work practice 2—Sealing, painting, coating and cleaning of asbestos cement products Safe Work Australia, Code of Practice: How to Safely Remove Asbestos Appendix E—Examples of asbestos removal work Asbestos cement products</p>	
Service Record	<p>Review– January 2028 Company: Date: Works: Clearance certificate:</p>

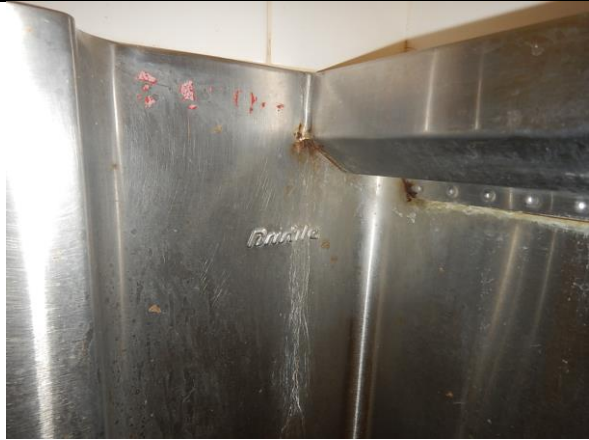
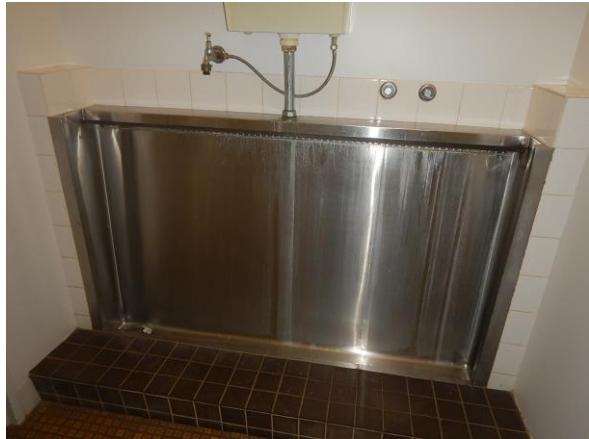
ID 2:- Urinal Backing Membrane (Suspected Asbestos Containing Material)

Material	Suspected asbestos containing material.		
Lab No.	Unable to sample (encapsulated)		
QED Sample No.	ID: N/A.		
Locations	Internal - Male toilets, urinal.		
Condition	Encased, intact, non-friable.		
Signage	Unable to adequately label.		
Potential for Disturbance	Low.		
Risk	<p>The ACM are not friable and are in stable condition. Ensure that they are regularly inspected to ensure they are not deteriorating or otherwise contributing to an unacceptable health risk.</p>

Management Actions	<p>May remain in-situ until replacement is required. Manage as per Asbestos Management Plan. Administrative – Follow safe work procedures during removal and maintenance. Personal protective equipment – P2 facemask and coveralls required when working on material.</p>		
References (See Appendices)	<p>Safe Work Australia, Code of Practice: How to Manage and Control Asbestos in the Workplace. Safe Work Australia, Code of Practice: How to Safely Remove Asbestos Appendix E—Examples of asbestos removal work Removing bituminous (malthoid) products</p>

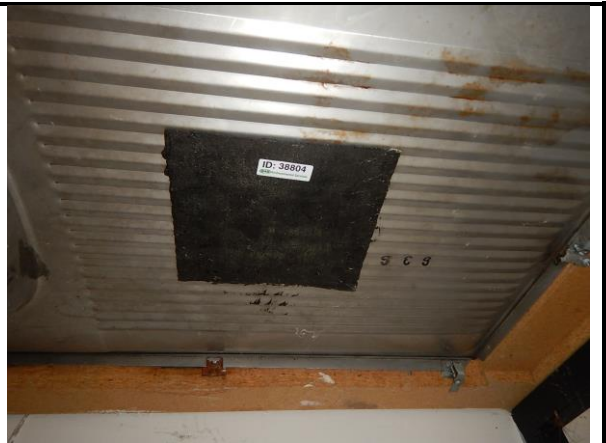
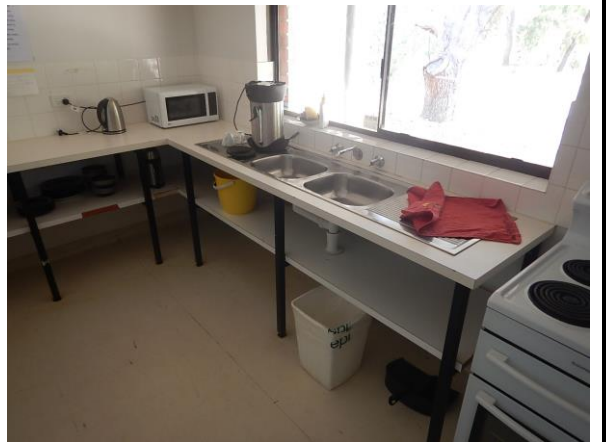
ID 3:- Under Sink Membrane (Presumed Asbestos Containing Material)	
Material	Presumed asbestos containing material.
Lab No.	N/A.
QED Sample No.	ID: Observed.
Locations	Internal – Kitchen, sink unit.
Condition	Composite, intact, non-friable.
Signage	None.
Potential for Disturbance	Low.
Risk	<p>The ACM are not friable and are in stable condition. Ensure that they remain clearly labelled and regularly inspect to ensure they are not deteriorating or otherwise contributing to an unacceptable health risk.</p>
Management Actions	<p>Label when practicable. May remain in-situ until replacement is required. Manage as per Asbestos Management Plan. Administrative – Follow safe work procedures during removal and maintenance. Personal protective equipment – P2 facemask and coveralls required when working on material.</p>
References (See Appendices)	<p>Safe Work Australia, Code of Practice: How to Manage and Control Asbestos in the Workplace. Safe Work Australia, Code of Practice: How to Safely Remove Asbestos Appendix E—Examples of asbestos removal work Removing bituminous (malthoid) products</p>

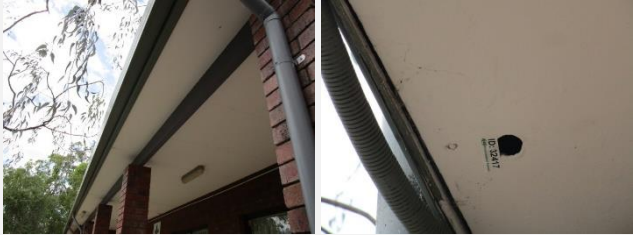
Item Description	Lab No.	Location	Photo	Comments
Front entry veranda ceiling.	ARL Lab No. 21-04932-3. QED ID: 32417.	Front Entrance.

No asbestos detected.
Eave Panelling.	ARL Lab No. 21-04932-2. QED ID: 32415.	Eaves surrounding the building.

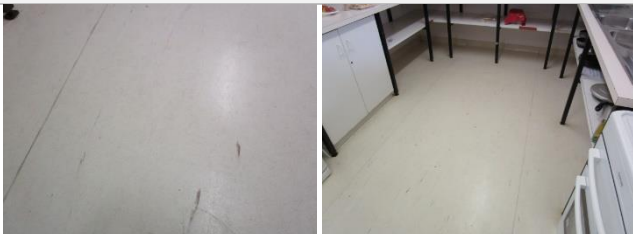
No asbestos detected.
Vinyl floor sheeting.	Greencap Report No. 41864. QED ID: 32416.	Kitchen flooring.

No asbestos detected.
