ASBESTOS REGISTER

Hartfield Country Club, 90 Hartfield Road, Forrestfield, WA

Report ID: **34730Br0**

Prepared for: **City of Kalamunda**

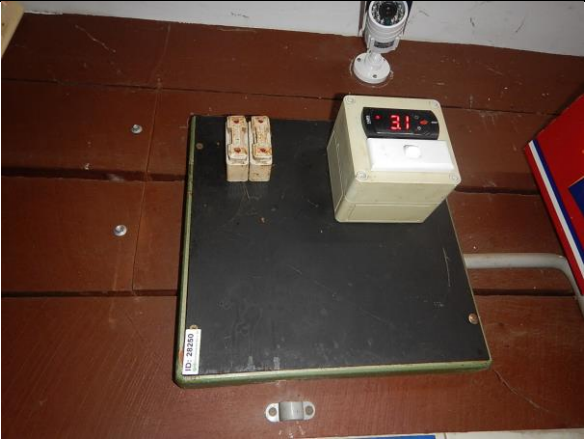
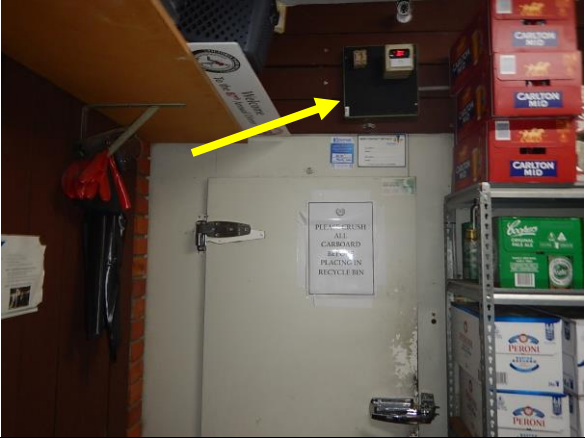
ID 2:- Electrical Mounting Board (Asbestos Detected)

Material	Chrysotile asbestos detected.	
Lab No.	Eurofins ARL Lab No. 21-10098-180.	
QED Sample No.	ID: 28250.	
Locations	Internal – Rear Storeroom, to wall.	
Condition	Good, non-friable.	
Signage	None.	
Potential for Disturbance	Low to medium.	
Risk	<p>The ACM are not friable and are in stable condition. Ensure that they remain clearly labelled and regularly inspect to ensure they are not deteriorating or otherwise contributing to an unacceptable health risk.</p>	
Management Actions	<p>Label when practical. May remain in-situ until replacement is required. Manage as per Asbestos Management Plan. Administrative – Follow safe work procedures during removal and maintenance. Personal protective equipment – P2 facemask and coveralls required when working on material.</p>	
References (See Appendices)	<p>Safe Work Australia, Code of Practice: How to Manage and Control Asbestos in the Workplace. WHS Appendix G—Recommended safe working practices Safe work practice 5—Working on electrical mounting boards (switchboards) containing asbestos</p> <p>Safe Work Australia, Code of Practice: How to Safely Remove Asbestos Appendix E—Examples of asbestos removal work Asbestos cement products</p>

Service Record	<p>Review– January 2028 Company: Date: Works: Clearance certificate:</p>	
Further Details	<p>All coal tar pitch boards should be presumed to contain asbestos Brand names include Zelemite, Miscolite and Lebah</p>

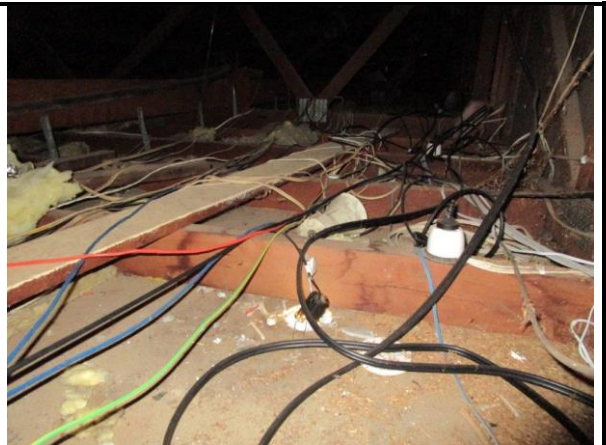
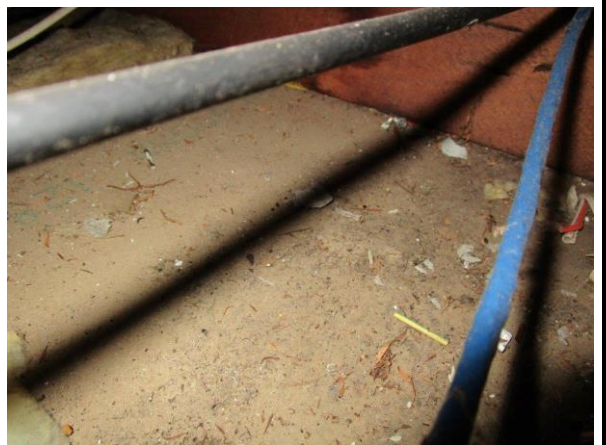
Photos from April 2021 inspection.

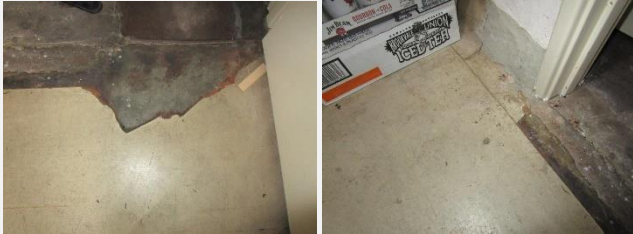
Item Description	Lab No.	Location	Photo	Comments
Vinyl Floor Sheeting.	Greencap Report No. 42331. QED ID: 28251.	Storeroom behind the bar.

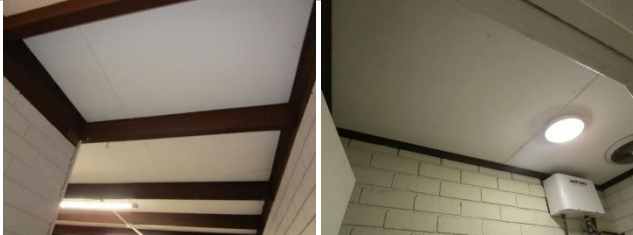
No asbestos detected.
Greenkeepers Office and Store Shed Ceiling Panelling.	Eurofins ARL Lab No. 21-10098-182. QED ID: 28254.	Ceilings throughout the greenkeeper's office, lunchroom, storeroom, locker room and bathroom/toilet.

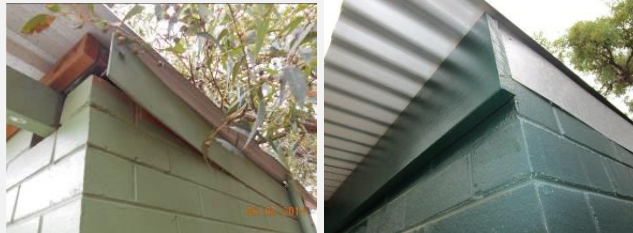
No asbestos detected.
5th and 16th Hole toilet block bord flashing.	Replaced (ARL Lab No. 20-07224-10, 12 and 13.)	Flashing under the roof on the toilet building of the 5 th and 16 th holes.

May 2019 April 2021	Removed between May 2019 and April 2021. Information taken from the City of Kalamunda register: Building: Hartfield Country Club. Asset ID: BD_5030-00 to BD_5030-02, BD_5030-04 to BD_5030-08. Date Inspected: 17-May-2019.
