ASBESTOS REGISTER

History Village (Museum), 15 Williams Road, Kalamunda, WA

Report ID: **34746Br0**

Prepared for: **City of Kalamunda**

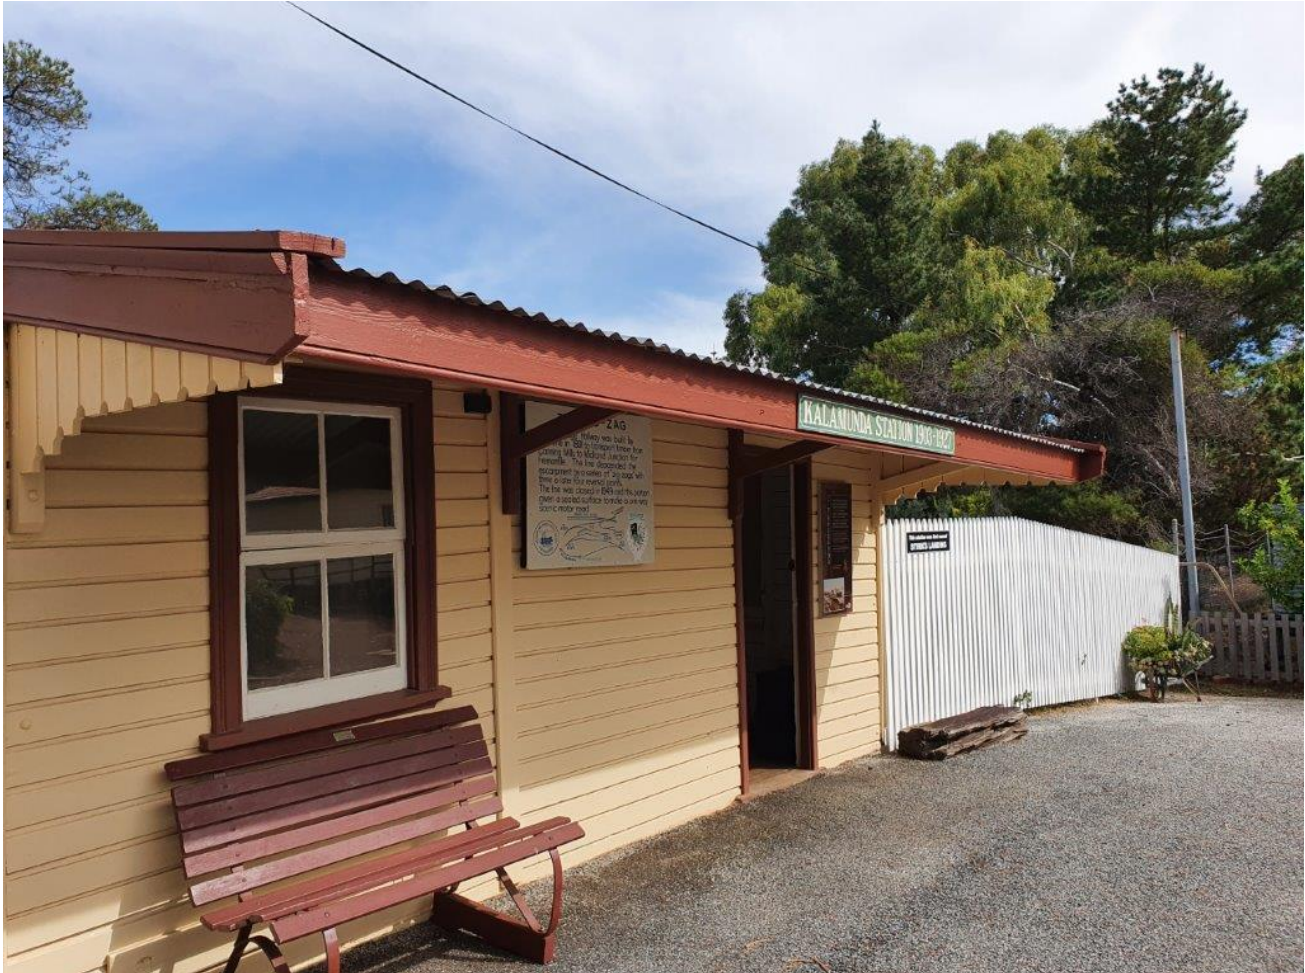
Railway Station 1903 - 1972

ID 1:- Fibre Cement Ceiling Panelling (Asbestos Detected)

Material	Chrysotile asbestos detected.	
Lab No.	Eurofins ARL Lab No. 21-10098-16.	
QED Sample No.	ID: 28281.	
Locations	Railway Station 1903-1972 - Internal – Front room, ceiling panels.	
Condition	Good, sealed non-friable.	
Signage	Labelled.	
Potential for Disturbance	Low.	
Risk	The ACM are not friable and are in stable condition. Ensure that they remain clearly labelled and regularly inspect to ensure they are not deteriorating or otherwise contributing to an unacceptable health risk.	
Management Actions	<p>May remain in-situ until replacement is required.</p> <p>Manage as per Asbestos Management Plan.</p> <p>Administrative – Follow safe work procedures during removal and maintenance.</p> <p>Personal protective equipment – P2 facemask and coveralls required when working on material.</p>	
References (See Appendices)	<p>Safe Work Australia, Code of Practice: How to Manage and Control Asbestos in the Workplace.</p> <p>WHS Appendix G—Recommended safe working practices</p> <ul style="list-style-type: none"> Safe work practice 1—Drilling of ACM Safe work practice 2—Sealing, painting, coating and cleaning of asbestos cement products <p>Safe Work Australia, Code of Practice: How to Safely Remove Asbestos</p> <p>Appendix E—Examples of asbestos removal work</p> <p>Asbestos cement products</p>

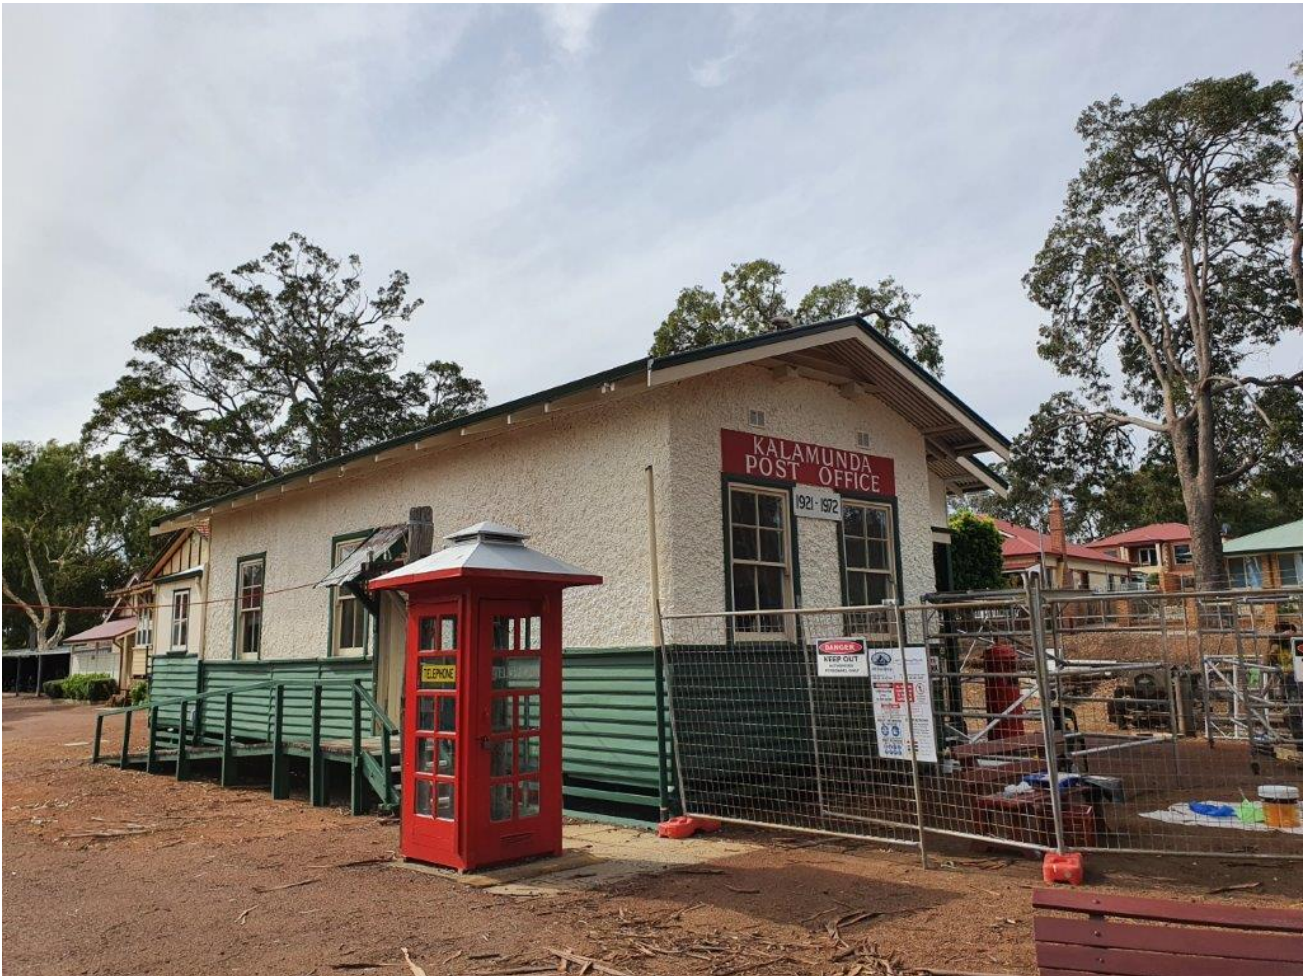
ID 2:- Fibre Cement Wall Panelling and Jointing Strips (Asbestos Detected)

Material	Chrysotile asbestos detected.	
Lab No.	Eurofins ARL Lab No. 21-10098-20 - 21.	
QED Sample No.	ID: 28285 & 28286.	
Locations	Post Office - External – Northern elevation of building, wall panels (including jointing strips).	
Condition	Good, sealed non-friable.	
Signage	Labelled.	
Potential for Disturbance	Low to medium.

Risk	<p>The ACM are not friable and are in stable condition. Ensure that they remain clearly labelled and regularly inspect to ensure they are not deteriorating or otherwise contributing to an unacceptable health risk.</p>	
Management Actions	<p>May remain in-situ until replacement is required. Manage as per Asbestos Management Plan. Administrative – Follow safe work procedures during removal and maintenance. Personal protective equipment – P2 facemask and coveralls required when working on material.</p>

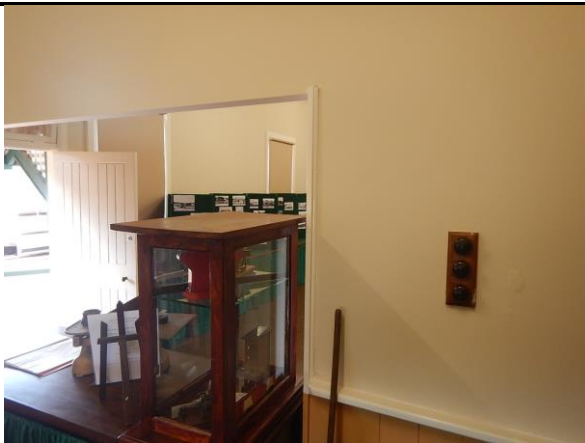
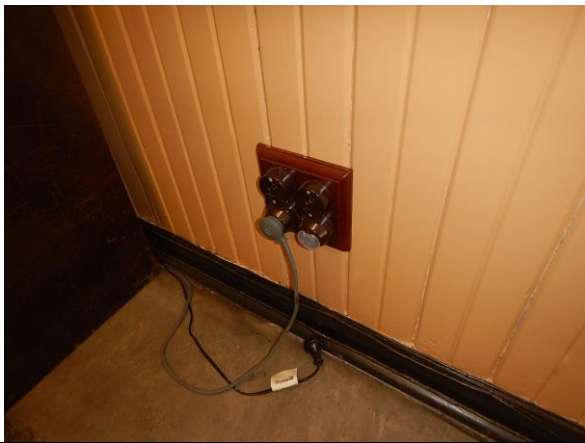
ID 3:- Bakelite Products (Suspected Asbestos Containing Material)

Material	Suspected asbestos containing material.	
Lab No.	N/A.	
QED Sample No.	ID: Observed.	
Locations	Post Office - Internal – Bakelite products including light switches, power points, ceiling light fittings throughout the building.	
Condition	Good, intact, non-friable.	
Signage	Labelled.	
Potential for Disturbance	Low.

Risk	<p>The ACM are not friable and are in stable condition. Ensure that they remain clearly labelled and regularly inspect to ensure they are not deteriorating or otherwise contributing to an unacceptable health risk.</p>	
Management Actions	May remain in-situ until replacement is required. Manage as per Asbestos Management Plan . Administrative – Follow safe work procedures during removal and maintenance. Personal protective equipment – P2 facemask and coveralls required when working on material.	
References (See Appendices)	<p>Safe Work Australia, Code of Practice: How to Manage and Control Asbestos in the Workplace. WHS Appendix G—Recommended safe working practices Safe work practice 5—Working on electrical mounting boards (switchboards) containing asbestos</p> <p>Safe Work Australia, Code of Practice: How to Safely Remove Asbestos Appendix E—Examples of asbestos removal work Asbestos cement products</p>

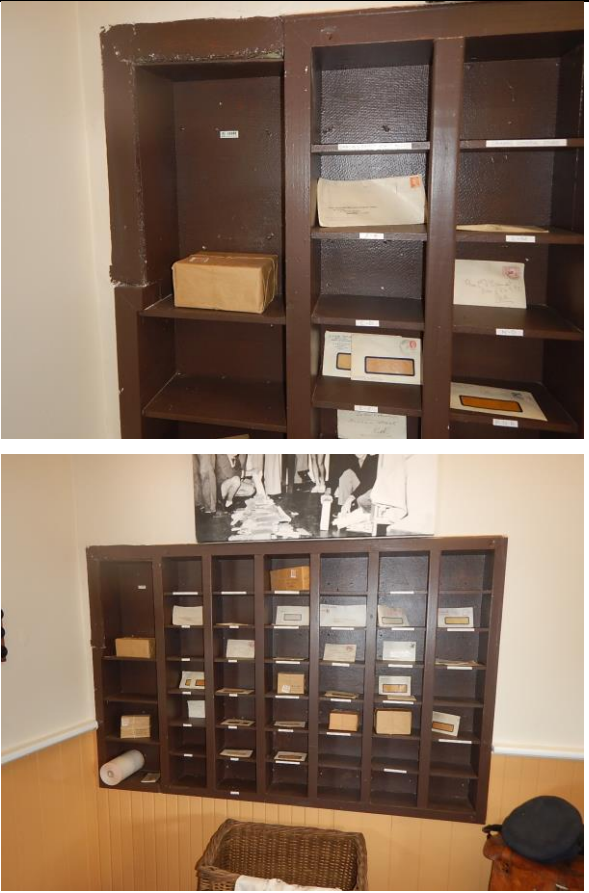
ID 4:- Fibre Cement Wall Panelling (Asbestos Detected)

Material	Chrysotile asbestos detected.	
Lab No.	Eurofins ARL Lab No. 21-10098-23.	
QED Sample No.	ID: 28288.	
Locations	Post Office – Internal – Pigeonholes, rear wall/panel.	
Condition	Good, sealed non-friable.	
Signage	Labelled.	
Potential for Disturbance	Low to medium.	
Risk	<p>The ACM are not friable and are in stable condition. Ensure that they remain clearly labelled and regularly inspect to ensure they are not deteriorating or otherwise contributing to an unacceptable health risk.</p>	
Management Actions	<p>May remain in-situ until replacement is required. Manage as per Asbestos Management Plan. Administrative – Follow safe work procedures during removal and maintenance. Personal protective equipment – P2 facemask and coveralls required when working on material.</p>	
References (See Appendices)	<p>Safe Work Australia, Code of Practice: How to Manage and Control Asbestos in the Workplace. WHS Appendix G—Recommended safe working practices Safe work practice 1—Drilling of ACM Safe work practice 2—Sealing, painting, coating and cleaning of asbestos cement products Safe Work Australia, Code of Practice: How to Safely Remove Asbestos Appendix E—Examples of asbestos removal work Asbestos cement products</p>

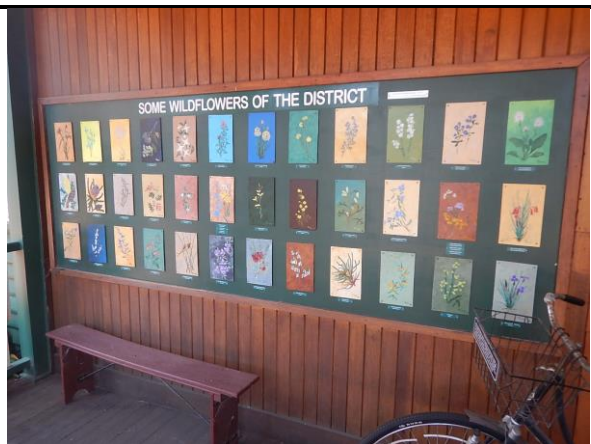
ID 5:- Fibre Cement Wall Panelling (Asbestos Detected)	
Material	Chrysotile asbestos detected.
Lab No.	Eurofins ARL Lab No. 21-10098-22.
QED Sample No.	ID: 28287.
Locations	Post Office – External – Eastern elevation, display board (below verandah).
Condition	Good, sealed non-friable.
Signage	Labelled.
Potential for Disturbance	Low to medium.
Risk	<p>The ACM are not friable and are in stable condition. Ensure that they remain clearly labelled and regularly inspect to ensure they are not deteriorating or otherwise contributing to an unacceptable health risk.</p>
Management Actions	<p>May remain in-situ until replacement is required. Manage as per Asbestos Management Plan. Administrative – Follow safe work procedures during removal and maintenance. Personal protective equipment – P2 facemask and coveralls required when working on material.</p>
References (See Appendices)	<p>Safe Work Australia, Code of Practice: How to Manage and Control Asbestos in the Workplace. WHS Appendix G—Recommended safe working practices Safe work practice 1—Drilling of ACM Safe work practice 2—Sealing, painting, coating and cleaning of asbestos cement products</p> <p>Safe Work Australia, Code of Practice: How to Safely Remove Asbestos Appendix E—Examples of asbestos removal work Asbestos cement products</p>

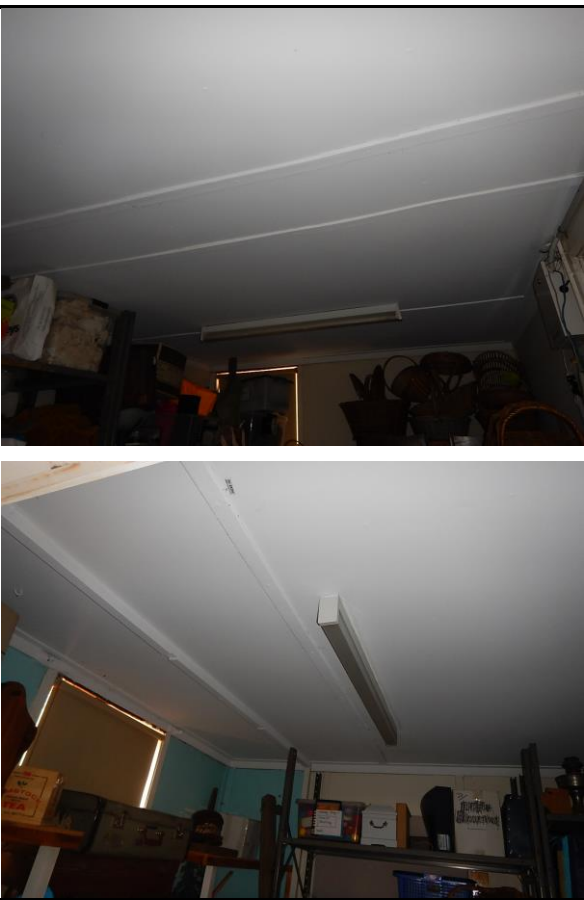
ID 6:- Fibre Cement Wall and Ceiling Panelling (Asbestos Detected)

Material	Chrysotile asbestos detected.	
Lab No.	Eurofins ARL Lab No. 21-10098-25.	
QED Sample No.	ID: 28292.	
Locations	Post Office – Internal – Storeroom off main (large) room, wall and ceiling panels.	
Condition	Good, sealed non-friable.	
Signage	Labelled.	
Potential for Disturbance	Low to medium.	
Risk	<p>The ACM are not friable and are in stable condition. Ensure that they remain clearly labelled and regularly inspect to ensure they are not deteriorating or otherwise contributing to an unacceptable health risk.</p>	
Management Actions	<p>May remain in-situ until replacement is required. Manage as per Asbestos Management Plan. Administrative – Follow safe work procedures during removal and maintenance. Personal protective equipment – P2 facemask and coveralls required when working on material.</p>	
References (See Appendices)	<p>Safe Work Australia, Code of Practice: How to Manage and Control Asbestos in the Workplace. WHS Appendix G—Recommended safe working practices Safe work practice 1—Drilling of ACM Safe work practice 2—Sealing, painting, coating and cleaning of asbestos cement products</p> <p>Safe Work Australia, Code of Practice: How to Safely Remove Asbestos Appendix E—Examples of asbestos removal work Asbestos cement products</p>

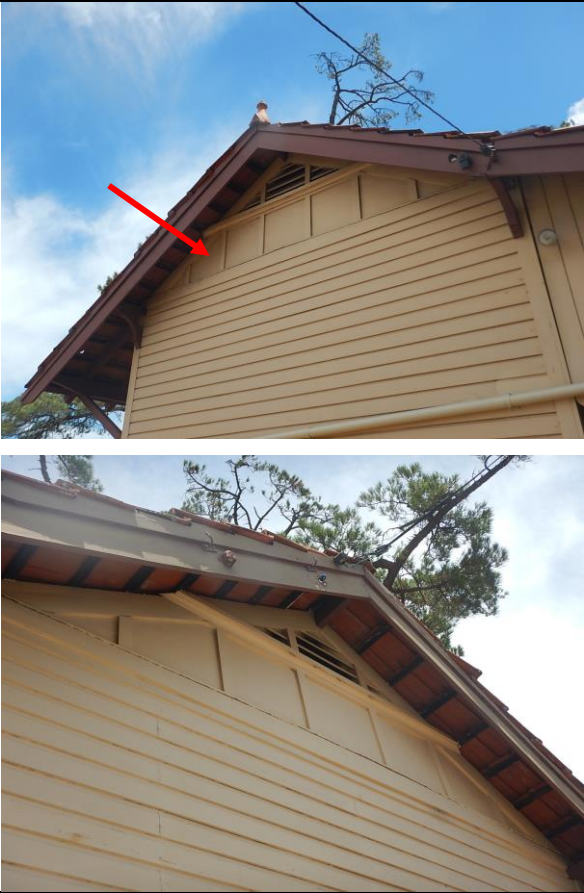
ID 7:- Fibre Cement Gable End/Infill Panelling (Suspected Asbestos Containing Material)

Material	Suspected asbestos containing material.	
Lab No.	Unable to obtain suitable sample [height].	
QED Sample No.	ID: Observed.	
Locations	Railway Station 1927–1949 - External – Northern and Southern elevation, gable ends/infill panels.	
Condition	Good, sealed, non-friable.	
Signage	None.	
Potential for Disturbance	Low to medium.	
Risk	<p>The ACM are not friable and are in stable condition. Ensure that they remain clearly labelled and regularly inspect to ensure they are not deteriorating or otherwise contributing to an unacceptable health risk.</p>	
Management Actions	<p>Label when practical. May remain in-situ until replacement is required. Manage as per Asbestos Management Plan. Administrative – Follow safe work procedures during removal and maintenance. Personal protective equipment – P2 facemask and coveralls required when working on material.</p>

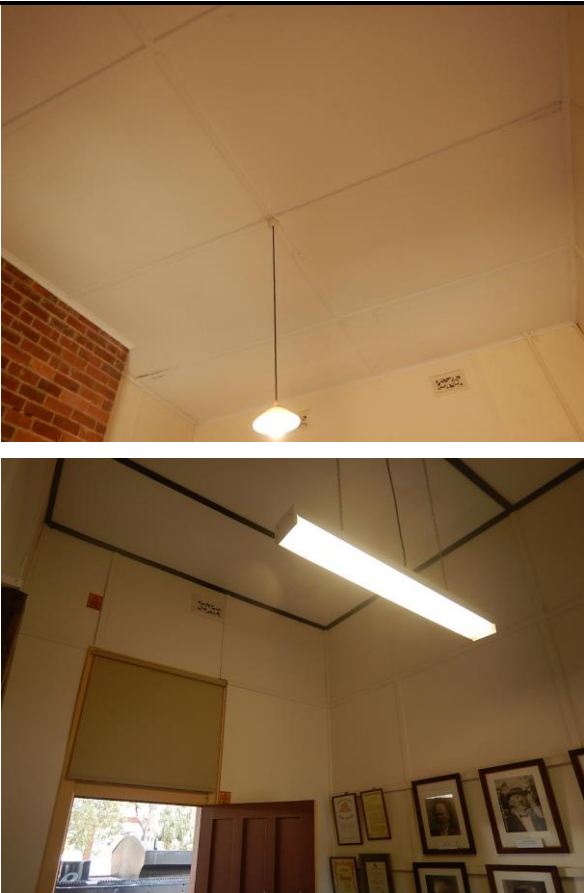
ID 8:- Fibre Cement Wall and Ceiling Panelling (Asbestos Detected)

Material	Chrysotile asbestos detected.	
Lab No.	Eurofins ARL Lab No. 21-10098-7.	
QED Sample No.	ID: 28267.	
Locations	Railway Station 1927-1949 – Internal, throughout, wall and ceiling panels.	
Condition	Good, sealed non-friable.	
Signage	Labelled.	
Potential for Disturbance	Low to medium.	
Risk	<p>The ACM are not friable and are in stable condition. Ensure that they remain clearly labelled and regularly inspect to ensure they are not deteriorating or otherwise contributing to an unacceptable health risk.</p>	
Management Actions	<p>May remain in-situ until replacement is required. Manage as per Asbestos Management Plan. Administrative – Follow safe work procedures during removal and maintenance. Personal protective equipment – P2 facemask and coveralls required when working on material.</p>	
References (See Appendices)	<p>Safe Work Australia, Code of Practice: How to Manage and Control Asbestos in the Workplace. WHS Appendix G—Recommended safe working practices Safe work practice 1—Drilling of ACM Safe work practice 2—Sealing, painting, coating and cleaning of asbestos cement products Safe Work Australia, Code of Practice: How to Safely Remove Asbestos Appendix E—Examples of asbestos removal work Asbestos cement products</p>

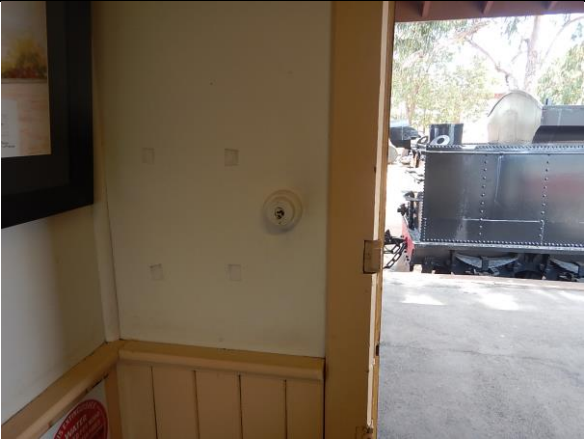
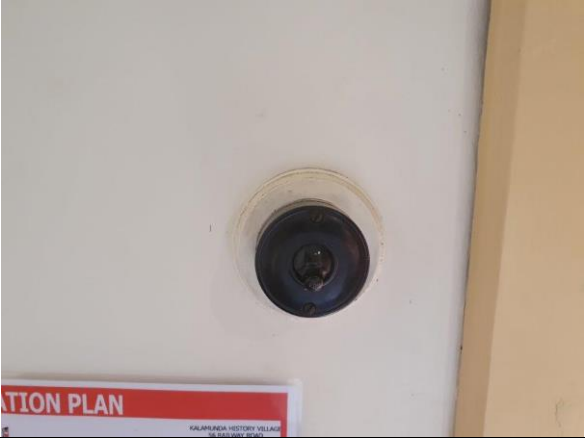
ID 9:- Bakelite Products (Suspected Asbestos Containing Material)

Material	Suspected asbestos containing material.	
Lab No.	N/A.	
QED Sample No.	ID: Observed.	
Locations	Railway Station 1927-1949 - Internal – Bakelite products including light switches, power points, ceiling light fittings throughout the building.	
Condition	Good, intact, non-friable.	
Signage	Labelled.	
Potential for Disturbance	Low.

Risk	<p>The ACM are not friable and are in stable condition. Ensure that they remain clearly labelled and regularly inspect to ensure they are not deteriorating or otherwise contributing to an unacceptable health risk.</p>	
Management Actions	<p>May remain in-situ until replacement is required. Manage as per Asbestos Management Plan. Administrative – Follow safe work procedures during removal and maintenance. Personal protective equipment – P2 facemask and coveralls required when working on material.</p>

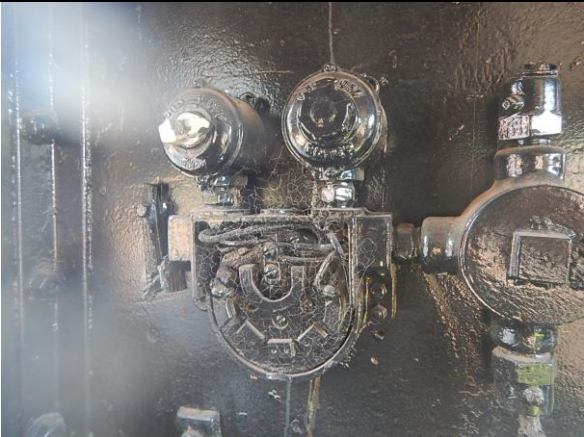
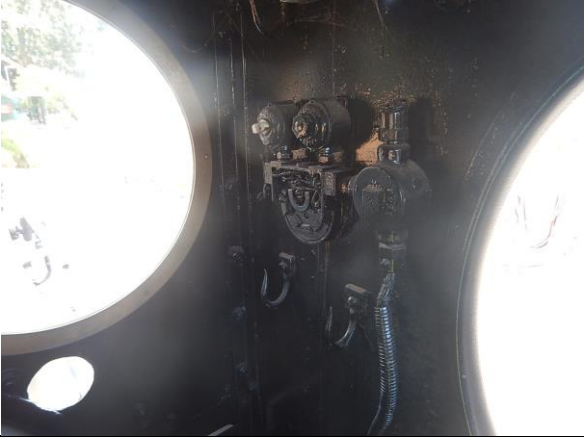
ID 10:- Wiring Outer Sheath (Suspected Asbestos Containing Material)

Material	Suspected asbestos containing material.		
Lab No.	Unable to obtain suitable sample (Live).		
QED Sample No.	ID: N/A.		
Locations	Steam Locomotive – Internal – right hand side whilst at controls. Potentially throughout the train.		
Condition	Good, non-friable.		
Signage	Unable to adequately label.		
Potential for Disturbance	Low to medium.		
Risk	<p>The ACM are not friable and are in stable condition. Ensure that they remain clearly labelled and regularly inspect to ensure they are not deteriorating or otherwise contributing to an unacceptable health risk.</p>

Management Actions	May remain in-situ until replacement is required. Manage as per Asbestos Management Plan . Administrative – Follow safe work procedures during removal and maintenance. Personal protective equipment – P2 facemask and coveralls required when working on material.

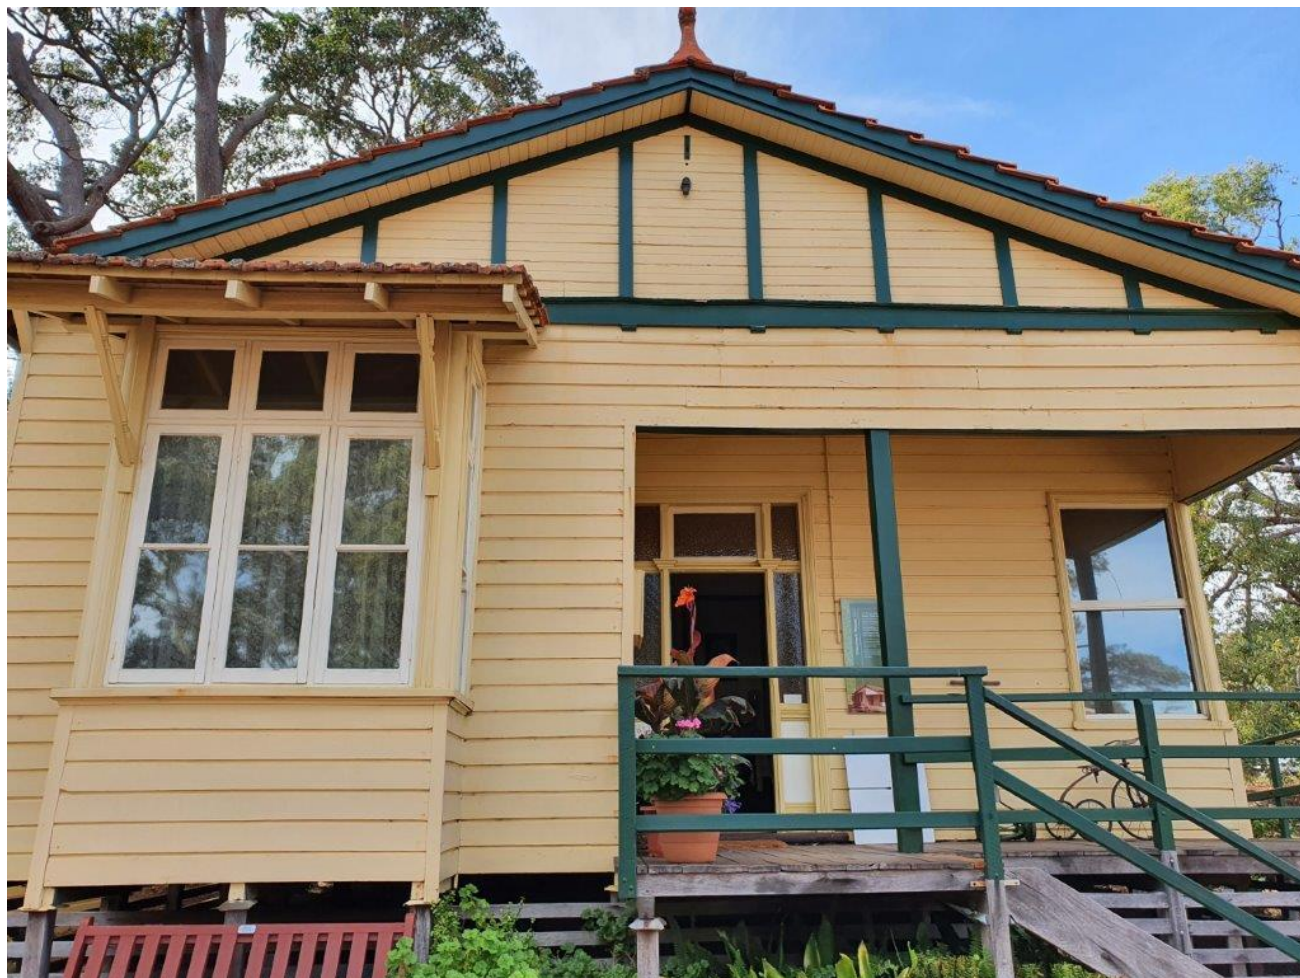
ID 11:- Fibre Cement Weatherboard Wall Panelling (Asbestos Detected)	
Material	Chrysotile and amosite asbestos detected.
Lab No.	Eurofins ARL Lab No. 21-10098-3.
QED Sample No.	ID: 28274.
Locations	Chambers House – External, Southern elevation, wall panels.
Condition	Good, sealed non-friable.
Signage	Labelled.
Potential for Disturbance	Low to medium.
Risk	<p>The ACM are not friable and are in stable condition. Ensure that they remain clearly labelled and regularly inspect to ensure they are not deteriorating or otherwise contributing to an unacceptable health risk.</p>
Management Actions	<p>May remain in-situ until replacement is required. Manage as per Asbestos Management Plan. Administrative – Follow safe work procedures during removal and maintenance. Personal protective equipment – P2 facemask and coveralls required when working on material.</p>
References (See Appendices)	<p>Safe Work Australia, Code of Practice: How to Manage and Control Asbestos in the Workplace. WHS Appendix G—Recommended safe working practices Safe work practice 1—Drilling of ACM Safe work practice 2—Sealing, painting, coating and cleaning of asbestos cement products</p> <p>Safe Work Australia, Code of Practice: How to Safely Remove Asbestos Appendix E—Examples of asbestos removal work Asbestos cement products</p>

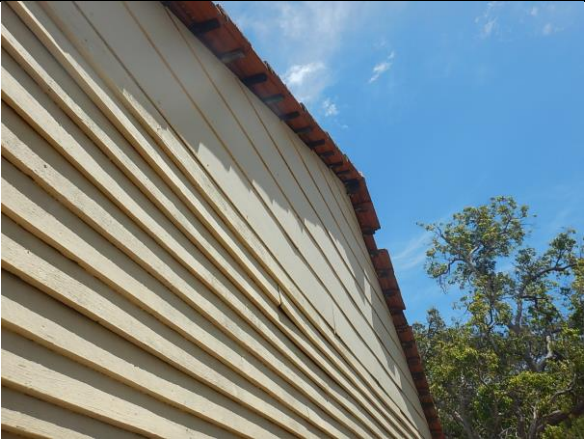
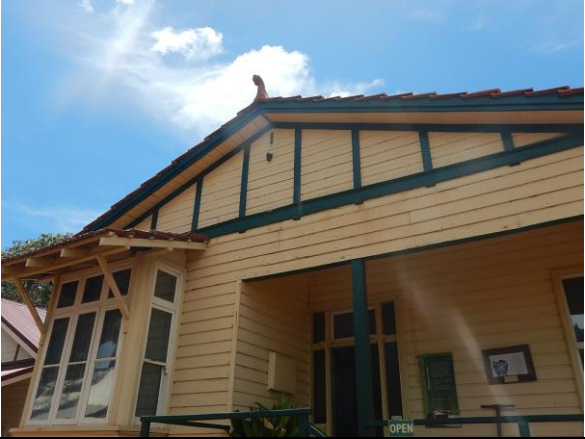
ID 12:- Fibre Cement Gable End Panelling (Suspected Asbestos Containing Material)

Material	Suspected asbestos containing material.		
Lab No.	Unable to obtain suitable sample [height].		
QED Sample No.	ID: Observed.		
Locations	Chambers House – External, Front and Rear elevation, gable ends.		
Condition	Good, sealed non-friable.		
Signage	Labelled.		
Potential for Disturbance	Low to medium.		
Risk	<p>The ACM are not friable and are in stable condition. Ensure that they remain clearly labelled and regularly inspect to ensure they are not deteriorating or otherwise contributing to an unacceptable health risk.</p>

Management Actions	<p>May remain in-situ until replacement is required. Manage as per Asbestos Management Plan. Administrative – Follow safe work procedures during removal and maintenance. Personal protective equipment – P2 facemask and coveralls required when working on material.</p>

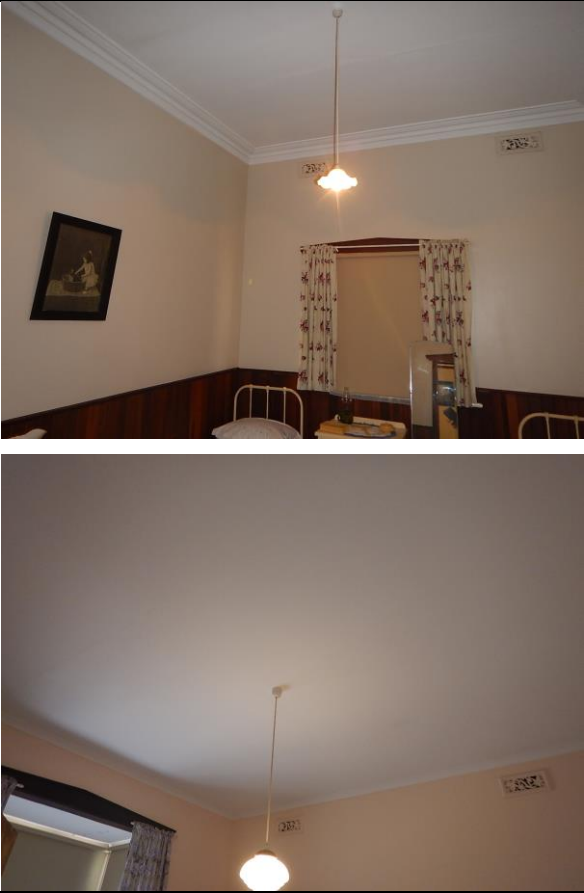
ID 13:- Fibre Cement Wall and Ceiling Panelling (Asbestos Detected)

Material	Chrysotile and amosite asbestos detected.	
Lab No.	Eurofins ARL Lab No. 21-10098-14.	
QED Sample No.	ID: 28278.	
Locations	Chambers House – Internal – Main and 2 nd bedroom, wall and ceiling panels.	
Condition	Good, sealed non-friable.	
Signage	Labelled.	
Potential for Disturbance	Low to medium.	
Risk	<p>The ACM are not friable and are in stable condition. Ensure that they remain clearly labelled and regularly inspect to ensure they are not deteriorating or otherwise contributing to an unacceptable health risk.</p>	
Management Actions	<p>May remain in-situ until replacement is required. Manage as per Asbestos Management Plan. Administrative – Follow safe work procedures during removal and maintenance. Personal protective equipment – P2 facemask and coveralls required when working on material.</p>	
References (See Appendices)	<p>Safe Work Australia, Code of Practice: How to Manage and Control Asbestos in the Workplace. WHS Appendix G—Recommended safe working practices Safe work practice 1—Drilling of ACM Safe work practice 2—Sealing, painting, coating and cleaning of asbestos cement products</p> <p>Safe Work Australia, Code of Practice: How to Safely Remove Asbestos Appendix E—Examples of asbestos removal work Asbestos cement products</p>

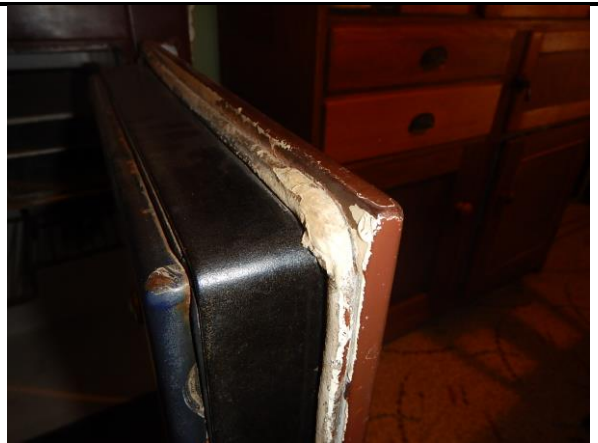
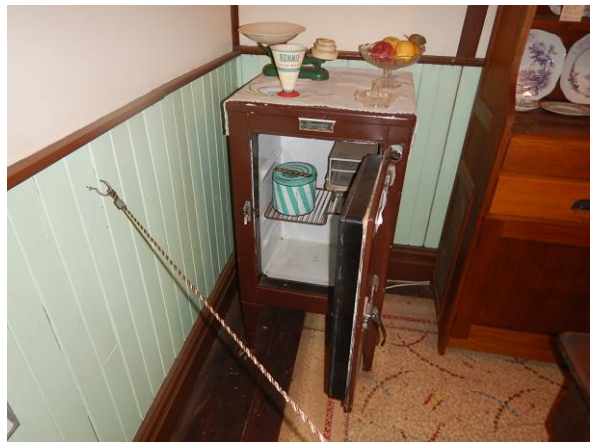
ID 15:- Fridge Door Seal (Suspected Asbestos Containing Material)	
Material	Suspected asbestos containing material.
Lab No.	N/A.
QED Sample No.	ID: Observed.
Locations	Chambers House – Internal, kitchen, loose/stored.
Condition	Good, encased, friable.
Signage	None.
Potential for Disturbance	Low (due to restricted access in area).
Risk	<p>The ACM are friable but are encapsulated within the door skins. Ensure that they remain clearly labelled and regularly inspect to ensure they are not deteriorating or otherwise contributing to an unacceptable health risk.</p>
Management Actions	<p>Asbestos thermal insulation may only be disturbed by a contractor holding a Class A Asbestos Removal License. May remain in-situ until replacement is required. Manage as per Asbestos Management Plan. Administrative – Follow safe work procedures during removal and maintenance. Personal protective equipment – P3 full face powered air respirator and coveralls required during removal of material.</p>

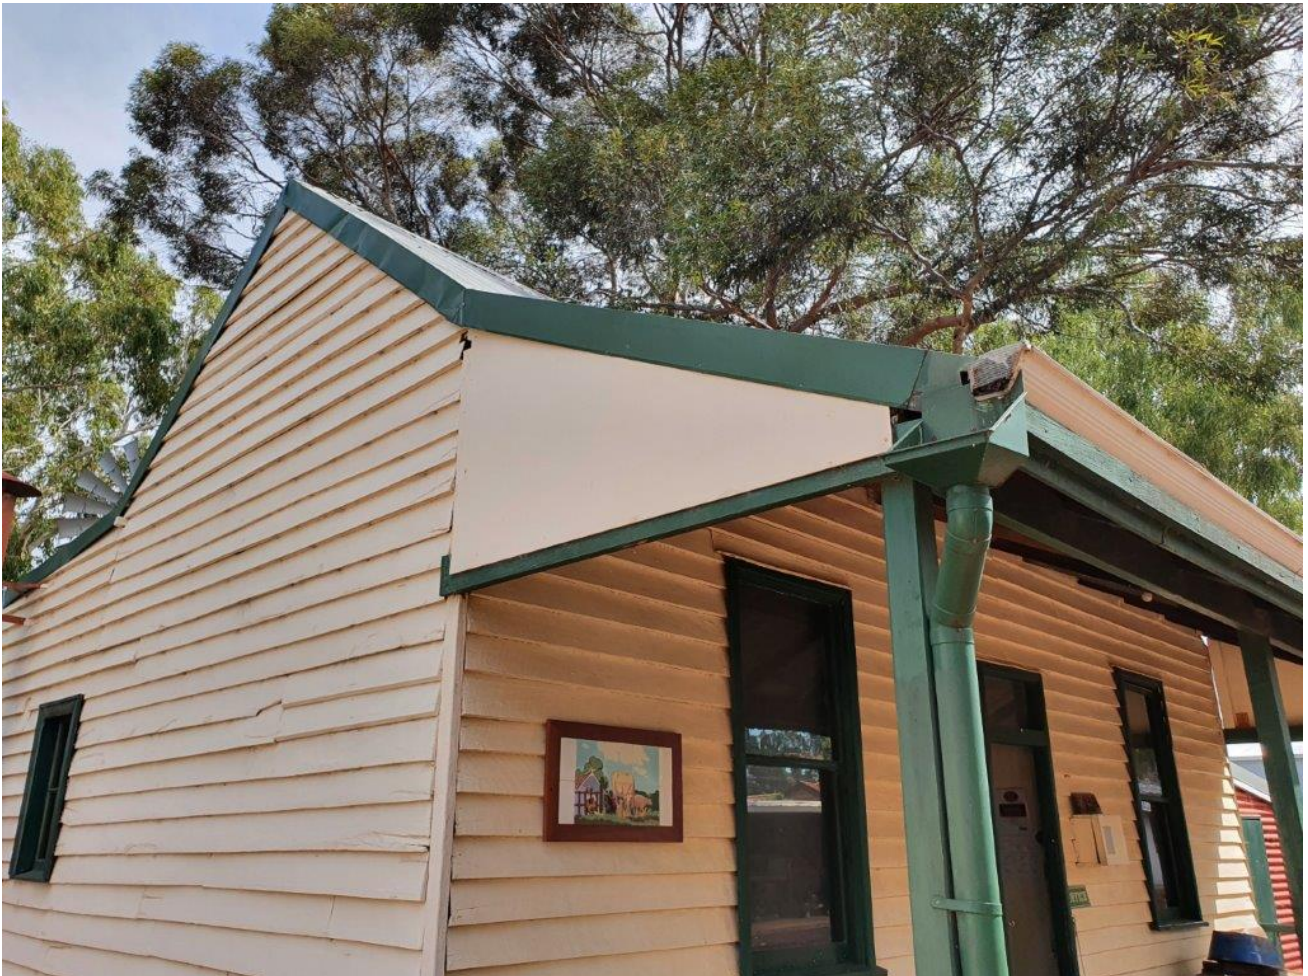
Ellis Cottage

ID 16:- Fibre Cement Wall Panelling (Asbestos Detected)

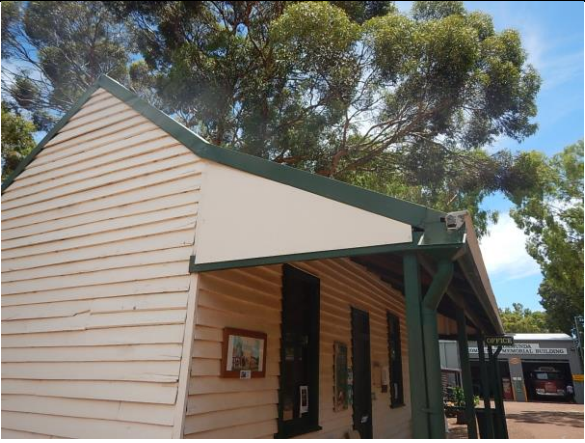
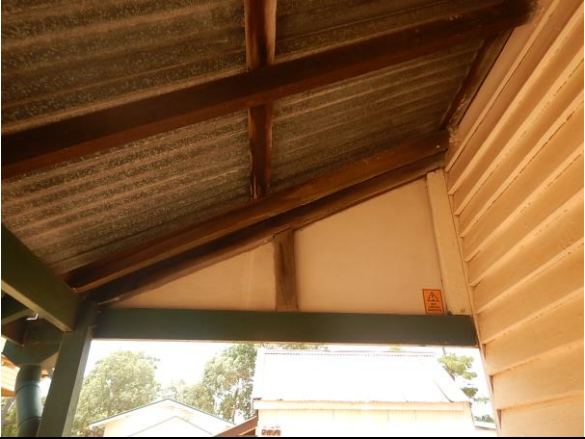
Material	Chrysotile and amosite asbestos detected.	
Lab No.	Eurofins ARL Lab No. 21-10098-1.	
QED Sample No.	ID: 28277.	
Locations	Ellis Cottage – External – Front veranda, infill panel (end of veranda).	
Condition	Good, sealed non-friable.	
Signage	Labelled.	
Potential for Disturbance	Low to medium.	
Risk	<p>The ACM are not friable and are in stable condition. Ensure that they remain clearly labelled and regularly inspect to ensure they are not deteriorating or otherwise contributing to an unacceptable health risk.</p>	
Management Actions	<p>May remain in-situ until replacement is required. Manage as per Asbestos Management Plan. Administrative – Follow safe work procedures during removal and maintenance. Personal protective equipment – P2 facemask and coveralls required when working on material.</p>	
References (See Appendices)	<p>Safe Work Australia, Code of Practice: How to Manage and Control Asbestos in the Workplace. WHS Appendix G—Recommended safe working practices Safe work practice 1—Drilling of ACM Safe work practice 2—Sealing, painting, coating and cleaning of asbestos cement products</p> <p>Safe Work Australia, Code of Practice: How to Safely Remove Asbestos Appendix E—Examples of asbestos removal work Asbestos cement products</p>

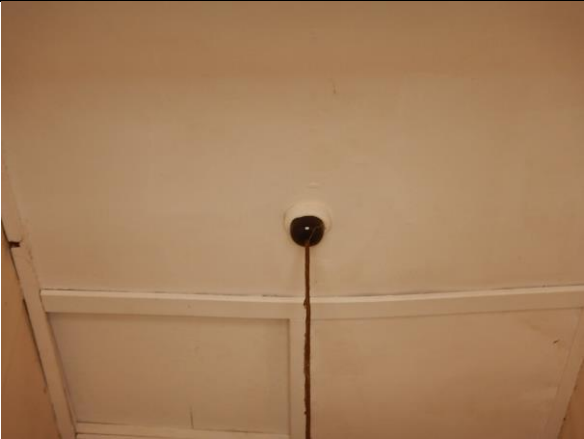
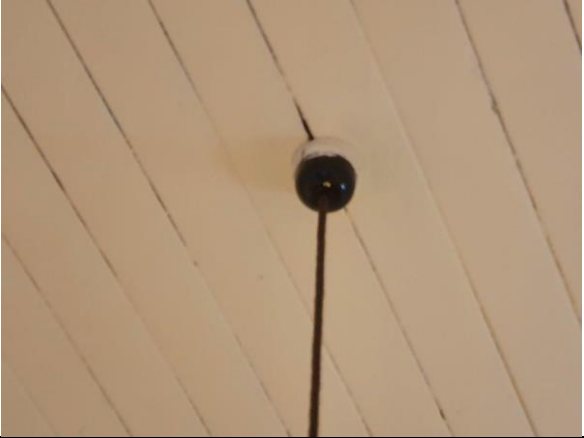
ID 17:- Bakelite Products (Suspected Asbestos Containing Material)

Material	Suspected asbestos containing material.	
Lab No.	N/A.	
QED Sample No.	ID: Observed.	
Locations	Ellis Cottage - Internal – Bakelite products including light switches, power points, ceiling light fittings throughout the building.

Condition	Good, intact, non-friable.	
Signage	Labelled.	
Potential for Disturbance	Low.	
Risk	<p>The ACM are not friable and are in stable condition. Ensure that they remain clearly labelled and regularly inspect to ensure they are not deteriorating or otherwise contributing to an unacceptable health risk.</p>	
Management Actions	<p>May remain in-situ until replacement is required. Manage as per Asbestos Management Plan. Administrative – Follow safe work procedures during removal and maintenance. Personal protective equipment – P2 facemask and coveralls required when working on material.</p>

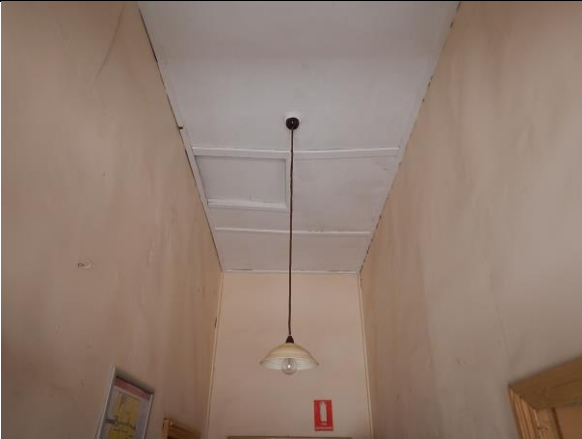
ID 18:- Wiring Outer Sheathing (Suspected Asbestos Containing Material)

Material	Suspected asbestos containing material.	
Lab No.	Unable to obtain suitable sample (Live).	
QED Sample No.	ID: N/A.	
Locations	Ellis Cottage – Potentially throughout building, ceiling space and wall cavities.	
Condition	Good, non-friable.	
Signage	Unable to adequately label.	
Potential for Disturbance	Low to medium.	
Risk	The ACM are not friable and are in stable condition. Ensure that they remain clearly labelled and regularly inspect to ensure they are not deteriorating or otherwise contributing to an unacceptable health risk.	
Management Actions	May remain in-situ until replacement is required. Manage as per Asbestos Management Plan . Administrative – Follow safe work procedures during removal and maintenance. Personal protective equipment – P2 facemask and coveralls required when working on material.	
References (See Appendices)	Safe Work Australia, Code of Practice: How to Manage and Control Asbestos in the Workplace. Safe Work Australia, Code of Practice: How to Safely Remove Asbestos Appendix E—Examples of asbestos removal work Removal of gaskets and rope seals

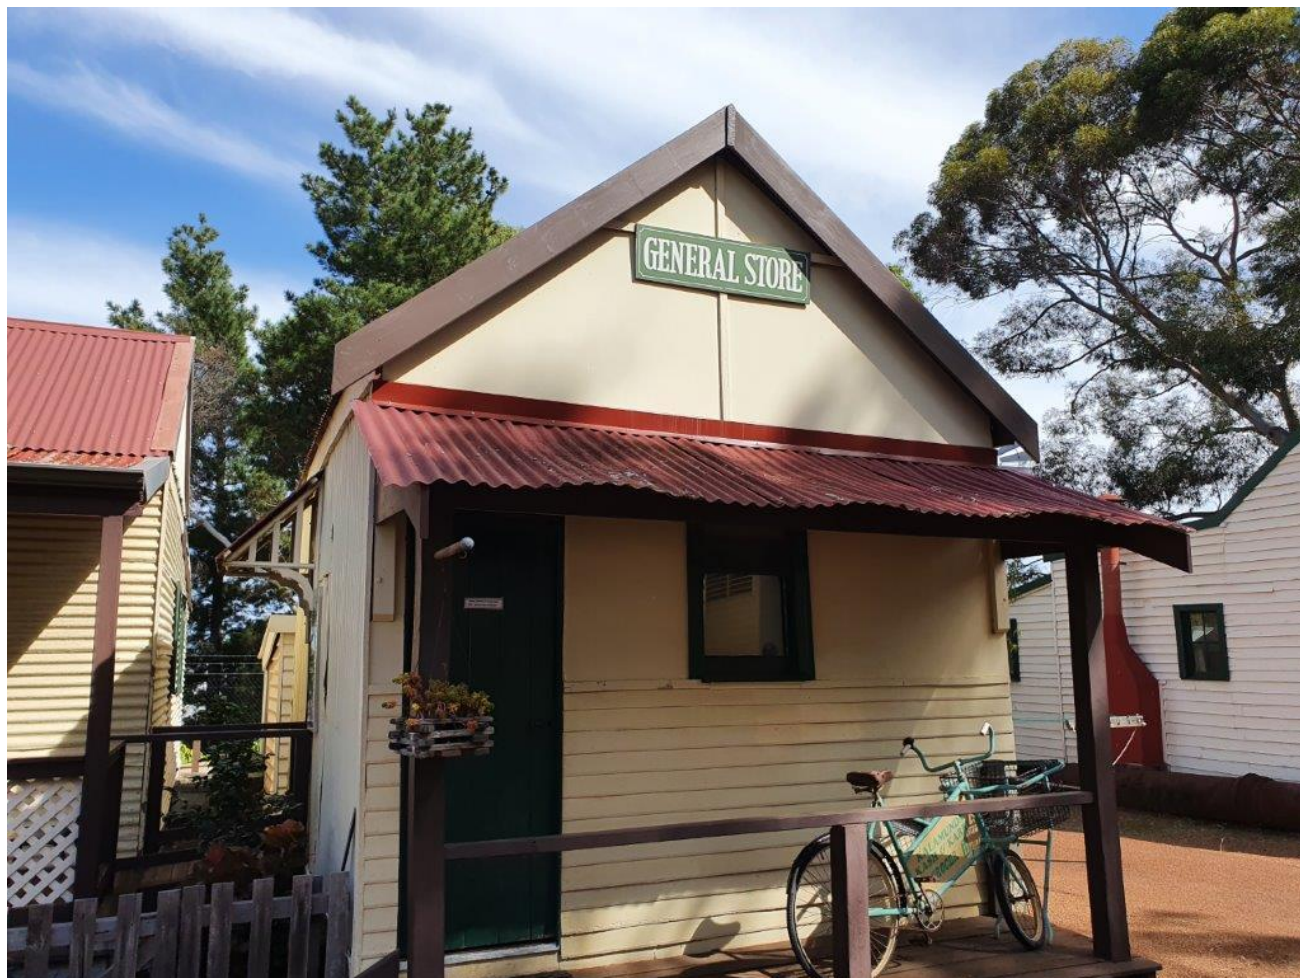
ID 19:- Fibre Cement Wall and Gable end Panelling (Asbestos Detected)	
Material	Chrysotile and amosite asbestos detected.
Lab No.	Eurofins ARL Lab No. 21-10098-5.
QED Sample No.	ID: 28273.
Locations	General Store – External, walls and gable ends.
Condition	Good, sealed non-friable.
Signage	Labelled.
Potential for Disturbance	Low to medium.
Risk	<p>The ACM are not friable and are in stable condition. Ensure that they remain clearly labelled and regularly inspect to ensure they are not deteriorating or otherwise contributing to an unacceptable health risk.</p>
Management Actions	<p>May remain in-situ until replacement is required. Manage as per Asbestos Management Plan. Administrative – Follow safe work procedures during removal and maintenance. Personal protective equipment – P2 facemask and coveralls required when working on material.</p>
References (See Appendices)	<p>Safe Work Australia, Code of Practice: How to Manage and Control Asbestos in the Workplace. WHS Appendix G—Recommended safe working practices Safe work practice 1—Drilling of ACM Safe work practice 2—Sealing, painting, coating and cleaning of asbestos cement products Safe Work Australia, Code of Practice: How to Safely Remove Asbestos Appendix E—Examples of asbestos removal work Asbestos cement products</p>

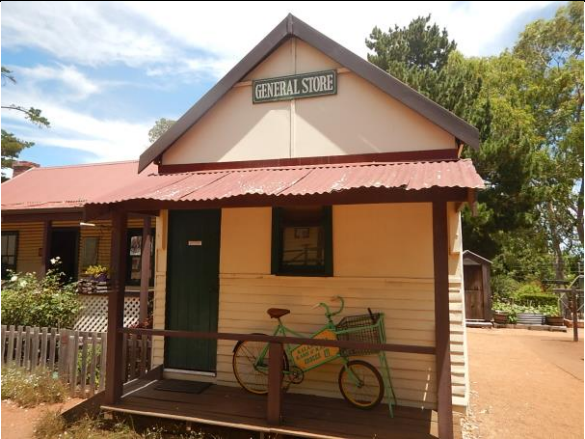
ID 20:- Wiring Outer Sheathing (Suspected Asbestos Containing Material)

Material	Suspected asbestos containing material.	
Lab No.	Unable to obtain suitable sample (Live).	
QED Sample No.	ID: N/A.	
Locations	General Store – Potentially throughout building, ceiling space and wall cavities.	
Condition	Good, non-friable.	
Signage	Unable to adequately label.	
Potential for Disturbance	Low to medium.	
Risk	<p>The ACM are not friable and are in stable condition. Ensure that they remain clearly labelled and regularly inspect to ensure they are not deteriorating or otherwise contributing to an unacceptable health risk.</p>	
Management Actions	<p>May remain in-situ until replacement is required. Manage as per Asbestos Management Plan. Administrative – Follow safe work procedures during removal and maintenance. Personal protective equipment – P2 facemask and coveralls required when working on material.</p>

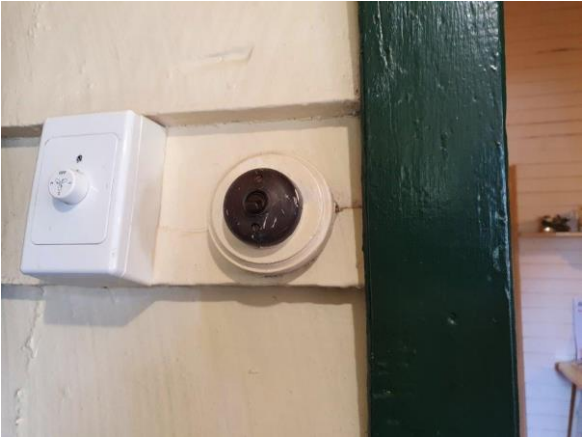
ID 21:- Bakelite Products (Suspected Asbestos Containing Material)

Material	Suspected asbestos containing material.	
Lab No.	N/A.	
QED Sample No.	ID: Observed.	
Locations	General Store - Internal – Bakelite products including light switches, power points, ceiling light fittings throughout the building.	
Condition	Good, intact, non-friable.	
Signage	Labelled.	
Potential for Disturbance	Low.	
Risk	The ACM are not friable and are in stable condition. Ensure that they remain clearly labelled and regularly inspect to ensure they are not deteriorating or otherwise contributing to an unacceptable health risk.	Photos from April 2021 inspection.
Management Actions	May remain in-situ until replacement is required. Manage as per Asbestos Management Plan . Administrative – Follow safe work procedures during removal and maintenance. Personal protective equipment – P2 facemask and coveralls required when working on material.

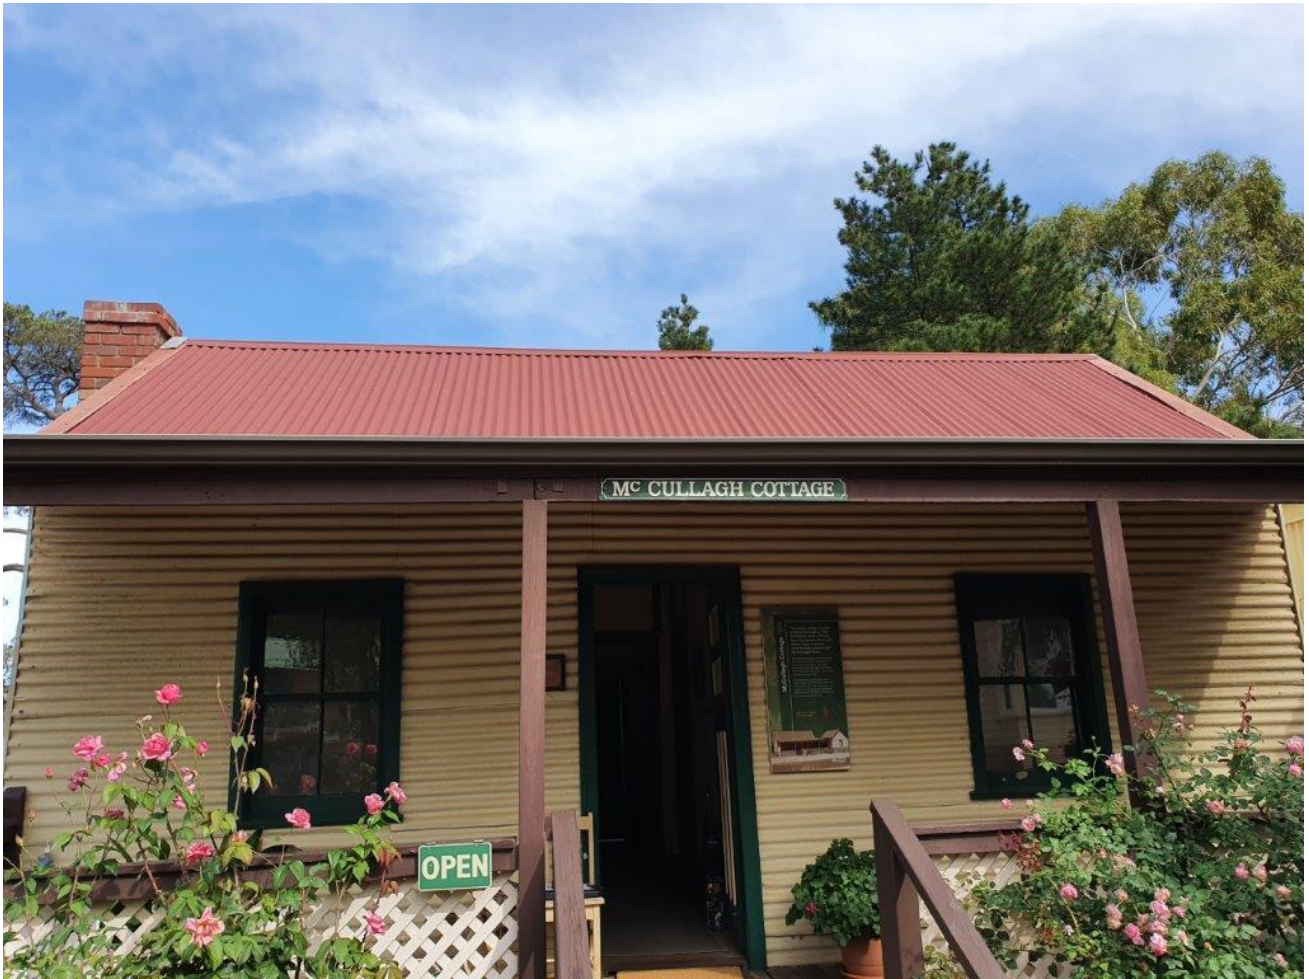
ID 22:- Fibre Cement Wall Panelling (Asbestos Detected)		 
Material	Chrysotile and crocidolite asbestos detected.	
Lab No.	Eurofins ARL Lab No. 21-10098-6.	
QED Sample No.	ID: 28268.	
Locations	McCullagh Cottage – Western elevation, veranda wall panels.	
Condition	Good, sealed non-friable.	
Signage	Labelled.	
Potential for Disturbance	Low to medium.	
Risk	<p>The ACM are not friable and are in stable condition. Ensure that they remain clearly labelled and regularly inspect to ensure they are not deteriorating or otherwise contributing to an unacceptable health risk.</p>	
Management Actions	<p>May remain in-situ until replacement is required. Manage as per Asbestos Management Plan. Administrative – Follow safe work procedures during removal and maintenance. Personal protective equipment – P2 facemask and coveralls required when working on material.</p>	
References (See Appendices)	<p>Safe Work Australia, Code of Practice: How to Manage and Control Asbestos in the Workplace. WHS Appendix G—Recommended safe working practices Safe work practice 1—Drilling of ACM Safe work practice 2—Sealing, painting, coating and cleaning of asbestos cement products</p> <p>Safe Work Australia, Code of Practice: How to Safely Remove Asbestos Appendix E—Examples of asbestos removal work Asbestos cement products</p>

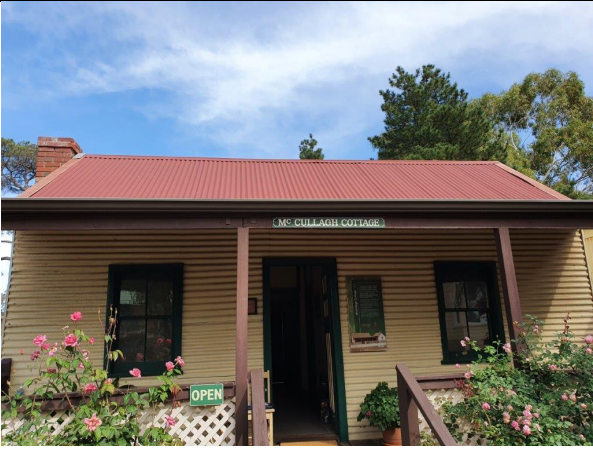
ID 23:- Wiring Outer Sheathing (Suspected Asbestos Containing Material)

Material	Suspected asbestos containing material.	
Lab No.	Unable to obtain suitable sample (Live).	
QED Sample No.	ID: N/A.	
Locations	McCullagh Cottage – Potentially throughout building, ceiling space and wall cavities.	
Condition	Good, non-friable.	
Signage	Unable to adequately label.	
Potential for Disturbance	Low to medium.	
Risk	The ACM are not friable and are in stable condition. Ensure that they remain clearly labelled and regularly inspect to ensure they are not deteriorating or otherwise contributing to an unacceptable health risk.	
Management Actions	May remain in-situ until replacement is required. Manage as per Asbestos Management Plan . Administrative – Follow safe work procedures during removal and maintenance. Personal protective equipment – P2 facemask and coveralls required when working on material.	
References (See Appendices)	Safe Work Australia, Code of Practice: How to Manage and Control Asbestos in the Workplace. Safe Work Australia, Code of Practice: How to Safely Remove Asbestos Appendix E—Examples of asbestos removal work Removal of gaskets and rope seals
