ASBESTOS REGISTER

History Village (Museum), 15 Williams Road, Kalamunda, WA

Report ID: **34746Br0**

Prepared for: **City of Kalamunda**

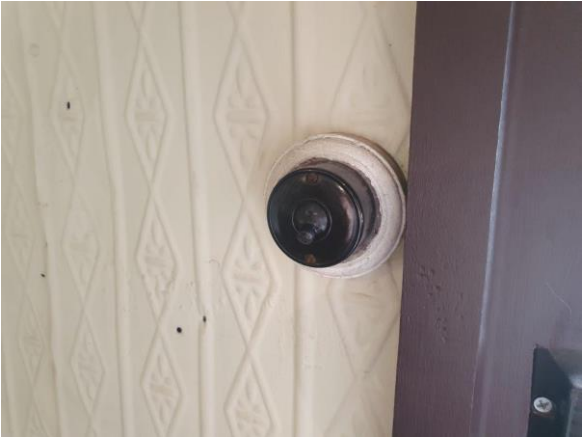
ID 24:- Bakelite Products (Suspected Asbestos Containing Material)

<p>Photos from April 2021 inspection.</p>
Material	Suspected asbestos containing material.	
Lab No.	N/A.	
QED Sample No.	ID: Observed.	
Locations	McCullagh Cottage - Internal – Bakelite products including light switches, power points, ceiling light fittings throughout the building.	
Condition	Good, intact, non-friable.	
Signage	Labelled.	
Potential for Disturbance	Low.	
Risk	The ACM are not friable and are in stable condition. Ensure that they remain clearly labelled and regularly inspect to ensure they are not deteriorating or otherwise contributing to an unacceptable health risk.	
Management Actions	May remain in-situ until replacement is required. Manage as per Asbestos Management Plan . Administrative – Follow safe work procedures during removal and maintenance. Personal protective equipment – P2 facemask and coveralls required when working on material.

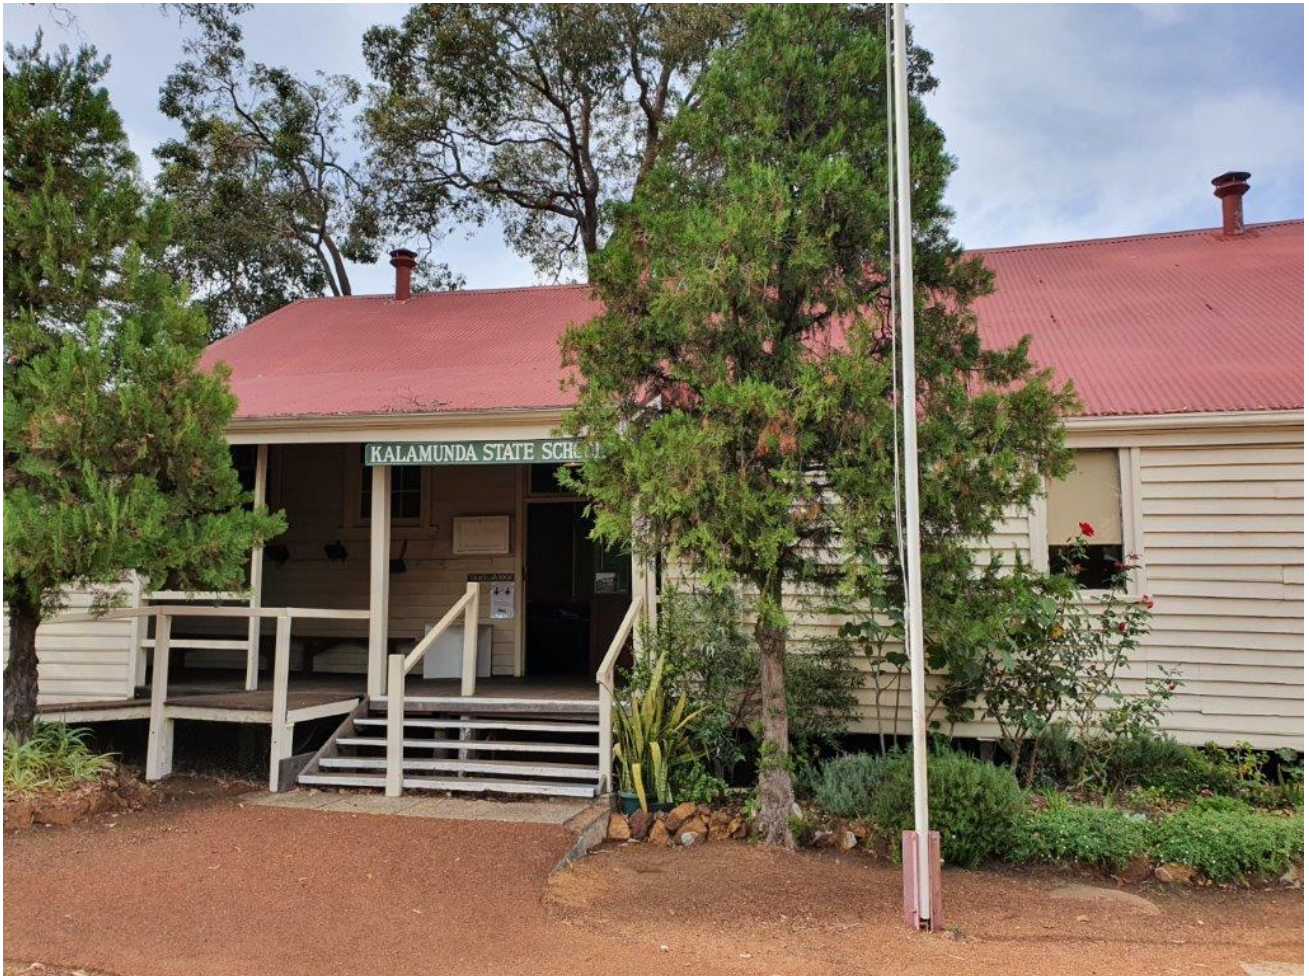
ID 25:- Under Sink Membrane (Asbestos Detected)	
Material	Chrysotile asbestos detected.
Lab No.	Eurofins ARL Lab No. 21-10098-8.
QED Sample No.	ID: 28266.
Locations	School House – Internal, kitchen, sink unit.
Condition	Good, intact, non-friable.
Signage	None.
Potential for Disturbance	Medium.
Risk	<p>The ACM are not friable and are in stable condition. Ensure that they remain clearly labelled and regularly inspect to ensure they are not deteriorating or otherwise contributing to an unacceptable health risk.</p>
Management Actions	<p>Label when practical. May remain in-situ until replacement is required. Manage as per Asbestos Management Plan. Administrative – Follow safe work procedures during removal and maintenance. Personal protective equipment – P2 facemask and coveralls required when working on material.</p>
References (See Appendices)	<p>Safe Work Australia, Code of Practice: How to Manage and Control Asbestos in the Workplace. Safe Work Australia, Code of Practice: How to Safely Remove Asbestos Appendix E—Examples of asbestos removal work Removing bituminous (malthoid) products</p>

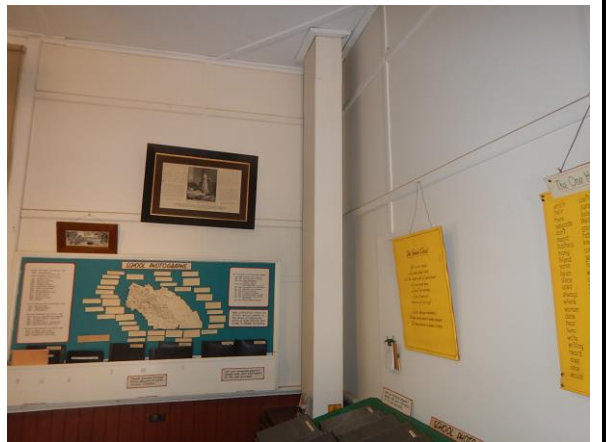
ID 26:- Fibre Cement Chimney Flue (Asbestos Detected)	
Material	Chrysotile, amosite and crocidolite asbestos detected.
Lab No.	Eurofins ARL Lab No. 21-10098-12.
QED Sample No.	ID: 28262.
Locations	School House – Internal – Fireplace in the T.B. Millar Room and Swindells Room.
Condition	Good, sealed non-friable.
Signage	Labelled.
Potential for Disturbance	Low to medium.
Risk	<p>The ACM are not friable and are in stable condition. Ensure that they remain clearly labelled and regularly inspect to ensure they are not deteriorating or otherwise contributing to an unacceptable health risk.</p>
Management Actions	<p>May remain in-situ until replacement is required. Manage as per Asbestos Management Plan. Administrative – Follow safe work procedures during removal and maintenance. Personal protective equipment – P2 facemask and coveralls required when working on material.</p>
References (See Appendices)	<p>Safe Work Australia, Code of Practice: How to Manage and Control Asbestos in the Workplace. WHS Appendix G—Recommended safe working practices Safe work practice 1—Drilling of ACM Safe work practice 2—Sealing, painting, coating and cleaning of asbestos cement products</p> <p>Safe Work Australia, Code of Practice: How to Safely Remove Asbestos Appendix E—Examples of asbestos removal work Asbestos cement products</p>

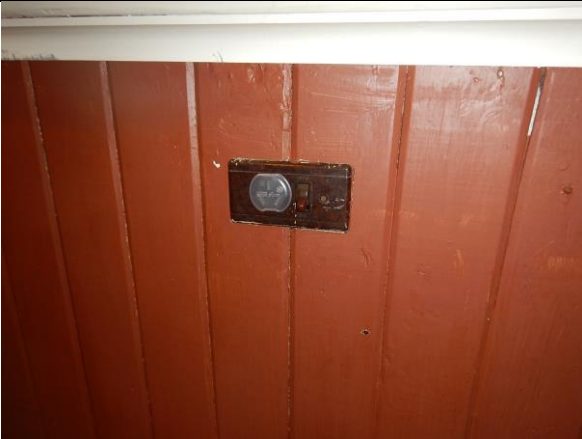
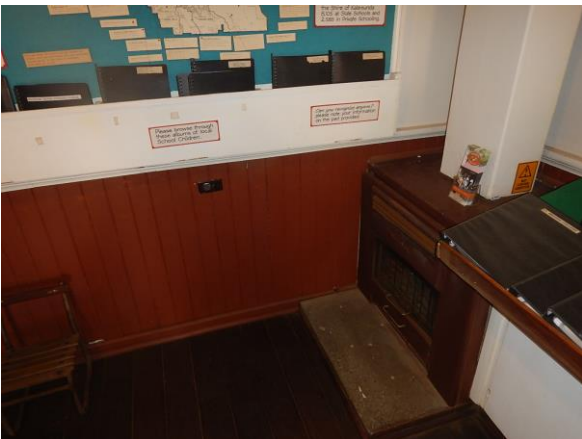
ID 27:- Bakelite Products (Suspected Asbestos Containing Material)

Material	Suspected asbestos containing material.		
Lab No.	N/A.		
QED Sample No.	ID: Observed.		
Locations	School House - Internal – Bakelite products including light switches, power points, ceiling light fittings throughout the building.		
Condition	Good, intact, non-friable.		
Signage	Labelled.		
Potential for Disturbance	Low.		
Risk	<p>The ACM are not friable and are in stable condition. Ensure that they remain clearly labelled and regularly inspect to ensure they are not deteriorating or otherwise contributing to an unacceptable health risk.</p>

Management Actions	<p>May remain in-situ until replacement is required. Manage as per Asbestos Management Plan. Administrative – Follow safe work procedures during removal and maintenance. Personal protective equipment – P2 facemask and coveralls required when working on material.</p>

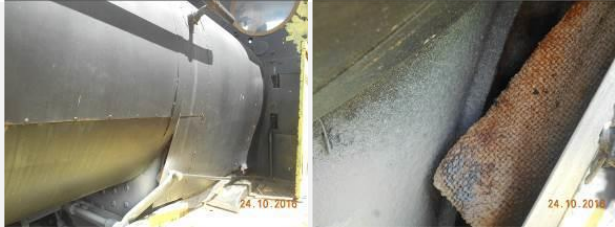
Item Description	Lab No.	Location	Photo	Comments
Asbestos Lagging and limpet Insulation	Removed 2019	G Class Steam Locomotive Display: Underneath external metal cladding of the Chimney, Dome, Smokebox, Boiler, Firebox, Cylinders.

<p>2019</p>	<p>Removed in 2019</p> <p>Information taken from City of Kalamunda Asbestos Register:</p> <p>Building: Kalamunda History Village Asset ID: BD_5037-00 to BD_5037-16 Date Inspected: 24-Feb-2020</p>
Asbestos limpet Insulation	Removed 2019	G Class Steam Locomotive Display: Under and around train Chassis, Wheels, and associated parts

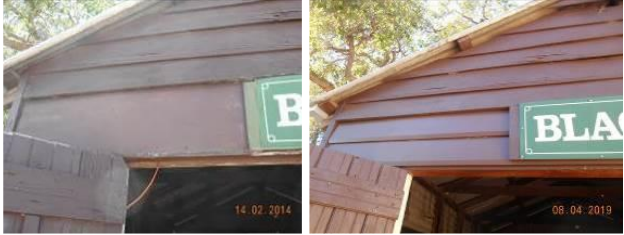
Item Description	Lab No.	Location	Photo	Comments
Wall cladding above door frame	Replaced	Blacksmith - Wall cladding above door frame

<p style="text-align: center;">2014 2019</p>	Replaced 2019 Information taken from City of Kalamunda Asbestos Register: Building: Kalamunda History Village Asset ID: BD_5037-00 to BD_5037-16 Date Inspected: 24-Feb-2020
Wall panelling	Eurofins ARL Lab No. 21-10098-17 QED ID: 28282	Horse Drawn Carriage Shed: Storeroom 1 (rear storeroom)

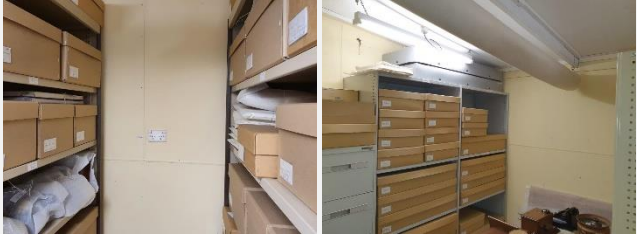
No asbestos detected.
Wall panelling	Eurofins ARL Lab No. 21-10098-18 QED ID: 28283	Horse Drawn Carriage Shed: Storeroom 1 (rear storeroom)

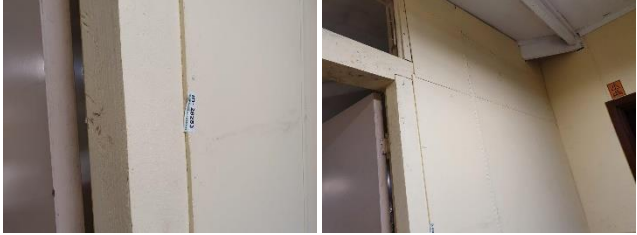
No asbestos detected.
Wall and ceiling panelling	Eurofins ARL Lab No. 21-10098-2 QED ID: 28279	Chambers House: Front lounge, kitchen and dining room ceiling and wall panelling

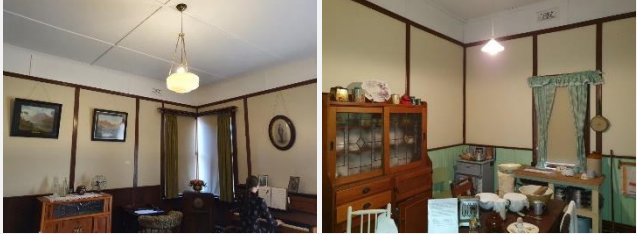
No asbestos detected.

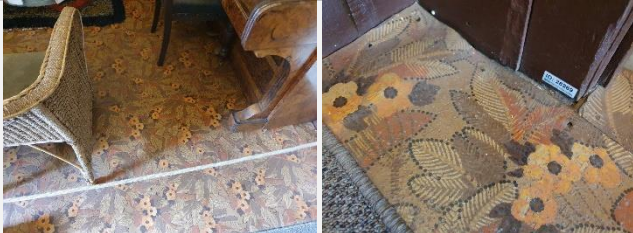
No asbestos detected.
Vinyl floor sheeting	Greencap Report No. 42502. QED ID: 28269	McCullagh Cottage: Flooring in the front left room

No asbestos detected.

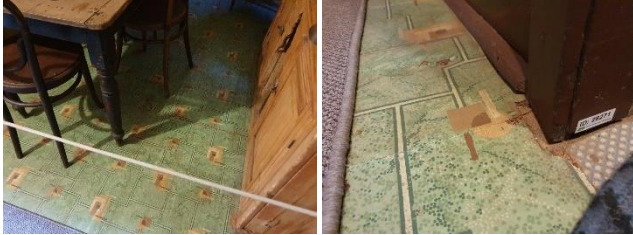
No asbestos detected.
Vinyl floor sheeting	Greencap Report No. 42502. QED ID: 28272	McCullagh Cottage: Flooring in the middle bedroom

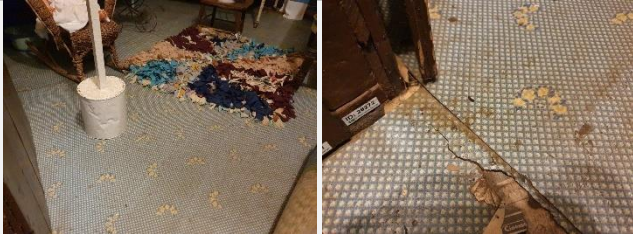
No asbestos detected.
Vinyl floor sheeting	Greencap Report No. 42502. QED ID: 28270	McCullagh Cottage: Flooring in the front right bedroom

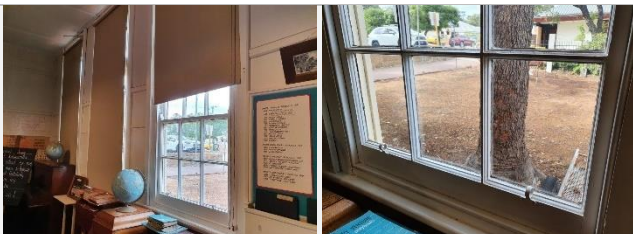
No asbestos detected.
Window putty	Eurofins ARL Lab No. 21-10098-10 QED ID: 28264	School House: Window frames in the school

No asbestos detected.
