# ASBESTOS REGISTER

Jack Healey Centre and Kitchen, 21 Mead Street, Kalamunda, WA

Report ID: **34747Br0**

Prepared for: **City of Kalamunda**

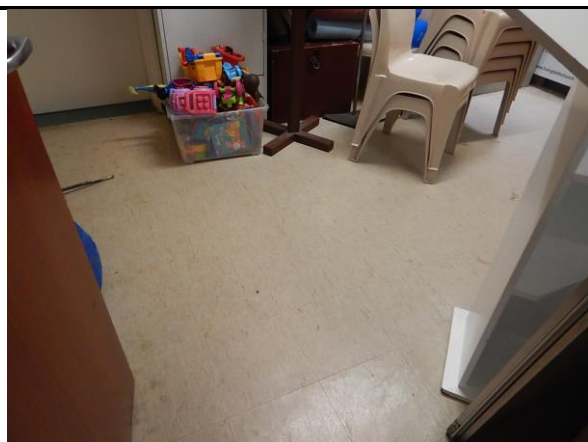
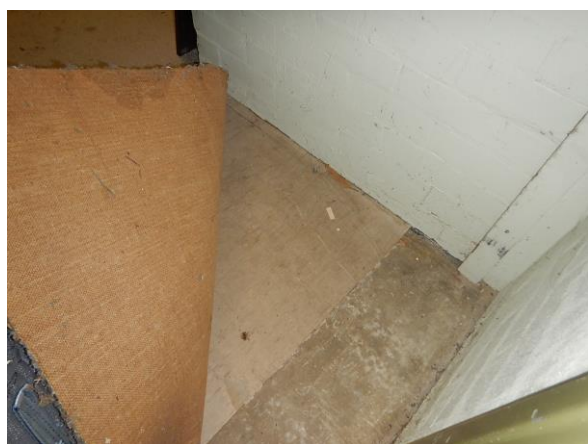
ID 1:- Beige Vinyl Floor Tiles (Asbestos Detected)	
Material	Chrysotile asbestos detected.
Lab No.	Greencap Report No. 41946.
QED Sample No.	ID: 32474.
Locations	Internal – Storeroom 3 and storeroom 2 (near stage), to floor.
Condition	Good, intact, non-friable.
Signage	Labelled.
Potential for Disturbance	Low.
<b>Risk</b>	<p>The ACM are not friable and are in stable condition. Ensure that they remain clearly labelled and regularly inspect to ensure they are not deteriorating or otherwise contributing to an unacceptable health risk.</p>
Management Actions	<p>May remain in-situ until replacement is required.                      Manage as per <b>Asbestos Management Plan</b>.                      Administrative – Follow safe work procedures during removal and maintenance.                      Personal protective equipment – P2 facemask and coveralls required when working on material.</p>
References (See Appendices)	<p><b>Safe Work Australia, Code of Practice: How to Manage and Control Asbestos in the Workplace.</b>  <b>WHS Appendix F—Example of asbestos-related work</b>  <b>WHS Appendix G—Recommended safe working practices</b>                      Safe work practice 1—Drilling of ACM  <b>Safe Work Australia, Code of Practice: How to Safely Remove Asbestos</b>  <b>Appendix E—Examples of asbestos removal work</b>                      Removal of floor tiles</p>

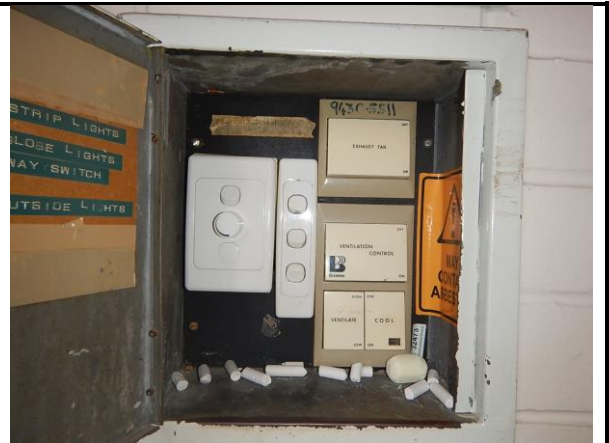
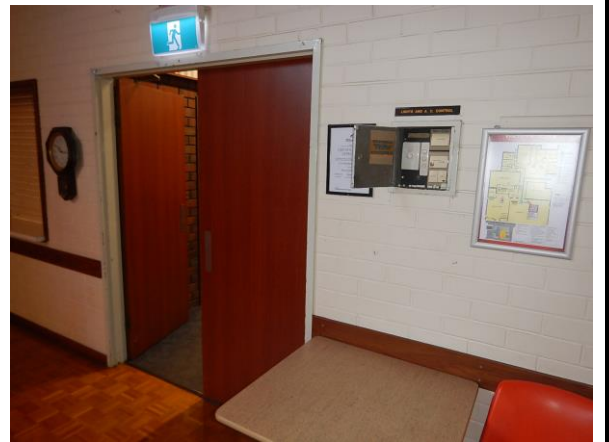
<b>ID 2:- Electrical Mounting Board (Asbestos Detected)</b>	
Material	Chrysotile asbestos detected.
Lab No.	Eurofins Lab No. 21-10098-153.
QED Sample No.	ID: 32473.
Locations	Internal – Main Hall, rear wall, light and fan control box.
Condition	Good to fair, non-friable.
Signage	Labelled.
Potential for Disturbance	Low.
<b>Risk</b>	<p><b>The ACM are not friable and are in stable condition. Ensure that they remain clearly labelled and regularly inspect to ensure they are not deteriorating or otherwise contributing to an unacceptable health risk.</b></p>
Management Actions	<p>May remain in-situ until replacement is required.                  Manage as per <b>Asbestos Management Plan</b>.                  Administrative – Follow safe work procedures during removal and maintenance.                  Personal protective equipment – P2 facemask and coveralls required when working on material.</p>
References (See Appendices)	<p><b>Safe Work Australia, Code of Practice: How to Manage and Control Asbestos in the Workplace. WHS Appendix G—Recommended safe working practices</b>                  Safe work practice 5—Working on electrical mounting boards (switchboards) containing asbestos  <b>Safe Work Australia, Code of Practice: How to Safely Remove Asbestos Appendix E—Examples of asbestos removal work</b>                  Asbestos cement products</p>

Service Record	<p>Review – January 2028                  Company:                  Date:                  Works:                  Clearance certificate:</p>
Further Details	<p>All coal tar pitch boards should be presumed to contain asbestos                  Brand names include Zelemite, Miscolite and Lebah</p>

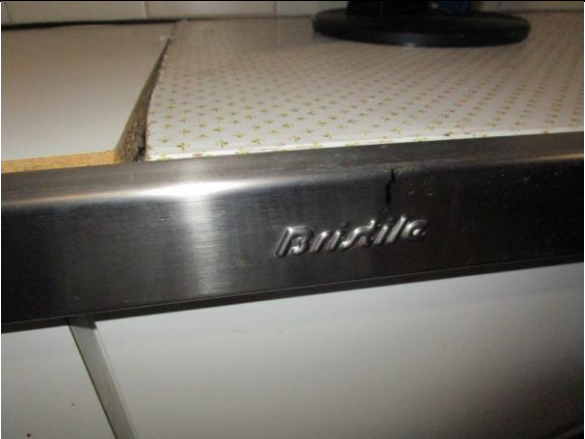
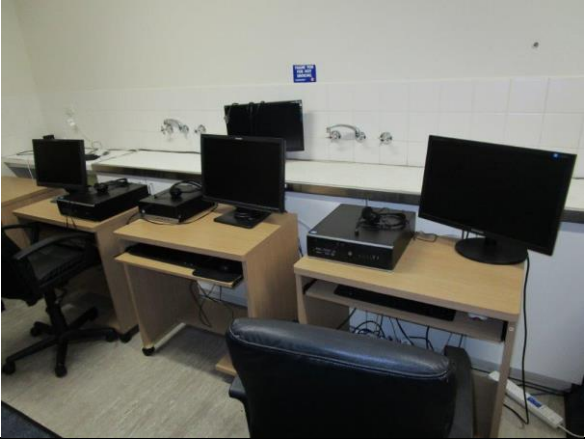
<b>ID 3:- Under Sink Membrane (Bristile) (Asbestos Detected)</b>

Material	Chrysotile asbestos detected.	
Lab No.	Eurofins ARL Lab No. 21-10098-155.	
QED Sample No.	ID: 32476.	
Locations	Internal – Computer room, sink unit.	
Condition	Unknown.	
Signage	Labelled.	
Potential for Disturbance	Low.	
<b>Risk</b>	<p><b>The ACM are not friable and are in stable condition. Ensure that they remain clearly labelled and regularly inspect to ensure they are not deteriorating or otherwise contributing to an unacceptable health risk.</b></p>	
Management Actions	<p>Unable to access in 2023. Assume material is still present unless information can be provided to state otherwise.                  May remain in-situ until replacement is required.                  Manage as per <b>Asbestos Management Plan</b>.                  Administrative – Follow safe work procedures during removal and maintenance.                  Personal protective equipment – P2 facemask and coveralls required when working on material.</p>

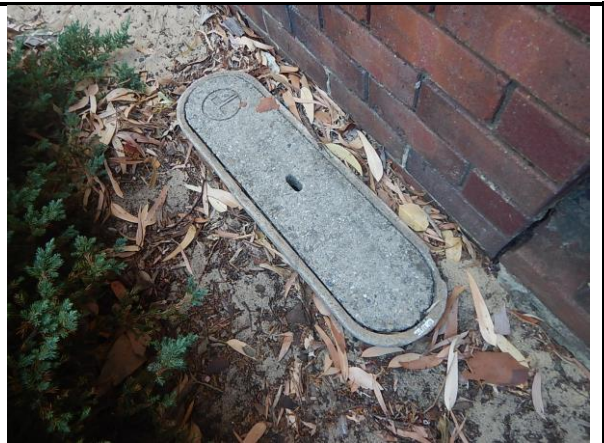
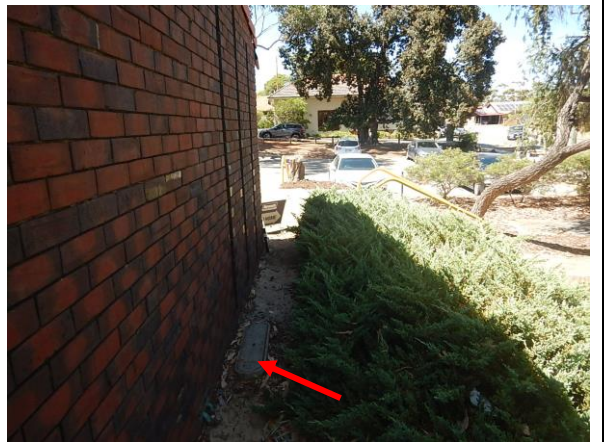
<b>ID 4:- Cable Pit Surrounds (Asbestos Detected)</b>	
Material	Chrysotile and amosite asbestos detected.
Lab No.	Eurofins ARL Lab No. 21-10098-154.
QED Sample No.	ID: 32475.
Locations	External – Western elevation, adjacent building wall, in ground.
Condition	Good, intact, non-friable.
Signage	None.
Potential for Disturbance	Low to medium.
<b>Risk</b>	<p>The ACM are not friable and are in stable condition. Ensure that they remain clearly labelled and regularly inspect to ensure they are not deteriorating or otherwise contributing to an unacceptable health risk.</p>
Management Actions	<p>May remain in-situ until replacement is required.                  Manage as per <b>Asbestos Management Plan</b>.                  Administrative – Follow safe work procedures during removal and maintenance.                  Personal protective equipment – P2 facemask and coveralls required when working on material.</p>

References (See Appendices)	<p><b>Safe Work Australia, Code of Practice: How to Manage and Control Asbestos in the Workplace.</b>  <b>WHS Appendix G—Recommended safe working practices</b>                  Safe work practice 1—Drilling of ACM                  Safe work practice 2—Sealing, painting, coating and cleaning of asbestos cement products                  Safe work practice 4—Replacing cabling in asbestos cement conduits or boxes  <b>Safe Work Australia, Code of Practice: How to Safely Remove Asbestos</b>  <b>Appendix E—Examples of asbestos removal work</b>                  Asbestos cement products</p>
Service Record	<p>Review – January 2028                  Company:                  Date:                  Works:                  Clearance certificate:</p>

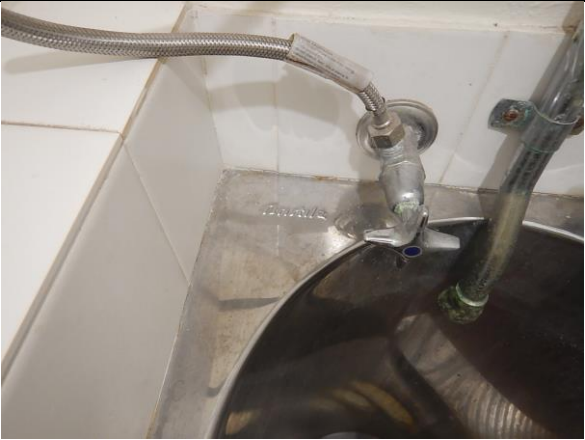
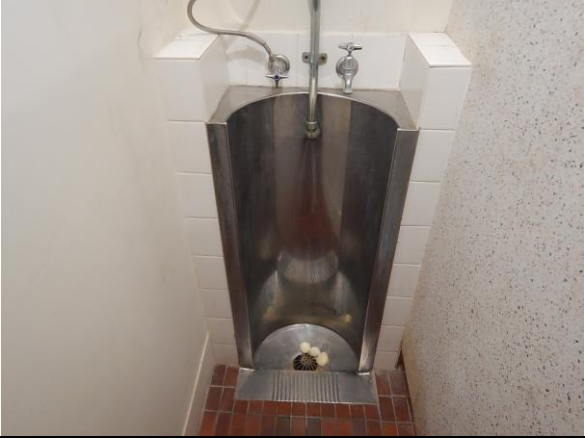
<b>ID 5:- Urinal Backing Membrane (Bristile) (Suspected Asbestos Containing Material)</b>

Material	Suspected asbestos containing material.	
Lab No.	Unable to sample (encapsulated)	
QED Sample No.	ID: N/A.	
Locations	Internal - Male toilets, urinal.	
Condition	Encased, non-friable.	
Signage	Unable to adequately label.	
Potential for Disturbance	Low.	
<b>Risk</b>	<p>The ACM are not friable and are in stable condition. Ensure that they are regularly inspected to ensure they are not deteriorating or otherwise contributing to an unacceptable health risk.</p>	
Management Actions	<p>May remain in-situ until replacement is required.                  Manage as per <b>Asbestos Management Plan</b>.                  Administrative – Follow safe work procedures during removal and maintenance.                  Personal protective equipment – P2 facemask and coveralls required when working on material.</p>

References (See Appendices)	<p><b>Safe Work Australia, Code of Practice: How to Manage and Control Asbestos in the Workplace.</b>  <b>Safe Work Australia, Code of Practice: How to Safely Remove Asbestos</b>  <b>Appendix E—Examples of asbestos removal work</b>                  Removing bituminous (malthoid) products</p>	
Service Record	<p>Review – January 2028                  Company:                  Date:                  Works:                  Clearance certificate:</p>

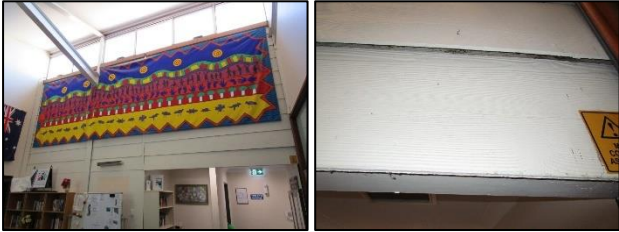
<p>Removed.</p> <p>Information taken from the City of Kalamunda register:</p> <p>Building: Jack Healey Centre</p> <p>Asset ID: BD_5042-00</p> <p>Inspected: Dec-2019</p>
<b>Internal weatherboard panels</b>	<p>Eurofins ARL Lab No. 21-10098-151</p> <p>QED ID: 32471</p>	Main foyer wall below high windows.

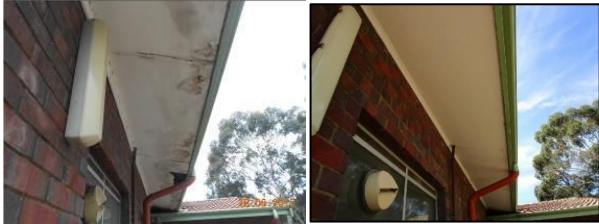
Item Description	Lab No.	Location	Photo	Comments
<b>Rear Eave Lining</b>	N/A	Eaves near rear lining.

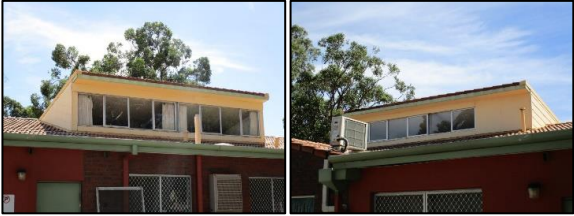
<p>Removed.</p> <p>Information taken from the City of Kalamunda register:</p> <p>Building: Jack Healey Centre</p> <p>Asset ID: BD_5042-00</p> <p>Inspected: Dec-2019</p>
<b>Window Surround Panels</b>	Greencap Report No. 47007  QED ID: 39725	Panels surrounding high windows, external.

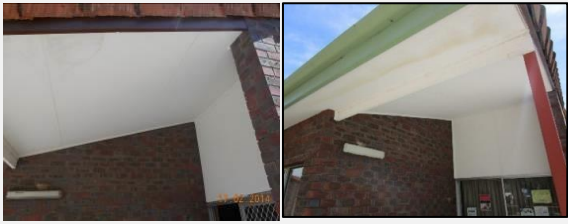
<p>No asbestos detected.</p>
<b>Rear Entry Veranda Ceiling</b>	N/A	External ceiling near rear veranda.
