ASBESTOS REGISTER

Kalamunda Lapidary Club, 3 Recreation Road, Kalamunda, WA

Report ID: **34752Br0**

Prepared for: **City of Kalamunda**

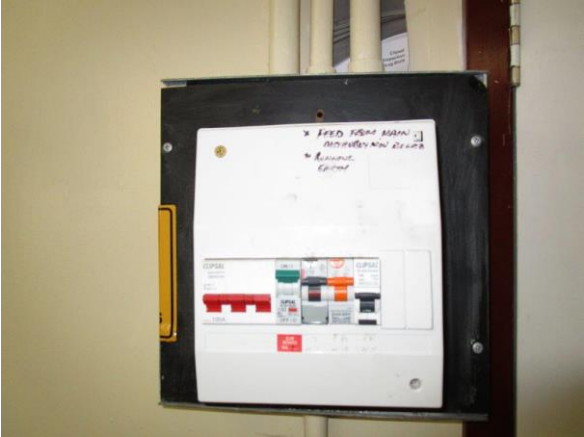
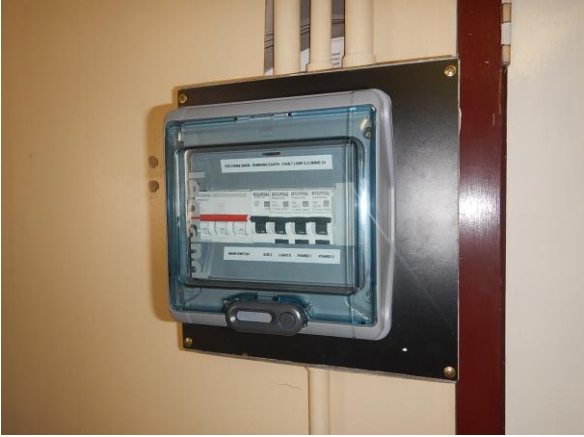
ID 1:- Electrical Mounting Board (Suspected Asbestos Containing Material)	
Material	Suspected asbestos containing material.
Lab No.	N/A.
QED Sample No.	ID: Observed.
Locations	Internal – Jewellery workshop, to wall.
Condition	Sealed, intact, non-friable.
Signage	Labelled.
Potential for Disturbance	Low to medium.
Risk	<p>The ACM are not friable and are in stable condition. Ensure that they remain clearly labelled and regularly inspect to ensure they are not deteriorating or otherwise contributing to an unacceptable health risk.</p>

<p style="text-align: center;">2021</p>

<p style="text-align: center;">2023</p>
Management Actions	<p>Material looks to have been removed and replaced. If information can be provided to confirm this, the item can be removed from this register. May remain in-situ until replacement is required. Manage as per Asbestos Management Plan. Administrative – Follow safe work procedures during removal and maintenance. Personal protective equipment – P2 facemask and coveralls required when working on material.</p>

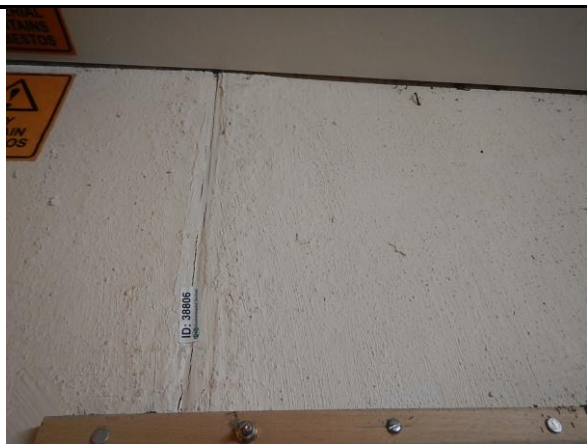
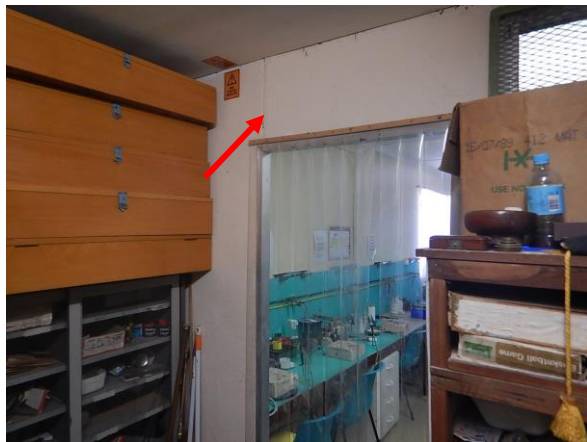
ID 2:- Grey Mastic (Presumed Asbestos Containing Material)	
Material	Presumed asbestos containing material.
Lab No.	N/A.
QED Sample No.	ID: Observed.
Locations	Internal – Mineral storeroom/throughout building, expansion joints.
Condition	Good, intact, non-friable.
Signage	None.
Potential for Disturbance	Low.
Risk	<p>The ACM are not friable and are in stable condition. Ensure that they remain clearly labelled and regularly inspect to ensure they are not deteriorating or otherwise contributing to an unacceptable health risk.</p>
Management Actions	<p>Label when practicable. May remain in-situ until replacement is required. Manage as per Asbestos Management Plan. Administrative – Follow safe work procedures during removal and maintenance. Personal protective equipment – P2 facemask and coveralls required when working on material.</p>
References (See Appendices)	<p>Safe Work Australia, Code of Practice: How to Manage and Control Asbestos in the Workplace. WHS Appendix G—Recommended safe working practices Safe work practice 1—Drilling of ACM Safe work practice 2—Sealing, painting, coating and cleaning of asbestos cement Safe Work Australia, Code of Practice: How to Safely Remove Asbestos Appendix E—Examples of asbestos removal work Removing bituminous (malthoid) products</p>

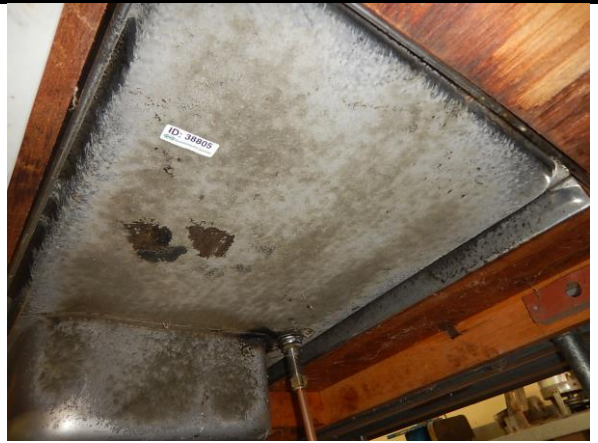
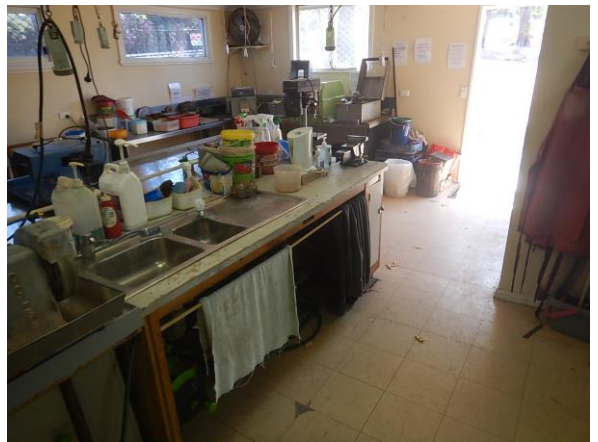
ID 3:- Under Sink Membrane (Presumed Asbestos Containing Material)	
Material	Presumed asbestos containing material.
Lab No.	N/A.
QED Sample No.	ID: Observed.
Locations	Internal – Main workshop, sink unit.
Condition	Good, intact, non-friable.
Signage	None.
Potential for Disturbance	Low to medium.
Risk	<p>The ACM are not friable and are in stable condition. Ensure that they remain clearly labelled and regularly inspect to ensure they are not deteriorating or otherwise contributing to an unacceptable health risk.</p>
Management Actions	<p>Label when practicable. May remain in-situ until replacement is required. Manage as per Asbestos Management Plan. Administrative – Follow safe work procedures during removal and maintenance. Personal protective equipment – P2 facemask and coveralls required when working on material.</p>
References (See Appendices)	<p>Safe Work Australia, Code of Practice: How to Manage and Control Asbestos in the Workplace. Safe Work Australia, Code of Practice: How to Safely Remove Asbestos Appendix E—Examples of asbestos removal work Removing bituminous (malthoid) products</p>

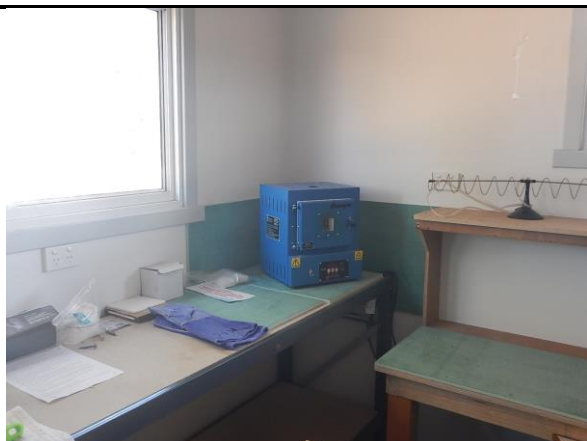
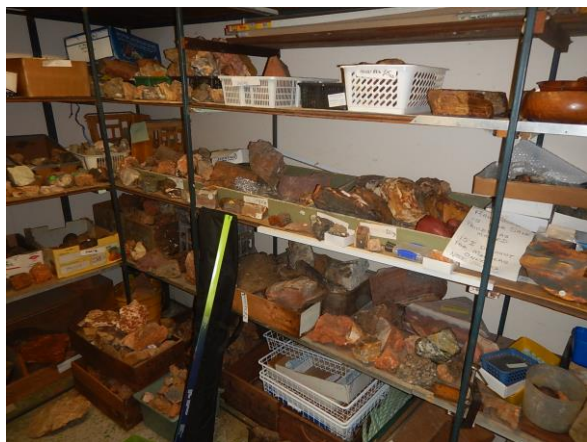
ID 4:- Loose/Stored Items (Kiln and Minerals) (Suspected Asbestos Containing Material)	
Material	Suspected asbestos containing materials.
Lab No.	N/A.
QED Sample No.	ID: Observed.
Locations	Internal – Mineral store & stored materials.
Condition	Kiln – Encased, intact, friable Minerals – Unsealed, intact, unknown.
Signage	None.
Potential for Disturbance	Medium (higher if minerals are disturbed).
Risk	<p align="center">ACTION REQUIRED.</p> <p align="center">The ACM are non-friable and are in stable condition. Ensure that they remain clearly labelled and regularly inspect to ensure they are sealed and not deteriorating or otherwise contributing to an unacceptable health risk.</p>
Management Actions	<p>The kiln could also contain asbestos, if this equipment is to be used, ensure all aspects are sealed, or sample to determine asbestos presence/non-presence.</p> <p>It is possible that asbestiform minerals are present for use e.g. tiger eye/riebeckite, lizardite or cummingtonite-grunerite. If any of these minerals are present, remove and dispose of as asbestos waste.</p> <p>May remain in-situ until replacement is required.</p> <p>Manage as per Asbestos Management Plan.</p> <p>Administrative – Follow safe work procedures during removal and maintenance.</p> <p>Personal protective equipment – P2 facemask and coveralls required when working on material.</p>

ID #	Product	Location
4	Loose/Stored Items (Kiln and Minerals).	Internal – Mineral store & stored materials.
<p><i>Recommendations:</i> The kiln could also contain asbestos, if this equipment is to be used, ensure all aspects are sealed, or sample to determine asbestos presence/non-presence.</p> <p>It is possible that asbestiform minerals are present for use e.g. tiger eye/riebeckite, lizardite or cummingtonite-grunerite. If any of these minerals are present, remove and dispose of as asbestos waste.</p>
