ASBESTOS MATERIALS REGISTER

Report ID: 28231r1 – supersedes
28231r0

**Building 7252 – Kalamunda Library, 50
Railway Road, Kalamunda WA 6076**

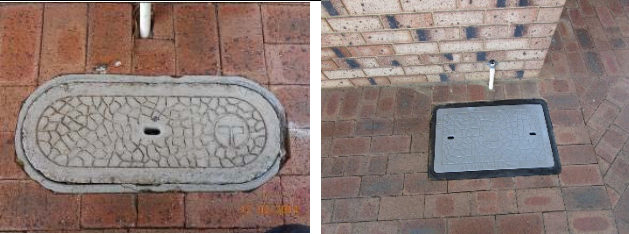
No asbestos detected. Information taken from the City of Kalamunda register: Building: Kalamunda Library Asset ID: BD_0502-00 Date Inspected: 11-Dec-2019
Cable pit surrounds.	Removed.	Southwest corner paving under veranda.

Replaced between the 2019 and 2021 audits.
Vinyl floor sheeting.	Greencap Report No. 41949. QED ID: 32439.	Cleaner's store, office, kitchen and storeroom.	 	No asbestos detected.
