ASBESTOS REGISTER

Kalamunda Toy Library and Garage, 33 Canning Road, Kalamunda, WA

Report ID: **33761Br0**

Prepared for: **City of Kalamunda**

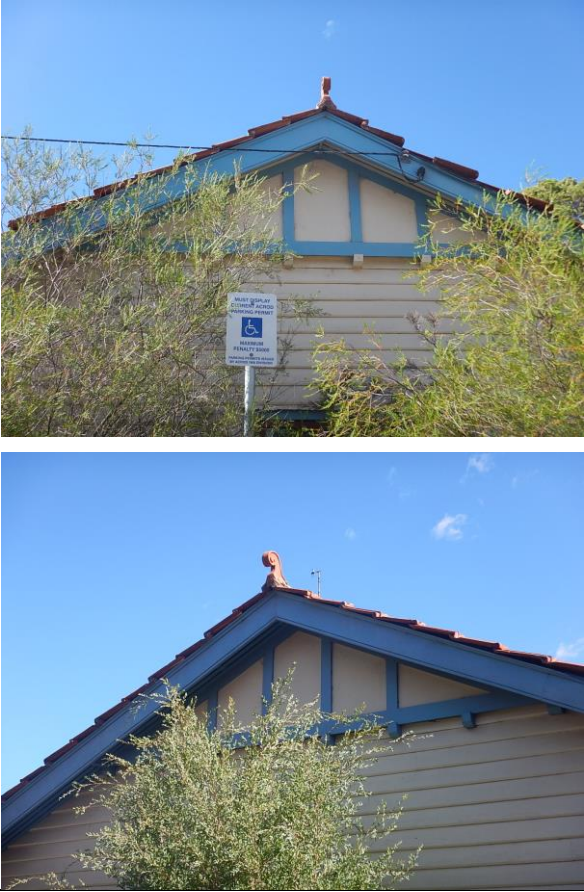
ID 1:- Fibre Cement Gable End Panelling (Suspected Asbestos Containing Material)

Material	Suspected asbestos containing material.	
Lab No.	Unable to obtain suitable sample [height].	
QED Sample No.	ID: Observed.	
Locations	External – Northern, western and southern elevations of roof, gable ends.	
Condition	Good, sealed, non-friable.	
Signage	Unable to access.	
Potential for Disturbance	Low.	
Risk	<p>The ACM are not friable and are in stable condition. Ensure that they remain clearly labelled and regularly inspect to ensure they are not deteriorating or otherwise contributing to an unacceptable health risk.</p>	
Management Actions	<p>Label if/when practicable. May remain in-situ until replacement is required. Manage as per Asbestos Management Plan. Administrative – Follow safe work procedures during removal and maintenance. Personal protective equipment – P2 facemask and coveralls required when working on material.</p>

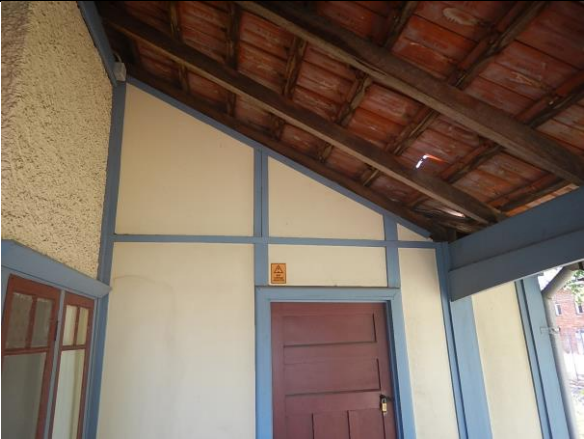
ID 2:- Fibre Cement Wall Panelling (Asbestos Detected)

Material	Chrysotile and crocidolite asbestos detected.	
Lab No.	Greencap Report No. 40073.	
QED Sample No.	ID: 32301.	
Locations	External/Internal – South-western elevation, upper section of wall (right hand side if observing from footpath).	
Condition	Good, sealed, non-friable.	
Signage	Labels in area.	
Potential for Disturbance	Low.	
Risk	The ACM are not friable and are in stable condition. Ensure that they remain clearly labelled and regularly inspect to ensure they are not deteriorating or otherwise contributing to an unacceptable health risk.	
Management Actions	May remain in-situ until replacement is required. Manage as per Asbestos Management Plan . Administrative – Follow safe work procedures during removal and maintenance. Personal protective equipment – P2 facemask and coveralls required when working on material.	
References (See Appendices)	Safe Work Australia, Code of Practice: How to Manage and Control Asbestos in the Workplace. WHS Appendix G—Recommended safe working practices Safe work practice 1—Drilling of ACM Safe work practice 2—Sealing, painting, coating and cleaning of asbestos cement products Safe Work Australia, Code of Practice: How to Safely Remove Asbestos Appendix E—Examples of asbestos removal work Asbestos cement products

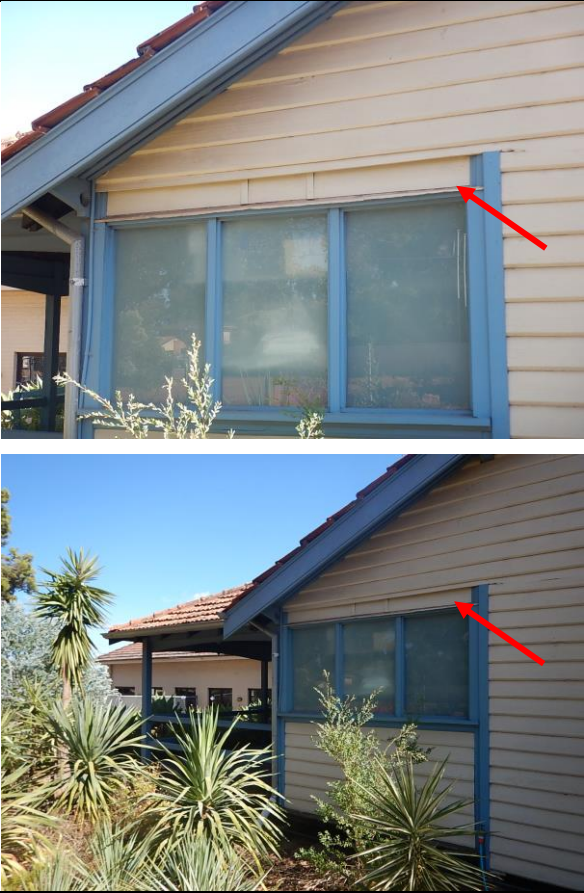
ID 3:- Fibre Cement Infill Panelling (Asbestos Detected)

Material	Chrysotile and crocidolite asbestos detected.	
Lab No.	Greencap Report No. 40073.	
QED Sample No.	ID: 32297.	
Locations	External – Western elevation, (infill) above windows.	
Condition	Good, sealed, non-friable.	
Signage	Labelled.	
Potential for Disturbance	Low.	
Risk	<p>The ACM are not friable and are in stable condition. Ensure that they remain clearly labelled and regularly inspect to ensure they are not deteriorating or otherwise contributing to an unacceptable health risk.</p>	
Management Actions	<p>May remain in-situ until replacement is required. Manage as per Asbestos Management Plan. Administrative – Follow safe work procedures during removal and maintenance. Personal protective equipment – P2 facemask and coveralls required when working on material.</p>	
References (See Appendices)	<p>Safe Work Australia, Code of Practice: How to Manage and Control Asbestos in the Workplace. WHS Appendix G—Recommended safe working practices Safe work practice 1—Drilling of ACM Safe work practice 2—Sealing, painting, coating and cleaning of asbestos cement products</p> <p>Safe Work Australia, Code of Practice: How to Safely Remove Asbestos Appendix E—Examples of asbestos removal work Asbestos cement products</p>

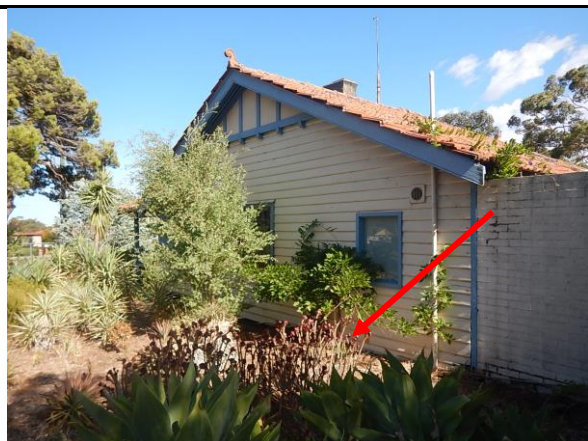
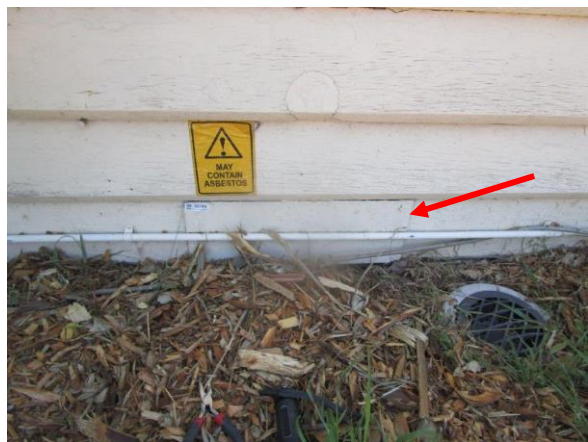
ID 4:- Fibre Cement Patch Panel (Asbestos Detected)	
Material	Chrysotile asbestos detected.
Lab No.	Greencap Report No. 40073.
QED Sample No.	ID: 32295.
Locations	External – Southern wall of building, low level patch panel.
Condition	Good, sealed, non-friable.
Signage	Labelled.
Potential for Disturbance	Low.
Risk	<p>The ACM are not friable and are in stable condition. Ensure that they remain clearly labelled and regularly inspect to ensure they are not deteriorating or otherwise contributing to an unacceptable health risk.</p>
Management Actions	<p>May remain in-situ until replacement is required. Manage as per Asbestos Management Plan. Administrative – Follow safe work procedures during removal and maintenance. Personal protective equipment – P2 facemask and coveralls required when working on material.</p>
References (See Appendices)	<p>Safe Work Australia, Code of Practice: How to Manage and Control Asbestos in the Workplace. WHS Appendix G—Recommended safe working practices Safe work practice 1—Drilling of ACM Safe work practice 2—Sealing, painting, coating and cleaning of asbestos cement products</p> <p>Safe Work Australia, Code of Practice: How to Safely Remove Asbestos Appendix E—Examples of asbestos removal work Asbestos cement products</p>

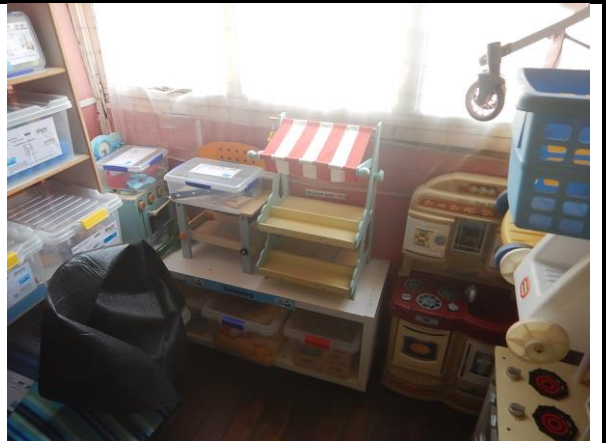
ID 5:- Fibre Cement Wall Panelling (Asbestos Detected)	
Material	Chrysotile and amosite asbestos detected.
Lab No.	Greencap Report No. 40073.
QED Sample No.	ID: 32299.
Locations	Internal – North-western room, wall panelling.
Condition	Good, sealed, non-friable.
Signage	Labelled.
Potential for Disturbance	Low to medium.
Risk	<p>The ACM are not friable and are in stable condition. Ensure that they remain clearly labelled and regularly inspect to ensure they are not deteriorating or otherwise contributing to an unacceptable health risk.</p>
Management Actions	<p>May remain in-situ until replacement is required. Manage as per Asbestos Management Plan. Administrative – Follow safe work procedures during removal and maintenance. Personal protective equipment – P2 facemask and coveralls required when working on material.</p>
References (See Appendices)	<p>Safe Work Australia, Code of Practice: How to Manage and Control Asbestos in the Workplace. WHS Appendix G—Recommended safe working practices Safe work practice 1—Drilling of ACM Safe work practice 2—Sealing, painting, coating and cleaning of asbestos cement products</p> <p>Safe Work Australia, Code of Practice: How to Safely Remove Asbestos Appendix E—Examples of asbestos removal work Asbestos cement products</p>

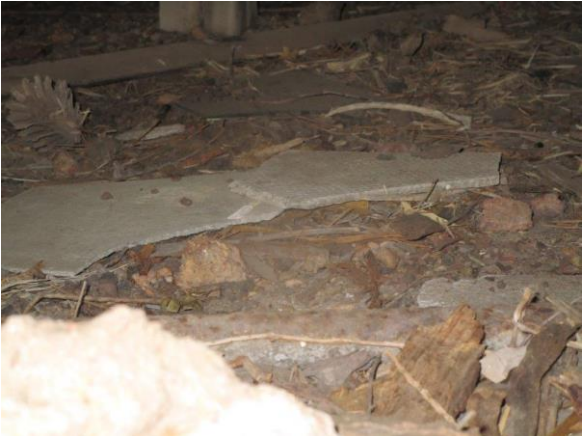
ID 6:- Fibre Cement Fragments/Debris (Suspected Asbestos Containing Material)

<p>Photos from November 2020 inspection.</p>
Material	Suspected asbestos containing material.	
Lab No.	Unable to obtain suitable sample [inaccessible].	
QED Sample No.	ID: Observed.	
Locations	External – Below building, loose.	
Condition	Fair, unsealed/debris, non-friable.	
Signage	Unable to access.	
Potential for Disturbance	Low.	
Risk	<p>The ACM are not friable and are in stable condition. Ensure that they remain clearly labelled and regularly inspect to ensure they are not deteriorating or otherwise contributing to an unacceptable health risk.</p>	
Management Actions	<p>Label if/when practical. May remain in-situ until replacement is required. Manage as per Asbestos Management Plan. Administrative – Follow safe work procedures during removal and maintenance. Personal protective equipment – P2 facemask and coveralls required when working on material.</p>

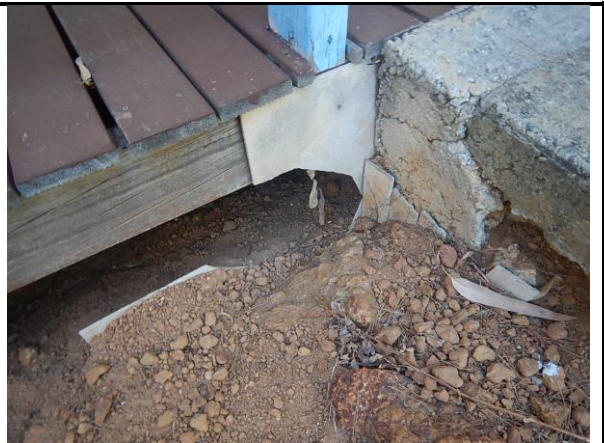
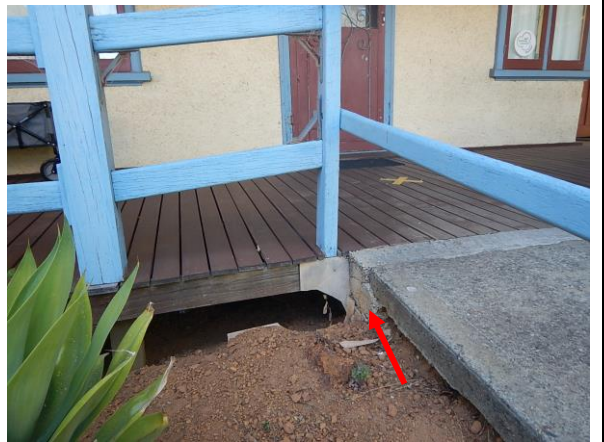
ID #	Product	Location
7	Fibre Cement Shuttering.	External – Western elevation, entry ramp, shuttering adjacent ramp.
<i>Recommendations:</i> The debris associated with the material requires removing. Removal of the in-situ material is also recommended.

ID 7:- Fibre Cement Shuttering (Suspected Asbestos Containing Material)	
Material	Suspected asbestos containing material.
Lab No.	Unable to obtain suitable sample.
QED Sample No.	ID: Observed.
Locations	External – Western elevation, entry ramp, shuttering adjacent ramp.
Condition	Fair, unsealed/debris, non-friable.
Signage	Unable to access.
Potential for Disturbance	Low.
Risk	<p>The ACM are not friable and are in stable condition. Ensure that they remain clearly labelled and regularly inspect to ensure they are not deteriorating or otherwise contributing to an unacceptable health risk.</p>
Management Actions	<p>Label if/when practical. May remain in-situ until replacement is required. Manage as per Asbestos Management Plan. Administrative – Follow safe work procedures during removal and maintenance. Personal protective equipment – P2 facemask and coveralls required when working on material.</p>
References (See Appendices)	<p>Safe Work Australia, Code of Practice: How to Manage and Control Asbestos in the Workplace. WHS Appendix G—Recommended safe working practices Safe work practice 1—Drilling of ACM Safe work practice 2—Sealing, painting, coating and cleaning of asbestos cement products</p> <p>Safe Work Australia, Code of Practice: How to Safely Remove Asbestos Appendix E—Examples of asbestos removal work Asbestos cement products</p>

1. ID#7 has become damaged and requires removal.
2. All remaining materials identified may remain in situ until requiring replacement although, where practicable, asbestos containing materials should be removed, consistent with the Federal Government's stated ultimate goal of the prohibition of asbestos, which is for "all workplaces to be free of asbestos".
3. Asbestos Management Plan (AMP) implemented:
 - a. City of Kalamunda site induction to include specific reference to AMP and Register.
 - b. Register and AMP document to be printed and kept onsite at the location where contractors sign-in and made available via the internet for contractors to use when accessing the site or planning for works.
 - c. Emergency Response chart to be printed and kept onsite at the location where contractors sign-in.

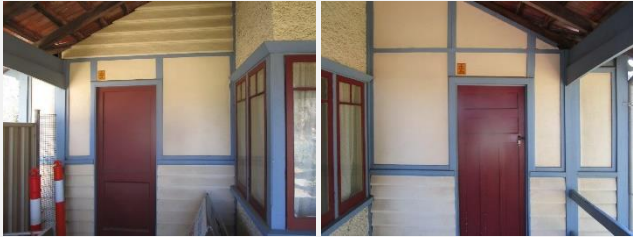
Item Description	Lab No.	Location	Photo	Comments
Lower sections of the front wall cladding.	Greencap Report No. 40073. ID: 32294.	Left and right front walls of the building.

No asbestos detected. Composite sample taken from both the left and right walls. Note: the upper section of the right-hand side contains asbestos. Caution should be taken when working in the area.
Rear external wall Panelling	Greencap Report No. 40073. ID: 32302.	Rear (east) external Wall

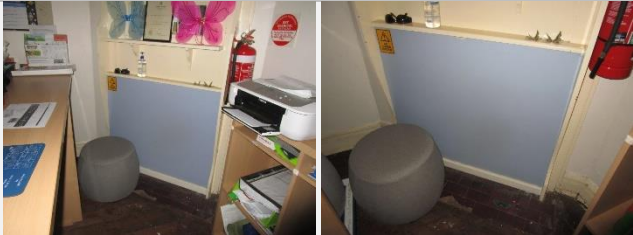
No asbestos detected. Sample was a composite taken from 3 panels.
Fireplace infill panelling	Greencap Report No. 40073. ID: 32298.	Behind the front room desk.

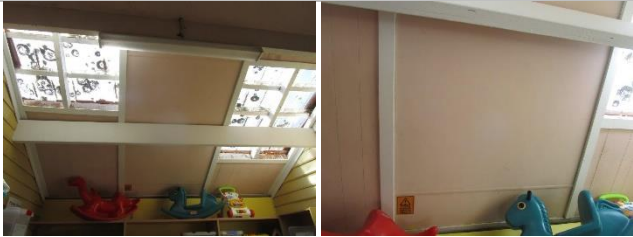
No asbestos detected.
Rear centre room ceiling lining	Greencap Report No. 40073. ID: 32300.	Rear centre room

No asbestos detected.

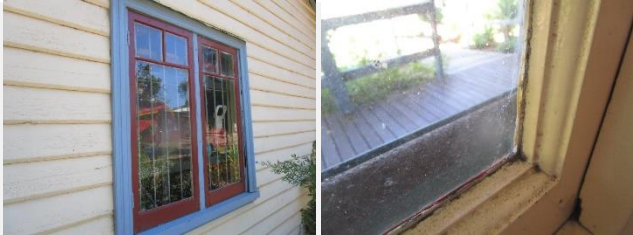
Item Description	Lab No.	Location	Photo	Comments
Window Mastic	Greencap Report No. 40073. ID: 32296	Windows throughout the building

No asbestos detected.
Electrical mounting board	Greencap Report No. 40073. ID: 32303	Pole on the western boundary

Window mastics were observed within the window frames of the building. A sample from one window frame was taken and found not to contain asbestos. However, due to the potential variety of mastics used throughout the building and the potential for variation in the installation dates, it is recommended that specific sampling be conducted prior to disturbance or removal of windows or if the condition of the material deteriorates.
