ASBESTOS REGISTER

Lesmurdie Guide Hall, Sanderson Road, Lesmurdie, WA

Report ID: **34760Br0**

Prepared for: **City of Kalamunda**

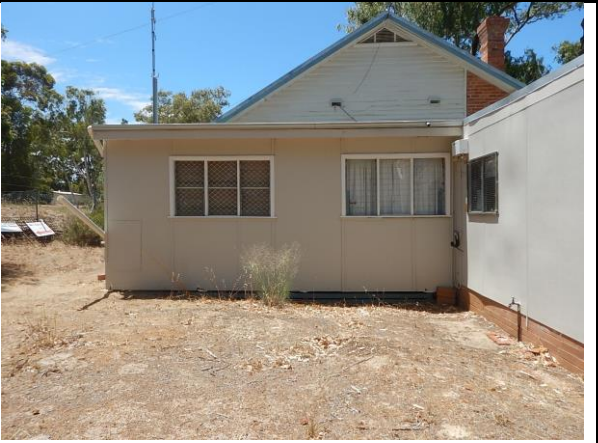
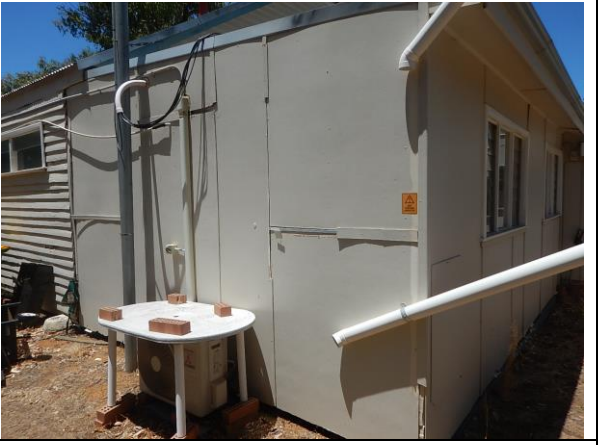
ID 1:- Fibre Cement Wall Panelling (including Jointing Strips) (Asbestos Detected)

Material	Chrysotile asbestos detected.	
Lab No.	Eurofins ARL Lab No. 21-10098-156.	
QED Sample No.	ID: 28131.	
Locations	External – Original sections of building, wall panels including jointing strips.	
Condition	Fair, some damage, typically sealed, non-friable.	
Signage	Labelled.	
Potential for Disturbance	Low to medium.	
Risk	<p>The ACM are not friable and are in stable condition. Ensure that they remain clearly labelled and regularly inspect to ensure they are not deteriorating or otherwise contributing to an unacceptable health risk.</p>	
Management Actions	<p>Ideally the fibre cement panels would be removed; if this is not practical, encapsulation of the exposed areas of the material will extend the serviceable lifespan.</p> <p>May remain in-situ until replacement is required.</p> <p>Manage as per Asbestos Management Plan.</p> <p>Administrative – Follow safe work procedures during removal and maintenance.</p> <p>Personal protective equipment – P2 facemask and coveralls required when working on material.</p>

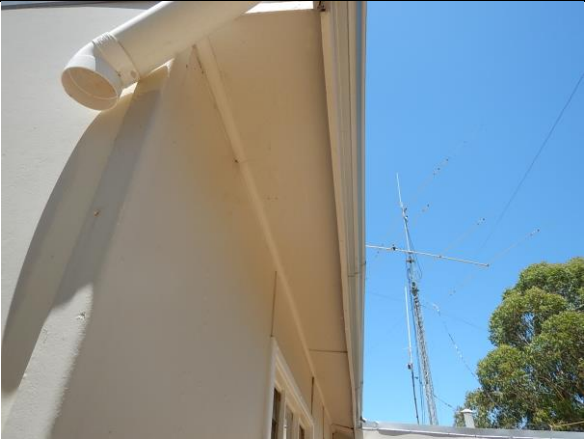
ID 2:- Fibre Cement Eaves Lining (Asbestos Detected)

Material	Chrysotile asbestos detected.	
Lab No.	Eurofins ARL Lab No. 21-10098-156.	
QED Sample No.	ID: 28131.	
Locations	External – Building perimeter, eaves lining.	
Condition	Good, sealed, non-friable.	
Signage	Labelled on wall panels.	
Potential for Disturbance	Low.	
Risk	<p>The ACM are not friable and are in stable condition. Ensure that they remain clearly labelled and regularly inspect to ensure they are not deteriorating or otherwise contributing to an unacceptable health risk.</p>	
Management Actions	<p>May remain in-situ until replacement is required. Manage as per Asbestos Management Plan. Administrative – Follow safe work procedures during removal and maintenance. Personal protective equipment – P2 facemask and coveralls required when working on material.</p>	
References (See Appendices)	<p>Safe Work Australia, Code of Practice: How to Manage and Control Asbestos in the Workplace. WHS Appendix G—Recommended safe working practices Safe work practice 1—Drilling of ACM Safe work practice 2—Sealing, painting, coating and cleaning of asbestos cement products Safe Work Australia, Code of Practice: How to Safely Remove Asbestos Appendix E—Examples of asbestos removal work Asbestos cement products</p>

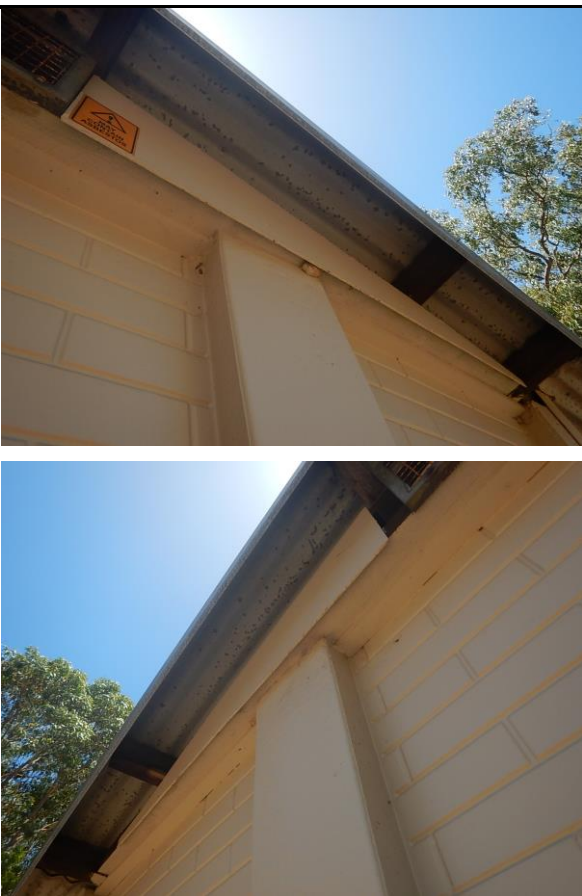
ID 3:- Fibre Cement Gable/Infill Panels (Suspected Asbestos Containing Material)

Material	Suspected asbestos containing material.	
Lab No.	N/A.	
QED Sample No.	ID: N/A.	
Locations	External – Southern elevation, gable/infill panels.	
Condition	Good, sealed, non-friable.	
Signage	Labelled on wall panels.	
Potential for Disturbance	Low.	
Risk	<p>The ACM are not friable and are in stable condition. Ensure that they remain clearly labelled and regularly inspect to ensure they are not deteriorating or otherwise contributing to an unacceptable health risk.</p>	
Management Actions	<p>May remain in-situ until replacement is required. Manage as per Asbestos Management Plan. Administrative – Follow safe work procedures during removal and maintenance. Personal protective equipment – P2 facemask and coveralls required when working on material.</p>	
References (See Appendices)	<p>Safe Work Australia, Code of Practice: How to Manage and Control Asbestos in the Workplace. WHS Appendix G—Recommended safe working practices Safe work practice 1—Drilling of ACM Safe work practice 2—Sealing, painting, coating and cleaning of asbestos cement products</p> <p>Safe Work Australia, Code of Practice: How to Safely Remove Asbestos Appendix E—Examples of asbestos removal work Asbestos cement products</p>

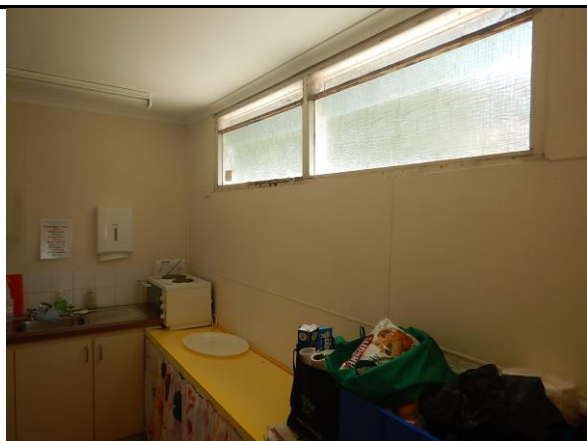
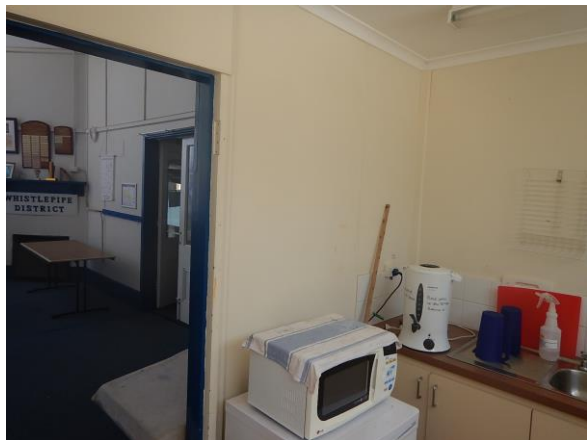
ID 4:- Fibre Cement Wall Panelling (Asbestos Detected)	
Material	Chrysotile asbestos detected.
Lab No.	Eurofins ARL Lab No. 21-10098-159.
QED Sample No.	ID: 28134.
Locations	Internal – Kitchen, wall panels (including rear wall inside cupboard).
Condition	Good, sealed, non-friable.
Signage	Labelled.
Potential for Disturbance	Low to medium.
Risk	<p>The ACM are not friable and are in stable condition. Ensure that they remain clearly labelled and regularly inspect to ensure they are not deteriorating or otherwise contributing to an unacceptable health risk.</p>
Management Actions	<p>May remain in-situ until replacement is required. Manage as per Asbestos Management Plan. Administrative – Follow safe work procedures during removal and maintenance. Personal protective equipment – P2 facemask and coveralls required when working on material.</p>
References (See Appendices)	<p>Safe Work Australia, Code of Practice: How to Manage and Control Asbestos in the Workplace. WHS Appendix G—Recommended safe working practices</p> <ul style="list-style-type: none"> Safe work practice 1—Drilling of ACM Safe work practice 2—Sealing, painting, coating and cleaning of asbestos cement products <p>Safe Work Australia, Code of Practice: How to Safely Remove Asbestos Appendix E—Examples of asbestos removal work</p> <p>Asbestos cement products</p>

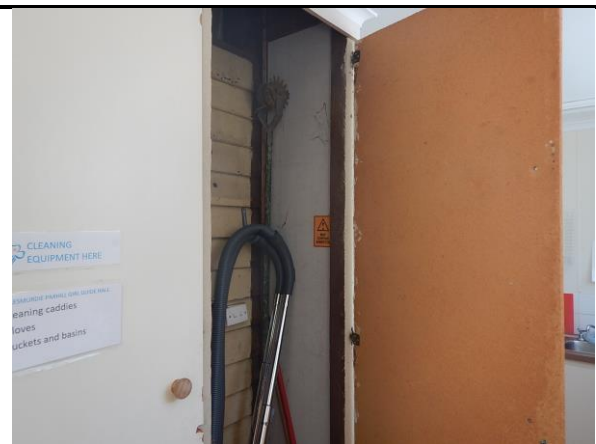
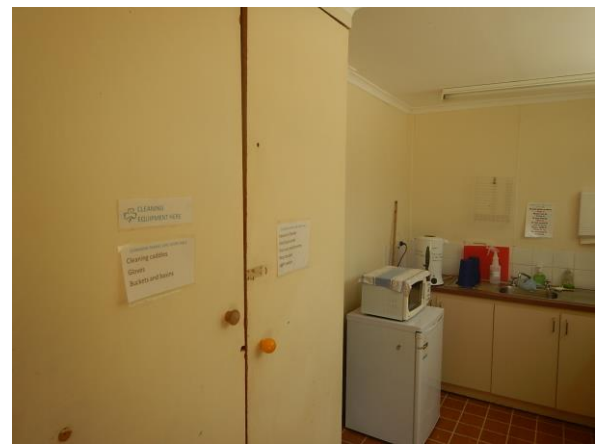
ID 5:- Fibre Cement Kitchen Cupboard Panelling (Asbestos Detected)	
Material	Chrysotile asbestos detected.
Lab No.	Eurofins ARL Lab No. 21-10098-160.
QED Sample No.	ID: 28135.
Locations	Internal – Kitchen cupboard, panel behind/inside cupboard.
Condition	Good, sealed, non-friable.
Signage	Labelled.
Potential for Disturbance	Low to medium.
Risk	<p>The ACM are not friable and are in stable condition. Ensure that they remain clearly labelled and regularly inspect to ensure they are not deteriorating or otherwise contributing to an unacceptable health risk.</p>
Management Actions	<p>May remain in-situ until replacement is required. Manage as per Asbestos Management Plan. Administrative – Follow safe work procedures during removal and maintenance. Personal protective equipment – P2 facemask and coveralls required when working on material.</p>
References (See Appendices)	<p>Safe Work Australia, Code of Practice: How to Manage and Control Asbestos in the Workplace. WHS Appendix G—Recommended safe working practices</p> <ul style="list-style-type: none"> Safe work practice 1—Drilling of ACM Safe work practice 2—Sealing, painting, coating and cleaning of asbestos cement products <p>Safe Work Australia, Code of Practice: How to Safely Remove Asbestos Appendix E—Examples of asbestos removal work</p> <p>Asbestos cement products</p>

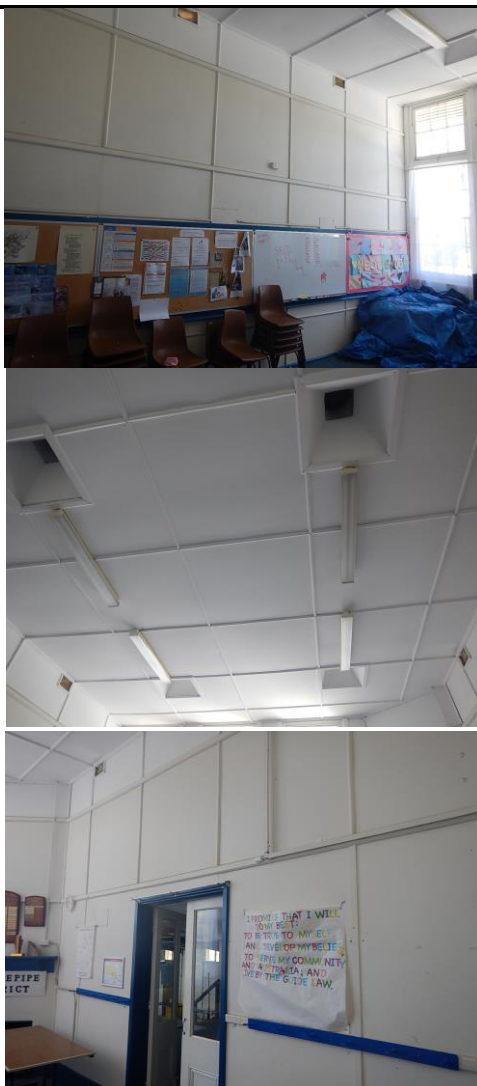
ID 6:- Fibre Cement Wall and Ceiling Panelling (Asbestos Detected)	
Material	Chrysotile and crocidolite asbestos detected.
Lab No.	Eurofins ARL Lab No. 21-10098-161.
QED Sample No.	ID: 28136.
Locations	Internal – Main/large room, wall and ceiling panels.
Condition	Good, sealed, non-friable.
Signage	Labelled.
Potential for Disturbance	Low to medium.
Risk	<p>The ACM are not friable and are in stable condition. Ensure that they remain clearly labelled and regularly inspect to ensure they are not deteriorating or otherwise contributing to an unacceptable health risk.</p>
Management Actions	<p>May remain in-situ until replacement is required. Manage as per Asbestos Management Plan. Administrative – Follow safe work procedures during removal and maintenance. Personal protective equipment – P2 facemask and coveralls required when working on material.</p>
References (See Appendices)	<p>Safe Work Australia, Code of Practice: How to Manage and Control Asbestos in the Workplace. WHS Appendix G—Recommended safe working practices Safe work practice 1—Drilling of ACM Safe work practice 2—Sealing, painting, coating and cleaning of asbestos cement products Safe Work Australia, Code of Practice: How to Safely Remove Asbestos Appendix E—Examples of asbestos removal work Asbestos cement products</p>

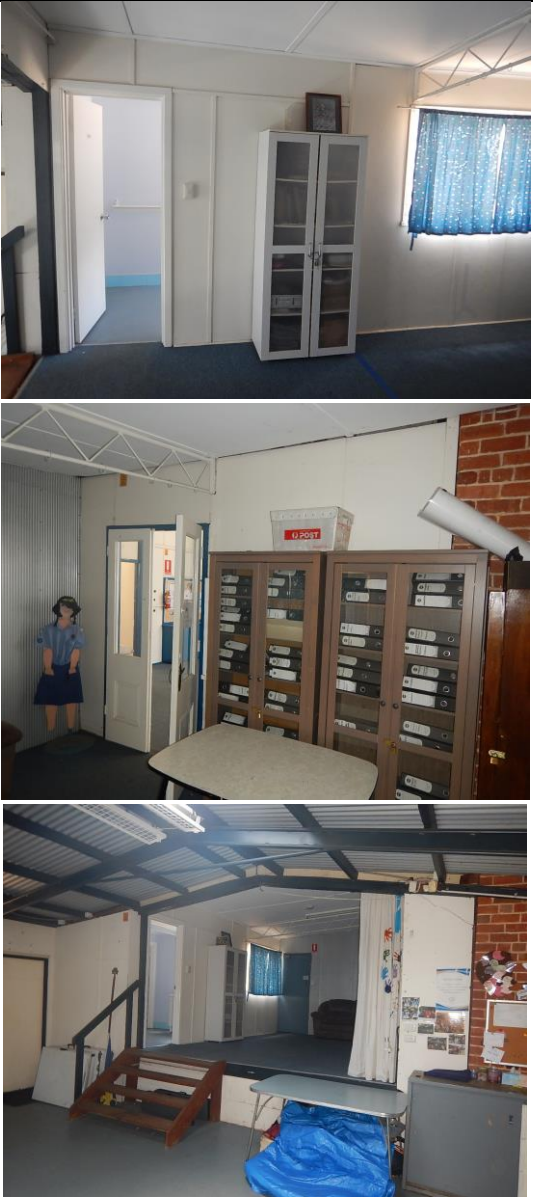
ID 7:- Fibre Cement Wall and Ceiling Panelling (Asbestos Detected)

Material	Chrysotile and crocidolite asbestos detected.	
Lab No.	Eurofins ARL Lab No. 21-10098-161.	
QED Sample No.	ID: 28136.	
Locations	Internal – Stage, and room to rear of stage, wall and ceiling panels.	
Condition	Good, sealed, non-friable.	
Signage	Labelled.	
Potential for Disturbance	Low to medium.	
Risk	<p>The ACM are not friable and are in stable condition. Ensure that they remain clearly labelled and regularly inspect to ensure they are not deteriorating or otherwise contributing to an unacceptable health risk.</p>	
Management Actions	<p>May remain in-situ until replacement is required. Manage as per Asbestos Management Plan. Administrative – Follow safe work procedures during removal and maintenance. Personal protective equipment – P2 facemask and coveralls required when working on material.</p>	
References (See Appendices)	<p>Safe Work Australia, Code of Practice: How to Manage and Control Asbestos in the Workplace. WHS Appendix G—Recommended safe working practices Safe work practice 1—Drilling of ACM Safe work practice 2—Sealing, painting, coating and cleaning of asbestos cement products</p> <p>Safe Work Australia, Code of Practice: How to Safely Remove Asbestos Appendix E—Examples of asbestos removal work Asbestos cement products</p>
