ASBESTOS REGISTER

Lesmurdie Hall, 96 Gladys Road, Lesmurdie, WA

Report ID: **34761Br0**

Prepared for: **City of Kalamunda**

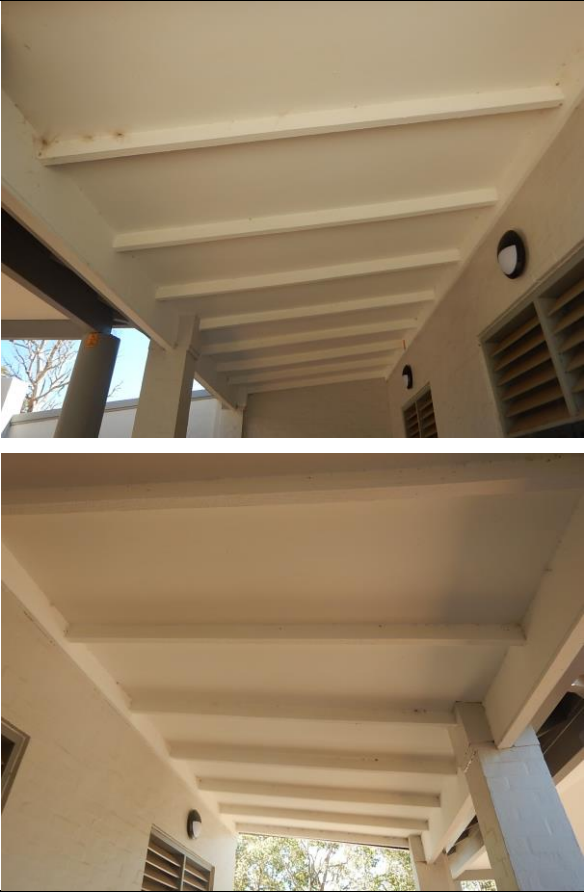
ID 1:- Fibre Cement Ceiling Panelling (Asbestos Detected)

Material	Chrysotile asbestos detected.	
Lab No.	Eurofins ARL Lab No. 21-08932-27.	
QED Sample No.	ID: 28198.	
Locations	External – Northern elevation veranda, ceiling panels.	
Condition	Good, sealed, non-friable.	
Signage	Labelled.	
Potential for Disturbance	Low.	
Risk	<p>The ACM are not friable and are in stable condition. Ensure that they remain clearly labelled and regularly inspect to ensure they are not deteriorating or otherwise contributing to an unacceptable health risk.</p>	
Management Actions	<p>May remain in-situ until replacement is required. Manage as per Asbestos Management Plan. Administrative – Follow safe work procedures during removal and maintenance. Personal protective equipment – P2 facemask and coveralls required when working on material.</p>	
References (See Appendices)	<p>Safe Work Australia, Code of Practice: How to Manage and Control Asbestos in the Workplace. WHS Appendix G—Recommended safe working practices Safe work practice 1—Drilling of ACM Safe work practice 2—Sealing, painting, coating and cleaning of asbestos cement products Safe Work Australia, Code of Practice: How to Safely Remove Asbestos Appendix E—Examples of asbestos removal work Asbestos cement products</p>

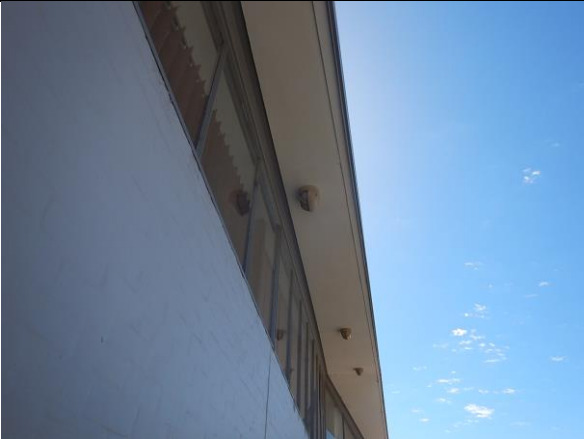
ID 2:- Fibre Cement Eaves Lining (Suspected Asbestos Containing Material)

Material	Suspected asbestos containing material.	
Lab No.	Unable to obtain suitable sample [height].	
QED Sample No.	ID: Observed.	
Locations	External – Building perimeter, eaves lining.	
Condition	Good, sealed, non-friable.	
Signage	None.	
Potential for Disturbance	Low.	
Risk	<p>The ACM are not friable and are in stable condition. Ensure that they remain clearly labelled and regularly inspect to ensure they are not deteriorating or otherwise contributing to an unacceptable health risk.</p>	
Management Actions	<p>Label immediately. May remain in-situ until replacement is required. Manage as per Asbestos Management Plan. Administrative – Follow safe work procedures during removal and maintenance. Personal protective equipment – P2 facemask and coveralls required when working on material.</p>	
References (See Appendices)	<p>Safe Work Australia, Code of Practice: How to Manage and Control Asbestos in the Workplace. WHS Appendix G—Recommended safe working practices Safe work practice 1—Drilling of ACM Safe work practice 2—Sealing, painting, coating and cleaning of asbestos cement products Safe Work Australia, Code of Practice: How to Safely Remove Asbestos Appendix E—Examples of asbestos removal work Asbestos cement products</p>

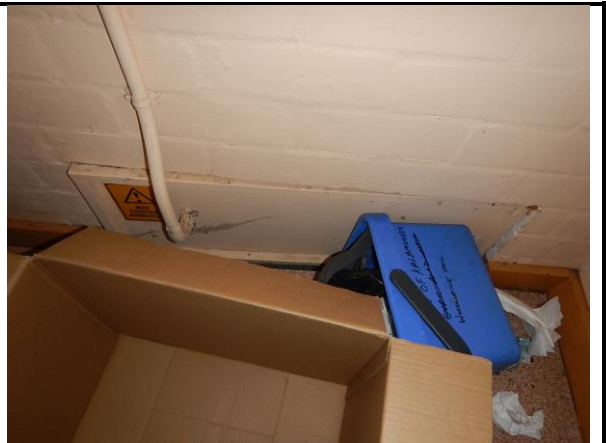
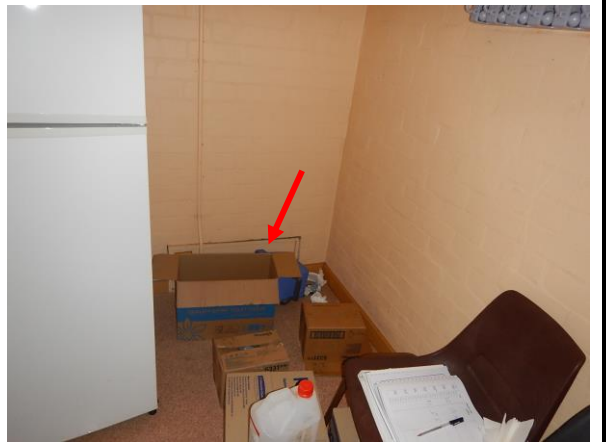
ID 3:- Fibre Cement Wall Panelling (Asbestos Detected)	
Material	Chrysotile and amosite asbestos detected.
Lab No.	Eurofins ARL Lab No. 21-08932-30.
QED Sample No.	ID: 28233.
Locations	Internal – Kitchen storeroom, low level infill panel.
Condition	Good, sealed, non-friable.
Signage	Labelled.
Potential for Disturbance	Low to medium.
Risk	<p>The ACM are not friable and are in stable condition. Ensure that they remain clearly labelled and regularly inspect to ensure they are not deteriorating or otherwise contributing to an unacceptable health risk.</p>
Management Actions	<p>May remain in-situ until replacement is required. Manage as per Asbestos Management Plan. Administrative – Follow safe work procedures during removal and maintenance. Personal protective equipment – P2 facemask and coveralls required when working on material.</p>
References (See Appendices)	<p>Safe Work Australia, Code of Practice: How to Manage and Control Asbestos in the Workplace. WHS Appendix G—Recommended safe working practices</p> <ul style="list-style-type: none"> Safe work practice 1—Drilling of ACM Safe work practice 2—Sealing, painting, coating and cleaning of asbestos cement products <p>Safe Work Australia, Code of Practice: How to Safely Remove Asbestos Appendix E—Examples of asbestos removal work</p> <p>Asbestos cement products</p>

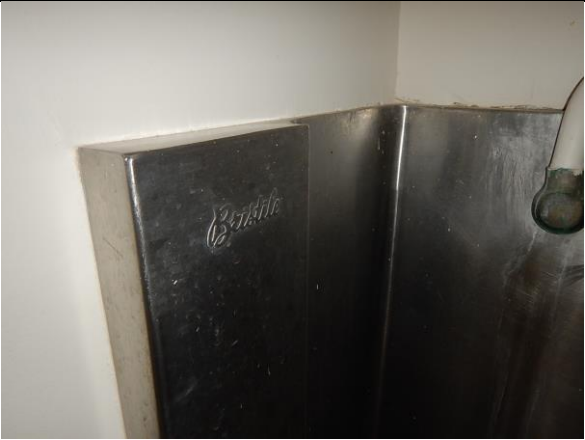
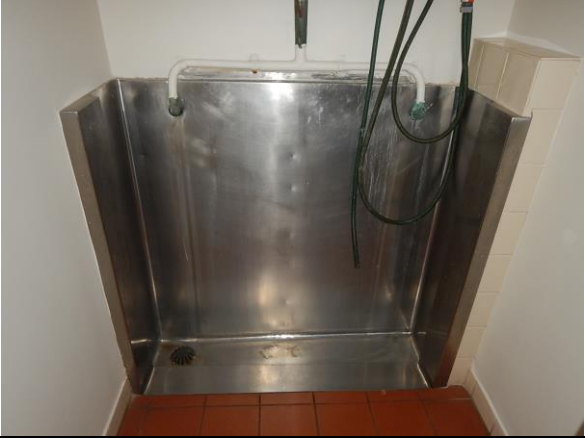
ID 5:- Urinal Backing Membrane (Bristile) (Suspected Asbestos Containing Material)

Material	Suspected asbestos containing material.	
Lab No.	Unable to sample (encapsulated)	
QED Sample No.	ID: N/A.	
Locations	Internal - Male toilets, urinal.	
Condition	Good, encased, non-friable.	
Signage	Unable to adequately label.	
Potential for Disturbance	Low.	
Risk	<p>The ACM are not friable and are in stable condition. Ensure that they are regularly inspected to ensure they are not deteriorating or otherwise contributing to an unacceptable health risk.</p>	
Management Actions	<p>May remain in-situ until replacement is required. Manage as per Asbestos Management Plan. Administrative – Follow safe work procedures during removal and maintenance. Personal protective equipment – P2 facemask and coveralls required when working on material.</p>	
References (See Appendices)	<p>Safe Work Australia, Code of Practice: How to Manage and Control Asbestos in the Workplace. Safe Work Australia, Code of Practice: How to Safely Remove Asbestos Appendix E—Examples of asbestos removal work Removing bituminous (malthoid) products</p>

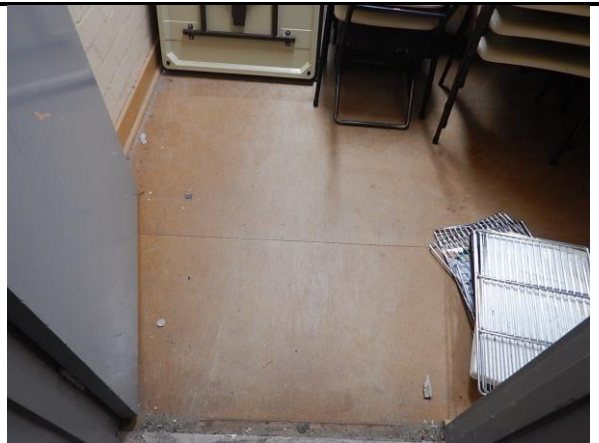
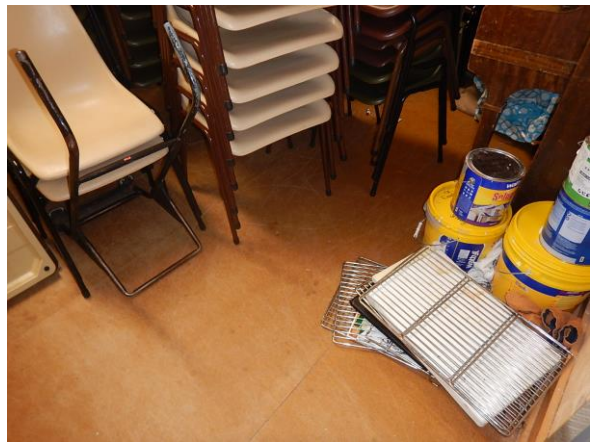
ID 6:- Fibre Cement Flooring Panels (Suspected Asbestos Containing Material)	
Material	Suspected asbestos containing material.
Lab No.	Unable to obtain suitable sample [inaccessible].
QED Sample No.	ID: Observed.
Locations	Internal – Kitchen storeroom, floor (below particle board flooring).
Condition	Good, sealed, non-friable.
Signage	None.
Potential for Disturbance	Low.
Risk	<p>The ACM are not friable and are in stable condition. Ensure that they remain clearly labelled and regularly inspect to ensure they are not deteriorating or otherwise contributing to an unacceptable health risk.</p>
Management Actions	<p>Label immediately. May remain in-situ until replacement is required. Manage as per Asbestos Management Plan. Administrative – Follow safe work procedures during removal and maintenance. Personal protective equipment – P2 facemask and coveralls required when working on material.</p>
References (See Appendices)	<p>Safe Work Australia, Code of Practice: How to Manage and Control Asbestos in the Workplace. WHS Appendix G—Recommended safe working practices Safe work practice 1—Drilling of ACM Safe work practice 2—Sealing, painting, coating and cleaning of asbestos cement products</p> <p>Safe Work Australia, Code of Practice: How to Safely Remove Asbestos Appendix E—Examples of asbestos removal work Asbestos cement products</p>

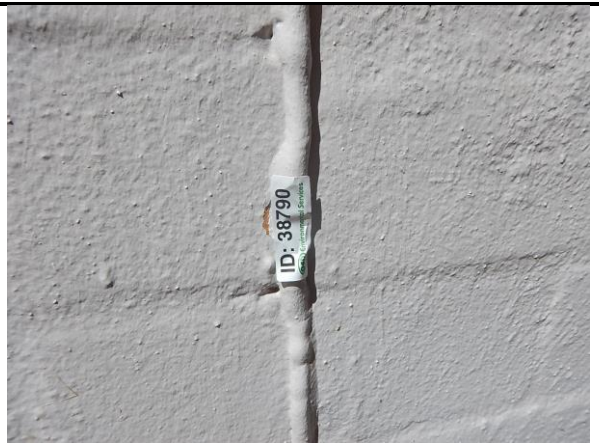
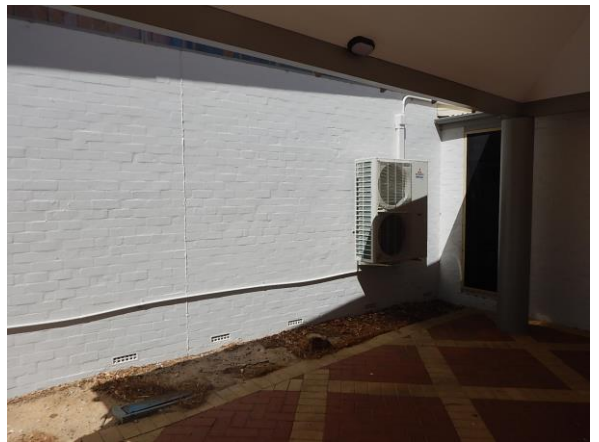
ID 7:- Grey Mastic (Suspected Asbestos Containing Material)	
Material	Suspected asbestos containing material.
Lab No.	N/A.
QED Sample No.	ID: Observed.
Locations	External – Throughout building expansion joints.
Condition	Intact, non-friable.
Signage	None.
Potential for Disturbance	Low.
Risk	<p>The ACM are not friable and are in stable condition. Ensure that they remain clearly labelled and regularly inspect to ensure they are not deteriorating or otherwise contributing to an unacceptable health risk.</p>
Management Actions	<p>Label when practical. May remain in-situ until replacement is required. Manage as per Asbestos Management Plan. Administrative – Follow safe work procedures during removal and maintenance. Personal protective equipment – P2 facemask and coveralls required when working on material.</p>
References (See Appendices)	<p>Safe Work Australia, Code of Practice: How to Manage and Control Asbestos in the Workplace. WHS Appendix G—Recommended safe working practices Safe work practice 1—Drilling of ACM Safe work practice 2—Sealing, painting, coating and cleaning of asbestos cement Safe Work Australia, Code of Practice: How to Safely Remove Asbestos Appendix E—Examples of asbestos removal work Removing bituminous (malthoid) products</p>

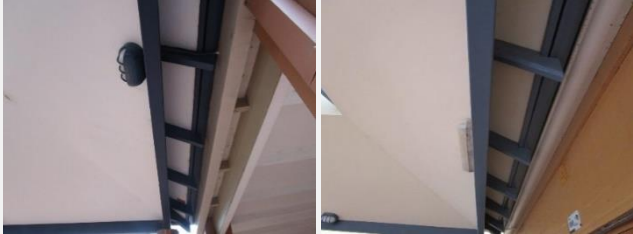
Item Description	Lab No.	Location	Photo	Comments
Cement sheet linings.	Eurofins ARL lab No. 21-08932-26. ID: 28197.	Front and rear portico eaves.

No asbestos detected.
Structural Columns.	Eurofins ARL lab No. 21-08932-25. ID: 28196.	Front and rear entry portico.

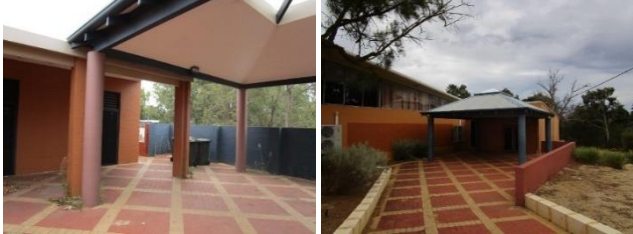
No asbestos detected.
Window Putty.	Eurofins ARL lab No. 21-08932-28. ID: 28199.	Windows under veranda.

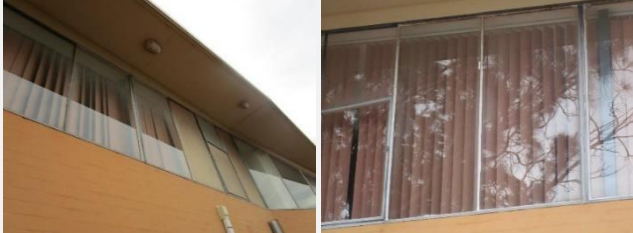
No asbestos detected.
Wall Cladding.	Eurofins ARL lab No. 21-08932-29. ID: 28200.	Front entry above the gutter line.

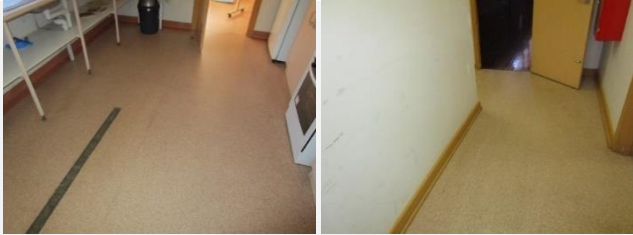
Item Description	Lab No.	Location	Photo	Comments
Vinyl Flooring.	Eurofins ARL lab No. 21-08932-31. ID: 28234.	Kitchen, hall and store.

No asbestos detected.
Fibre cement floor sheeting – Grey.	Eurofins ARL lab No. 21-08932-32. ID: 28235.	Grey strip in Kitchen.

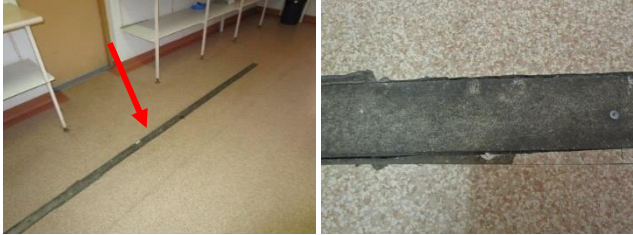
No asbestos detected.
Fibre cement floor sheeting – Pink.	Eurofins ARL lab No. 21-08932-33. ID: 28236.	Underneath the hall vinyl flooring.
