# ASBESTOS REGISTER

Maida Vale Pre-School, Acacia Road, Maida Vale, WA

Report ID: **34766Br1**

Prepared for: **City of Kalamunda**

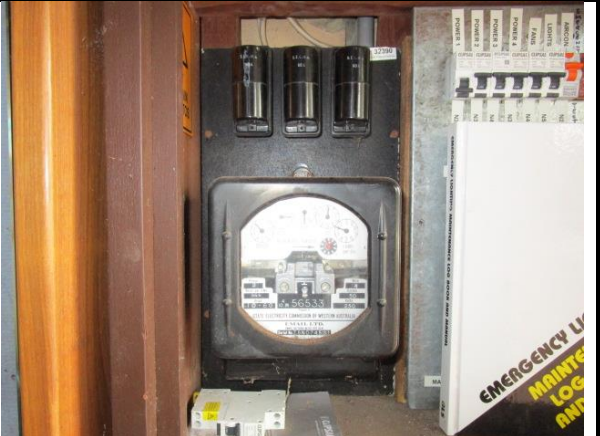
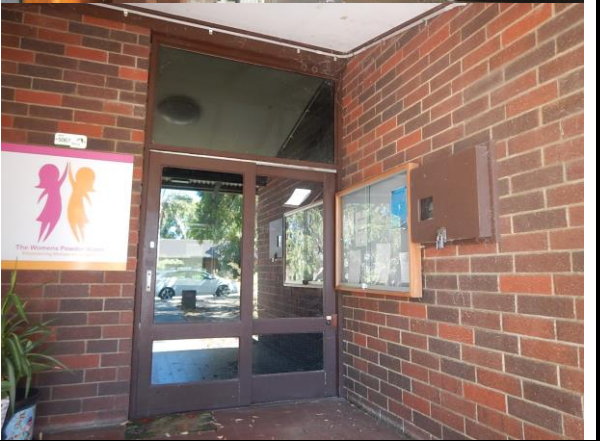
<b>ID 1:- Electrical Mounting Board (Asbestos Detected)</b>

Material	Chrysotile asbestos detected.		
Lab No.	ARL Lab No. 21-05777-A-1.		
QED Sample No.	ID: 32390.		
Locations	External – Electrical Cabinet adjacent Entry Doorway.		
Condition	Good, sealed, non-friable.		
Signage	Labelled.		
Potential for Disturbance	Low.		
<b>Risk</b>	<p>The ACM are not friable and are in stable condition. Ensure that they remain clearly labelled and regularly inspect to ensure they are not deteriorating or otherwise contributing to an unacceptable health risk.</p>

Management Actions	<p>May remain in-situ until replacement is required.                  Manage as per <b>Asbestos Management Plan</b>.                  Administrative – Follow safe work procedures during removal and maintenance.                  Personal protective equipment – P2 facemask and coveralls required when working on material.</p>		
References (See Appendices)	<p><b>Safe Work Australia, Code of Practice: How to Manage and Control Asbestos in the Workplace. WHS Appendix G—Recommended safe working practices</b>                  Safe work practice 5—Working on electrical mounting boards (switchboards) containing asbestos  <b>Safe Work Australia, Code of Practice: How to Safely Remove Asbestos Appendix E—Examples of asbestos removal work</b>                  Asbestos cement products</p>

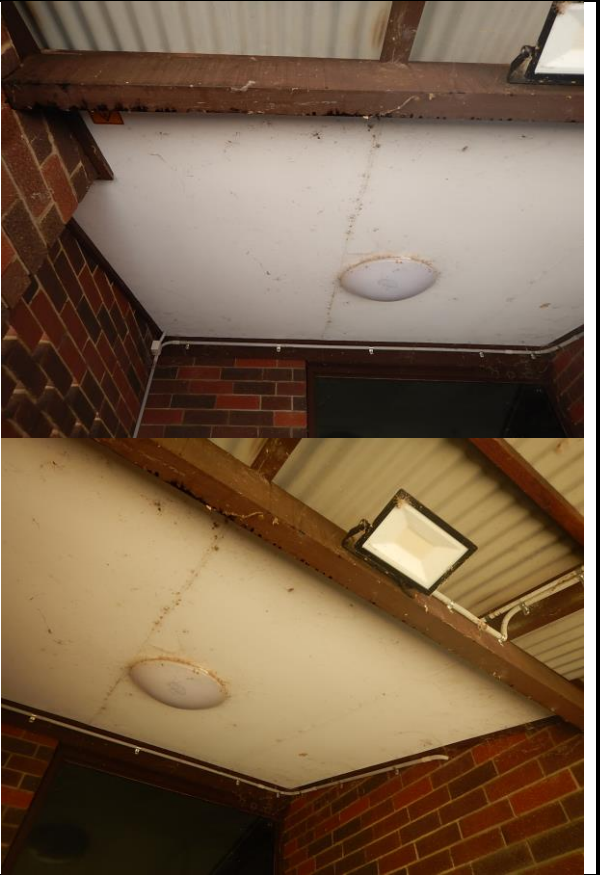
<b>ID 2:- Fibre Cement Panelling – Ceiling Panels (Asbestos Detected)</b>

Material	Chrysotile asbestos detected.	
Lab No.	ARL Lab No. 21-05777-A-3.	
QED Sample No.	ID: 32392.	
Locations	External – Entry canopy, ceiling panels.	
Condition	Good, sealed, non-friable.	
Signage	Labelled.	
Potential for Disturbance	Low.	
<b>Risk</b>	<p>The ACM are not friable and are in stable condition. Ensure that they remain clearly labelled and regularly inspect to ensure they are not deteriorating or otherwise contributing to an unacceptable health risk.</p>	
Management Actions	<p>Previously the panels were unsealed; however, material seems to be sealed now. No information has been provided to QED regarding these actions.                  May remain in-situ until replacement is required.                  Manage as per <b>Asbestos Management Plan</b>.                  Administrative – Follow safe work procedures during removal and maintenance.                  Personal protective equipment – P2 facemask and coveralls required when working on material.</p>

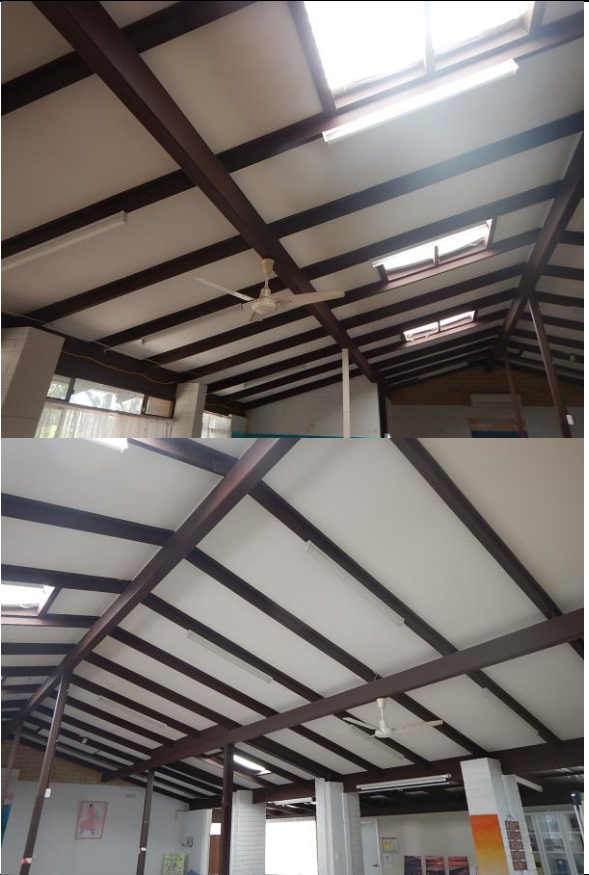
<b>ID 4:- Fibre Cement Panelling – Ceiling Panels (Asbestos Detected)</b>

Material	Chrysotile asbestos detected.	
Lab No.	ARL Lab No. 21-05777-A-4.	
QED Sample No.	ID: 32393.	
Locations	Internal – Throughout, ceiling panels.	
Condition	Typically good (some small damaged areas), sealed, non-friable.	
Signage	Labelled.	
Potential for Disturbance	Low.	
<b>Risk</b>	<p><b>The ACM are not friable and are in stable condition. Ensure that they remain clearly labelled and regularly inspect to ensure they are not deteriorating or otherwise contributing to an unacceptable health risk.</b></p>	
Management Actions	<p>Previously the panels were unsealed; however, material seems to be sealed now. No information has been provided to QED regarding these actions.                  May remain in-situ until replacement is required.                  Manage as per <b>Asbestos Management Plan</b>.                  Administrative – Follow safe work procedures during removal and maintenance.                  Personal protective equipment – P2 facemask and coveralls required when working on material.</p>

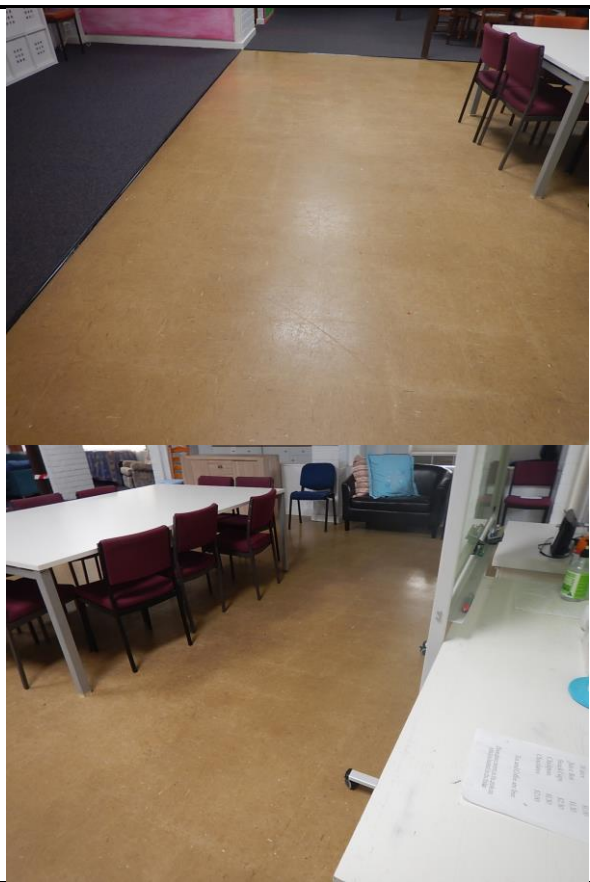
<b>ID 5:- Vinyl Floor Tiles (Asbestos Detected)</b>	
Material	Chrysotile asbestos detected.
Lab No.	Greencap Report No. 41785.
QED Sample No.	ID: 32389.
Locations	Internal – Main room/area, kitchen and store room, floor.
Condition	Good, intact, non-friable.
Signage	None.
Potential for Disturbance	Low to medium.
<b>Risk</b>	<p><b>The ACM are not friable and are in stable condition. Ensure that they remain clearly labelled and regularly inspect to ensure they are not deteriorating or otherwise contributing to an unacceptable health risk.</b></p>
Management Actions	<p>Label when practical.                      May remain in-situ until replacement is required.                      Manage as per <b>Asbestos Management Plan</b>.                      Administrative – Follow safe work procedures during removal and maintenance.                      Personal protective equipment – P2 facemask and coveralls required when working on material.</p>

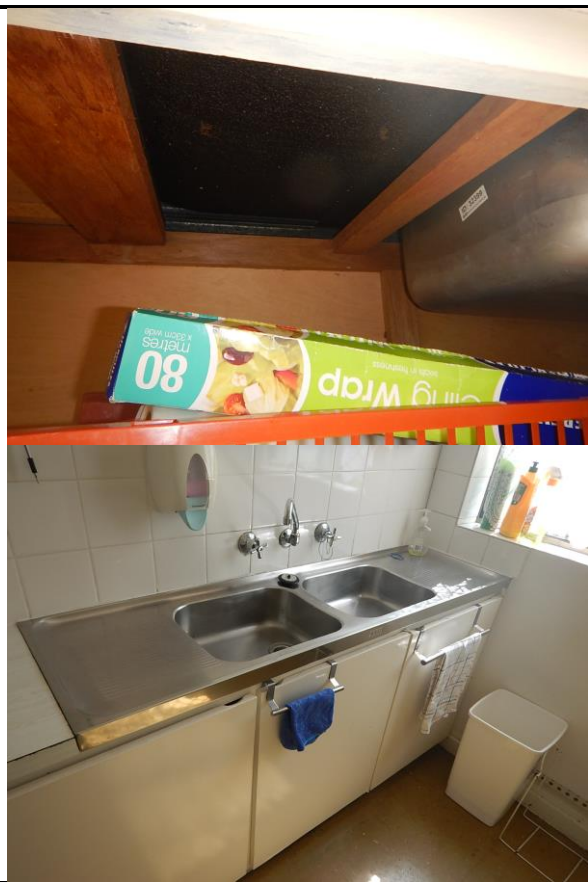
<b>ID 6:- Under Sink Membrane (Asbestos Detected)</b>	
Material	Chrysotile asbestos detected.
Lab No.	ARL Lab No. 21-05777-A-10.
QED Sample No.	ID: 32399.
Locations	Internal – Kitchen, sink unit.
Condition	Good, intact, non-friable.
Signage	None.
Potential for Disturbance	Low.
<b>Risk</b>	<p>The ACM are not friable and are in stable condition. Ensure that they remain clearly labelled and regularly inspect to ensure they are not deteriorating or otherwise contributing to an unacceptable health risk.</p>
Management Actions	<p>Label when practical.                  May remain in-situ until replacement is required.                  Manage as per <b>Asbestos Management Plan</b>.                  Administrative – Follow safe work procedures during removal and maintenance.                  Personal protective equipment – P2 facemask and coveralls required when working on material.</p>
References (See Appendices)	<p><b>Safe Work Australia, Code of Practice: How to Manage and Control Asbestos in the Workplace.</b>  <b>Safe Work Australia, Code of Practice: How to Safely Remove Asbestos</b>  <b>Appendix E—Examples of asbestos removal work</b>                  Removing bituminous (malthoid) products</p>

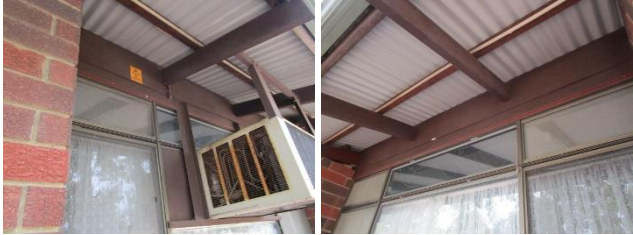
Report ENVSS_0012375_HAZ_VCC_01_2022708
<b>Rafter infill panels at the front of the building.</b>	ARL Lab No. 21-05777-A-2. QED ID: 32391.	Above the windows at the front of the building.

No asbestos detected.  Wood material observed in the front window panelling.  Note: the panels at the rear of the building are fibre cement and contain asbestos.
<b>Cover panelling on the veranda columns.</b>	ARL Lab No. 21-05777-A-8. QED ID: 32397.	Rear veranda columns.

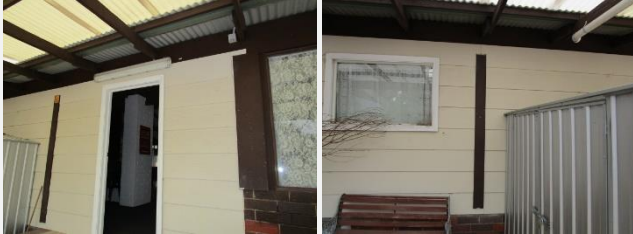
No asbestos detected.

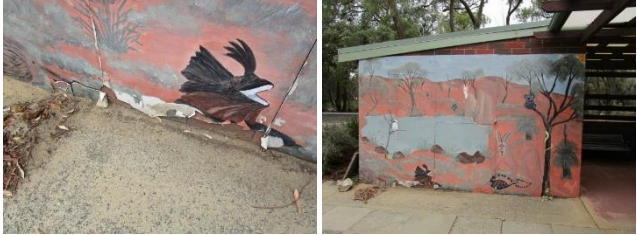
Item Description	Lab No.	Location	Photo	Comments
<p><b>Shed wall panelling.</b></p>	<p>ARL Lab No. 21-05777-A-9.  QED ID: 32398.</p>	<p>Rear shed, side wall.</p>

<p>No asbestos detected.</p>
