# ASBESTOS REGISTER

Pistol Club, 155 Lawnbrook Road, Walliston, WA

Report ID: **34774Br0**

Prepared for: **City of Kalamunda**

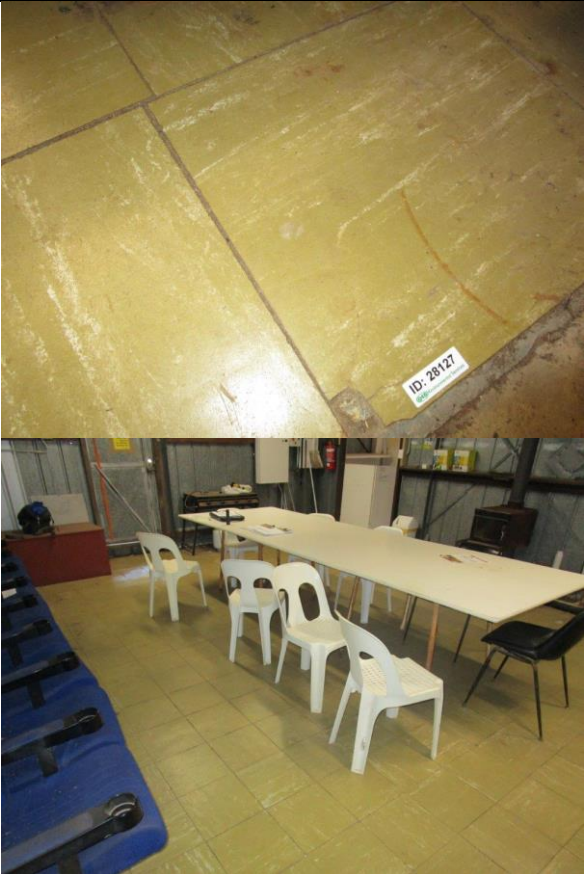
<b>ID 1:- Clubrooms - Vinyl Floor Tiles (Asbestos Detected)</b>

Material	Chrysotile asbestos detected.	
Lab No.	Greencap Report No. 42064.	
QED Sample No.	ID: 28127.	
Locations	Internal – Main room, floor.	
Condition	Good to fair, some damage, non-friable.	
Signage	Labelled.	
Potential for Disturbance	Low to medium.	
<b>Risk</b>	<p>The ACM are not friable and are in stable condition. Ensure that they remain clearly labelled and regularly inspect to ensure they are not deteriorating or otherwise contributing to an unacceptable health risk.</p>	Photos from 2021.
Management Actions	<p>Unable to access in 2023. Assume present.                  May remain in-situ until replacement is required.                  Manage as per <b>Asbestos Management Plan</b>.                  Administrative – Follow safe work procedures during removal and maintenance.                  Personal protective equipment – P2 facemask and coveralls required when working on material.</p>

References (See Appendices)	<p><b>Safe Work Australia, Code of Practice: How to Manage and Control Asbestos in the Workplace.</b>  <b>WHS Appendix F—Example of asbestos-related work</b>  <b>WHS Appendix G—Recommended safe working practices</b>                  Safe work practice 1—Drilling of ACM  <b>Safe Work Australia, Code of Practice: How to Safely Remove Asbestos</b>  <b>Appendix E—Examples of asbestos removal work</b>                  Removal of floor tiles</p>	
Service Record	<p>Review– January 2028                  Company:                  Date:                  Works:                  Clearance certificate:</p>

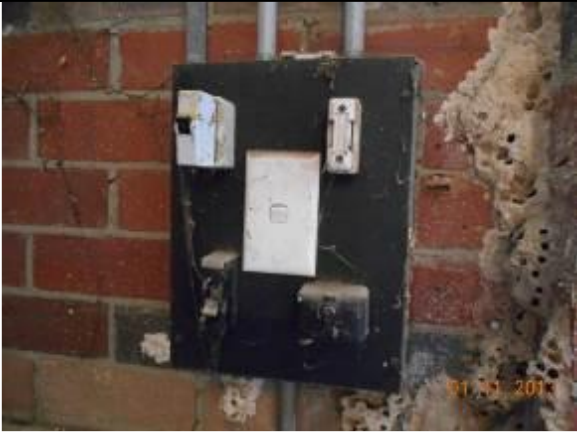
<b>ID 2:- Electrical Mounting Board (Suspected Asbestos Containing Material)</b>

Material	Suspected asbestos containing material.	
Lab No.	N/A.	
QED Sample No.	ID: Observed.	
Locations	Internal – Switch board adjacent entry doorway.	
Condition	Good, non-friable.	
Signage	Labelled (according to provided information).	
Potential for Disturbance	Low to medium.	
<b>Risk</b>	<b>The ACM are not friable and are in stable condition. Ensure that they remain clearly labelled and regularly inspect to ensure they are not deteriorating or otherwise contributing to an unacceptable health risk.</b>	<p>Photo from City of Kalamunda asbestos register. Unable to access building. Information taken from City of Kalamunda asbestos register: Building: Kalamunda Pistol Club Asset ID: BD_5054-00 to BD_5054-07 Date Inspected: 24-Feb-2020</p>
Management Actions	<p>May remain in-situ until replacement is required. Manage as per <b>Asbestos Management Plan</b>. Administrative – Follow safe work procedures during removal and maintenance. Personal protective equipment – P2 facemask and coveralls required when working on material.</p>

References (See Appendices)	<p><b>Safe Work Australia, Code of Practice: How to Manage and Control Asbestos in the Workplace. WHS Appendix G—Recommended safe working practices</b> Safe work practice 5—Working on electrical mounting boards (switchboards) containing asbestos <b>Safe Work Australia, Code of Practice: How to Safely Remove Asbestos Appendix E—Examples of asbestos removal work</b> Asbestos cement products</p>	
Service Record	<p>Review— January 2028 Company: Date: Works: Clearance certificate:</p>	
Further Details	<p>All coal tar pitch boards should be presumed to contain asbestos Brand names include Zelemite, Miscolite and Lebah</p>

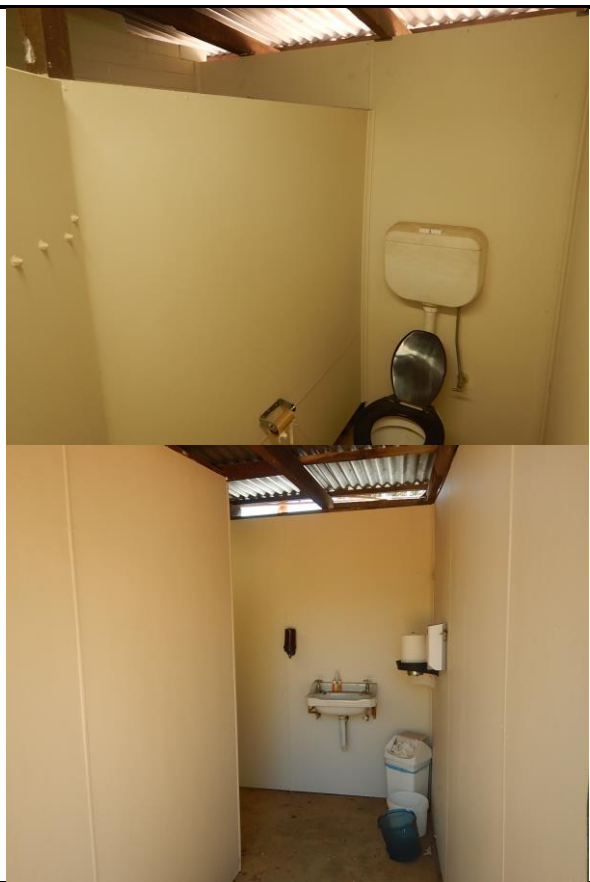
<b>ID 4:- Fibre Cement Wall Panelling (Asbestos Detected)</b>	
Material	Chrysotile and amosite asbestos detected.
Lab No.	Eurofins ARL Lab No. 21-10098-172.
QED Sample No.	ID: 28124.
Locations	External Toilets – Wall panels.
Condition	Good, sealed, non-friable.
Signage	Labelled.
Potential for Disturbance	Low.
<b>Risk</b>	<p>The ACM are not friable and are in stable condition. Ensure that they remain clearly labelled and regularly inspect to ensure they are not deteriorating or otherwise contributing to an unacceptable health risk.</p>
Management Actions	<p>May remain in-situ until replacement is required.                  Manage as per <b>Asbestos Management Plan</b>.                  Administrative – Follow safe work procedures during removal and maintenance.                  Personal protective equipment – P2 facemask and coveralls required when working on material.</p>
References (See Appendices)	<p><b>Safe Work Australia, Code of Practice: How to Manage and Control Asbestos in the Workplace.</b>  <b>WHS Appendix G—Recommended safe working practices</b>                  Safe work practice 1—Drilling of ACM                  Safe work practice 2—Sealing, painting, coating and cleaning of asbestos cement products  <b>Safe Work Australia, Code of Practice: How to Safely Remove Asbestos</b>  <b>Appendix E—Examples of asbestos removal work</b>                  Asbestos cement products</p>

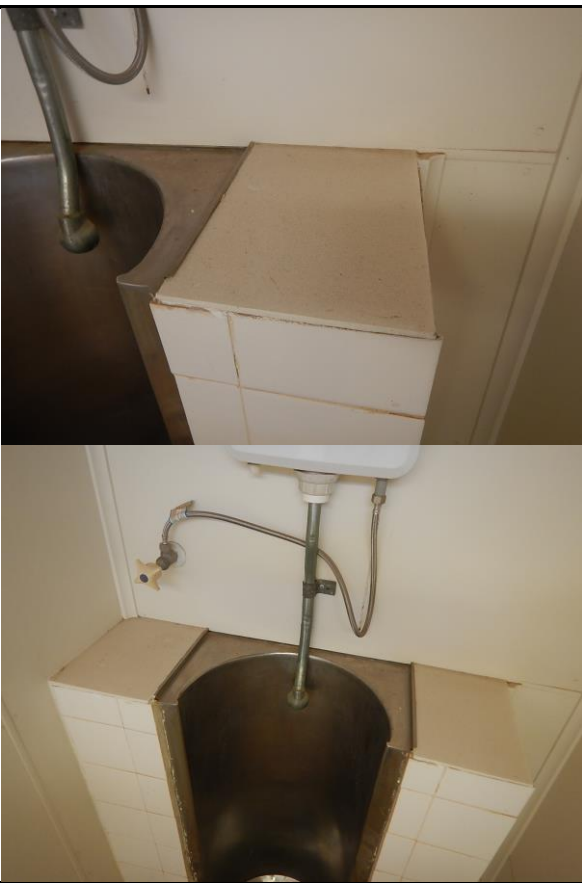
<b>ID 5:- Fibre Cement Infill Panelling (Asbestos Detected)</b>

Material	Chrysotile asbestos detected.	
Lab No.	Eurofins ARL Lab No. 21-10098-173.	
QED Sample No.	ID: 28125.	
Locations	External Toilets – Left and right side of urinal (infill panels).	
Condition	Good, sealed, non-friable.	
Signage	Labelled.	
Potential for Disturbance	Low to medium.	
<b>Risk</b>	<p><b>The ACM are not friable and are in stable condition. Ensure that they remain clearly labelled and regularly inspect to ensure they are not deteriorating or otherwise contributing to an unacceptable health risk.</b></p>	
Management Actions	<p>May remain in-situ until replacement is required.                  Manage as per <b>Asbestos Management Plan</b>.                  Administrative – Follow safe work procedures during removal and maintenance.                  Personal protective equipment – P2 facemask and coveralls required when working on material.</p>

References (See Appendices)	<p><b>Safe Work Australia, Code of Practice: How to Manage and Control Asbestos in the Workplace.</b>  <b>WHS Appendix G—Recommended safe working practices</b>                  Safe work practice 1—Drilling of ACM                  Safe work practice 2—Sealing, painting, coating and cleaning of asbestos cement products  <b>Safe Work Australia, Code of Practice: How to Safely Remove Asbestos</b>  <b>Appendix E—Examples of asbestos removal work</b>                  Asbestos cement products</p>	
Service Record	<p>Review– January 2028                  Company:                  Date:                  Works:                  Clearance certificate:</p>

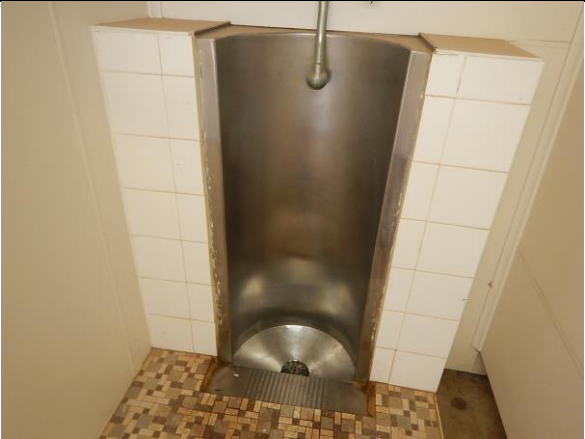
<b>ID 6:- Urinal Backing Membrane (Suspected Asbestos Containing Material)</b>

Material	Suspected asbestos containing material.	
Lab No.	Unable to sample (encapsulated)	
QED Sample No.	ID: N/A.	
Locations	External Toilets - Male toilets	
Condition	Encased, non-friable.	
Signage	Unable to adequately label.	
Potential for Disturbance	Low.	
<b>Risk</b>	<p><b>The ACM are not friable and are in stable condition. Ensure that they are regularly inspected to ensure they are not deteriorating or otherwise contributing to an unacceptable health risk.</b></p>	
Management Actions	<p>May remain in-situ until replacement is required.                  Manage as per <b>Asbestos Management Plan</b>.                  Administrative – Follow safe work procedures during removal and maintenance.                  Personal protective equipment – P2 facemask and coveralls required when working on material.</p>	
References (See Appendices)	<p><b>Safe Work Australia, Code of Practice: How to Manage and Control Asbestos in the Workplace.</b>  <b>Safe Work Australia, Code of Practice: How to Safely Remove Asbestos</b>  <b>Appendix E—Examples of asbestos removal work</b>                  Removing bituminous (malthoid) products</p>

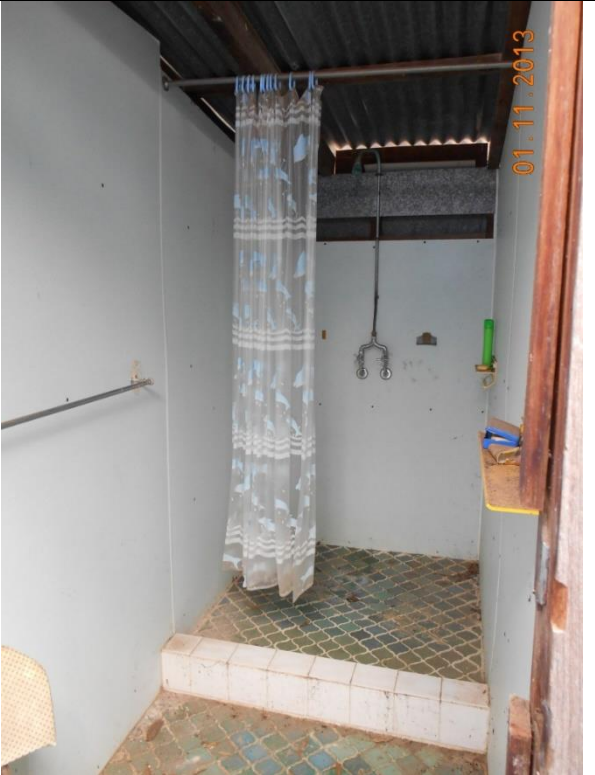
<b>ID 7:- Fibre Cement Wall Panelling (Suspected Asbestos Containing Material)</b>

Material	Suspected asbestos containing material.	
Lab No.	Unable to obtain suitable sample [inaccessible].	
QED Sample No.	ID: Observed.	
Locations	External Toilets – Female shower area, wall panels.	
Condition	Unknown.	
Signage	None.	
Potential for Disturbance	Low to medium.	
<b>Risk</b>	<p><b>The ACM are not friable and are in stable condition. Ensure that they remain clearly labelled and regularly inspect to ensure they are not deteriorating or otherwise contributing to an unacceptable health risk.</b></p>	<p>Photograph from 2013 inspection.</p>
Management Actions	<p>Label when practical.                  May remain in-situ until replacement is required.                  Manage as per <b>Asbestos Management Plan</b>.                  Administrative – Follow safe work procedures during removal and maintenance.                  Personal protective equipment – P2 facemask and coveralls required when working on material.</p>

References (See Appendices)	<p><b>Safe Work Australia, Code of Practice: How to Manage and Control Asbestos in the Workplace.</b>  <b>WHS Appendix G—Recommended safe working practices</b>                  Safe work practice 1—Drilling of ACM                  Safe work practice 2—Sealing, painting, coating and cleaning of asbestos cement products</p> <p><b>Safe Work Australia, Code of Practice: How to Safely Remove Asbestos</b>  <b>Appendix E—Examples of asbestos removal work</b>                  Asbestos cement products</p>	
Service Record	<p>Review– January 2028                  Company:                  Date:                  Works:                  Clearance certificate:</p>

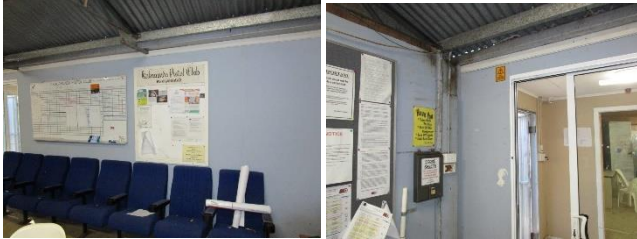
No asbestos detected.  Organic fibres detected.
<b>Entry/lobby wall cladding</b>	Eurofins ARL Lab No. 21-10098-175  QED ID: 28128	Entry/lobby

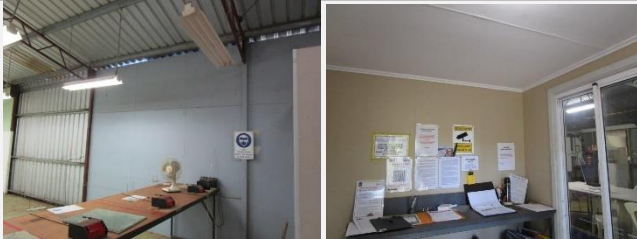
No asbestos detected.  Note: sample is a composite of the entry and range wall panelling.
<b>Wall cladding</b>	Eurofins ARL Lab No. 21-10098-175  QED ID: 28128	Entry to range and range walls

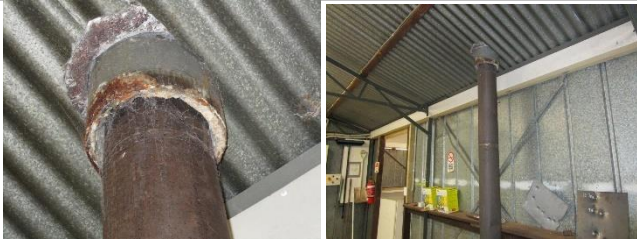
No asbestos detected.  Note: sample is a composite of the entry and range wall panelling.
<b>Fireplace flue pipe insulation</b>	Eurofins ARL Lab No. 21-10098-176  QED ID: 28129	Main room fireplace

No asbestos detected.  Synthetic mineral fibres detected.

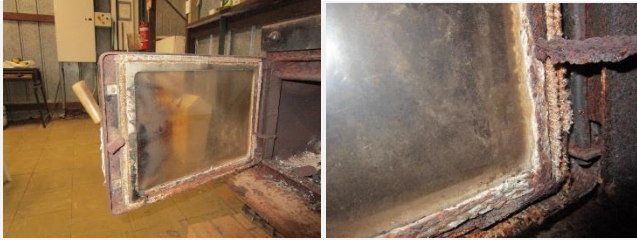
Item Description	Lab No.	Location	Photo	Comments
<b>Fireplace door insulation</b>	Eurofins ARL Lab No. 21-10098-177  QED ID: 28130	Fireplace

No asbestos detected.  Synthetic mineral fibres detected.
<b>Dividing walls</b>	Eurofins ARL Lab No. 21-10098-171  QED ID: 28123	Range shelter #1.

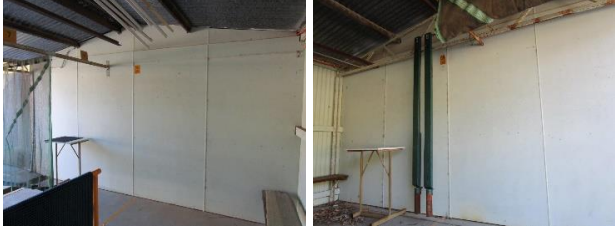
No asbestos detected.  Organic fibres detected.
<b>Ceiling in main Room</b>	Removed	Clubroom – main room

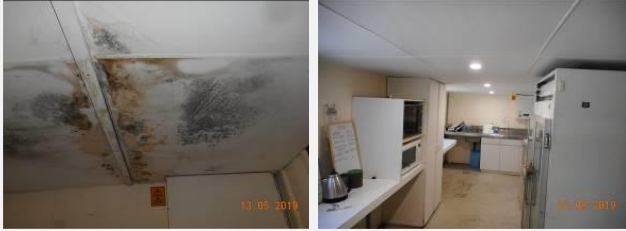
Removed 2019  Information taken from City of Kalamunda asbestos register: Building: Kalamunda Pistol Club Asset ID: BD_5054-00 to BD_5054-07 Date Inspected: 24-Feb-2020
