ASBESTOS REGISTER

Rollerama, 38 Collins Road, Kalamunda, WA

Report ID: **34743Br0**

Prepared for: **City of Kalamunda**

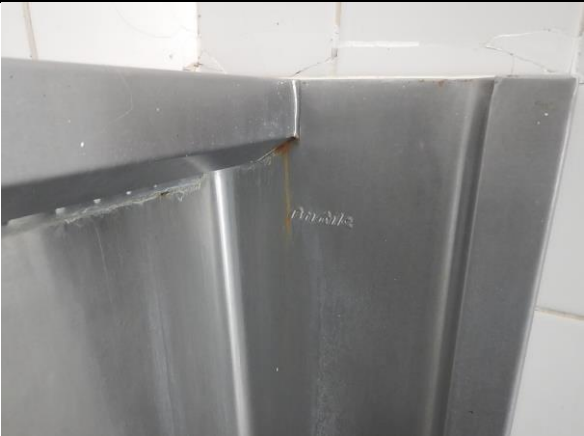
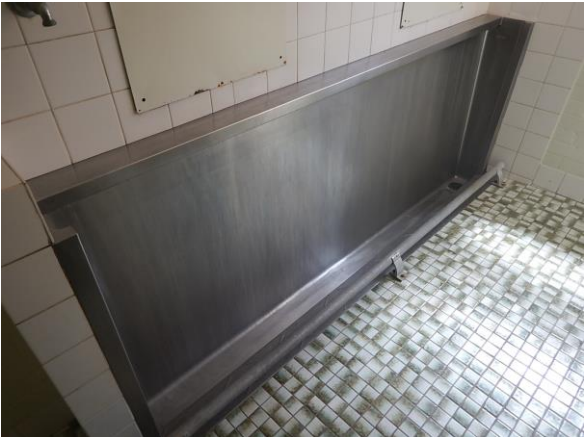
ID 1:- Urinal Backing Membrane (Bristle) (Suspected Asbestos Containing Material)

Material	Suspected asbestos containing material.		
Lab No.	Unable to sample (encapsulated)		
QED Sample No.	ID: N/A.		
Locations	Internal - Male toilets, urinal.		
Condition	Encased, intact, non-friable.		
Signage	Unable to adequately label.		
Potential for Disturbance	Low.		
Risk	<p>The ACM are not friable and are in stable condition. Ensure that they are regularly inspected to ensure they are not deteriorating or otherwise contributing to an unacceptable health risk.</p>

Management Actions	May remain in-situ until replacement is required. Manage as per Asbestos Management Plan . Administrative – Follow safe work procedures during removal and maintenance. Personal protective equipment – P2 facemask and coveralls required when working on material.		
References (See Appendices)	Safe Work Australia, Code of Practice: How to Manage and Control Asbestos in the Workplace. Safe Work Australia, Code of Practice: How to Safely Remove Asbestos Appendix E—Examples of asbestos removal work Removing bituminous (malthoid) products

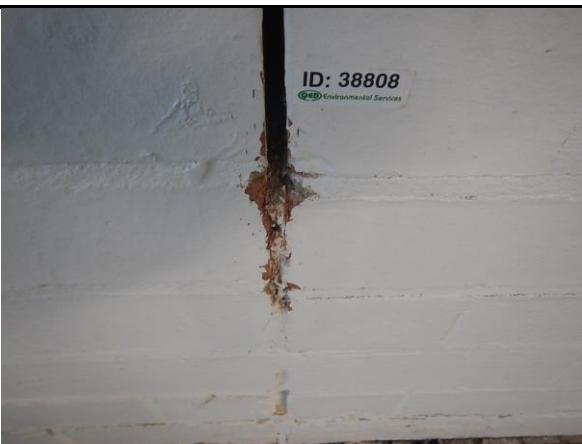
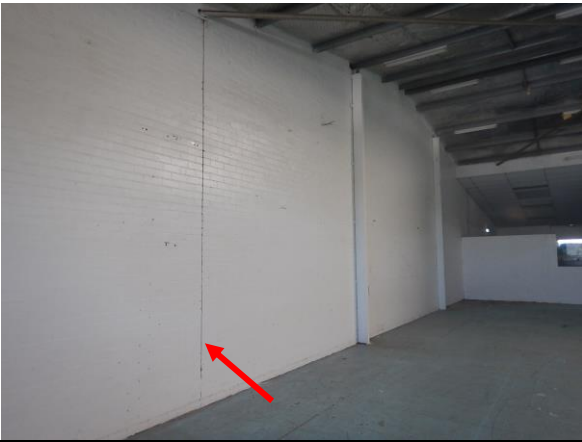
ID 3:- Mastic (Presumed Asbestos Containing Material)

Material	Presumed asbestos containing material.	
Lab No.	N/A.	
QED Sample No.	ID: Observed.	
Locations	Internal/External – Throughout building expansion joints.	
Condition	Fair, mostly intact, non-friable.	
Signage	None.	
Potential for Disturbance	Low to medium.	
Risk	<p>The ACM are not friable and are in stable condition. Ensure that they remain clearly labelled and regularly inspect to ensure they are not deteriorating or otherwise contributing to an unacceptable health risk.</p>	
Management Actions	<p>Label when practicable. May remain in-situ until replacement is required. Manage as per Asbestos Management Plan. Administrative – Follow safe work procedures during removal and maintenance. Personal protective equipment – P2 facemask and coveralls required when working on material.</p>	
References (See Appendices)	<p>Safe Work Australia, Code of Practice: How to Manage and Control Asbestos in the Workplace. WHS Appendix G—Recommended safe working practices Safe work practice 1—Drilling of ACM Safe work practice 2—Sealing, painting, coating and cleaning of asbestos cement Safe Work Australia, Code of Practice: How to Safely Remove Asbestos Appendix E—Examples of asbestos removal work Removing bituminous (malthoid) products</p>

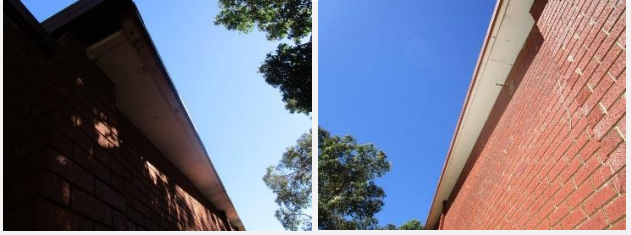
Item Description	Lab No.	Location	Photo	Comments
<p>Eave Panels.</p>	<p>Eurofins ARL Lab No. 21-10098-129 QED ID: 28105</p>	<p>Eave panels surrounding the building. Sampled from the rear eaves.</p>

<p>No asbestos detected. Organic fibres detected.</p>
