ASBESTOS REGISTER

SKAMP Hall, 22 Falls Road, Lesmurdie, WA

Report ID: **34764Br0**

Prepared for: **City of Kalamunda**

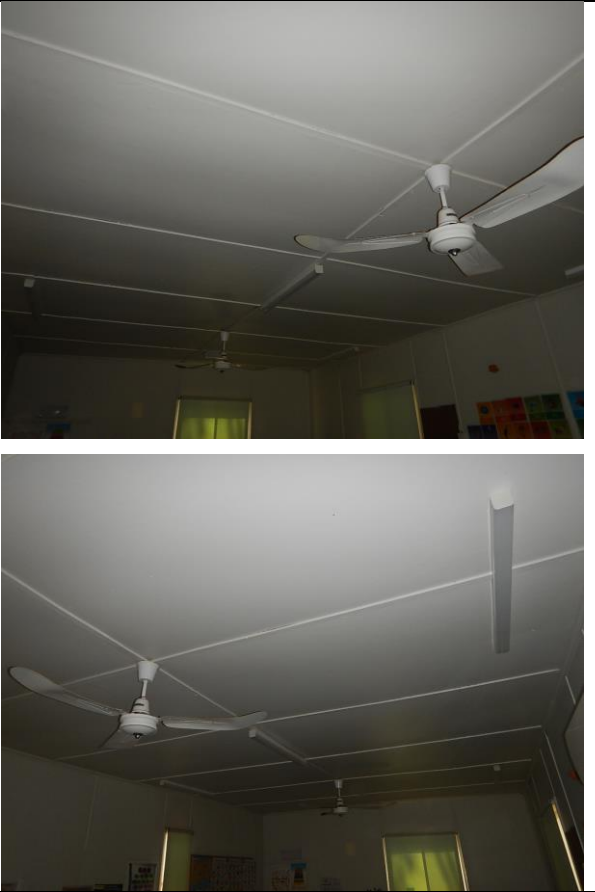
ID 1:- Fibre Cement Ceiling Panelling and Jointing Strips (Asbestos Detected)

Material	Chrysotile and amosite asbestos detected.	
Lab No.	Eurofins ARL Lab No. 21-08932-3.	
QED Sample No.	ID: 28172.	
Locations	Internal – Throughout original building ceilings and jointing strips.	
Condition	Good, sealed, non-friable.	
Signage	Labelled.	
Potential for Disturbance	Low.	
Risk	<p>The ACM are not friable and are in stable condition. Ensure that they remain clearly labelled and regularly inspect to ensure they are not deteriorating or otherwise contributing to an unacceptable health risk.</p>	
Management Actions	<p>May remain in-situ until replacement is required.</p> <p>Manage as per Asbestos Management Plan.</p> <p>Administrative – Follow safe work procedures during removal and maintenance.</p> <p>Personal protective equipment – P2 facemask and coveralls required when working on material.</p>	
References (See Appendices)	<p>Safe Work Australia, Code of Practice: How to Manage and Control Asbestos in the Workplace.</p> <p>WHS Appendix G—Recommended safe working practices</p> <p>Safe work practice 1—Drilling of ACM</p> <p>Safe work practice 2—Sealing, painting, coating and cleaning of asbestos cement products</p> <p>Safe Work Australia, Code of Practice: How to Safely Remove Asbestos</p> <p>Appendix E—Examples of asbestos removal work</p> <p>Asbestos cement products</p>

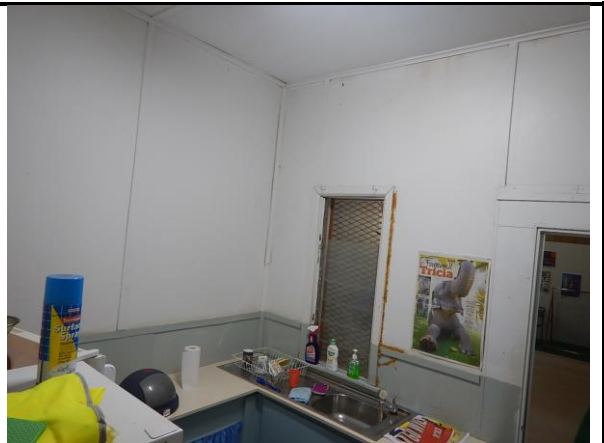
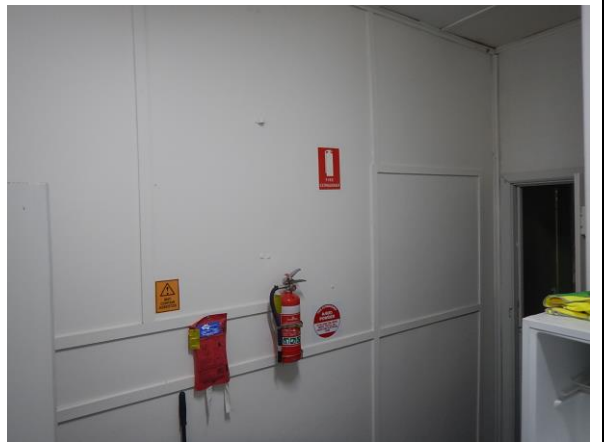
ID 2:- Fibre Cement Wall Panelling and Jointing Strips (Asbestos Detected)	
Material	Chrysotile and amosite asbestos detected.
Lab No.	Eurofins ARL Lab No. 21-08932-3.
QED Sample No.	ID: 28172.
Locations	Internal – Throughout original building walls and jointing strips.
Condition	Good, sealed, non-friable.
Signage	Labelled.
Potential for Disturbance	Low.
Risk	<p>The ACM are not friable and are in stable condition. Ensure that they remain clearly labelled and regularly inspect to ensure they are not deteriorating or otherwise contributing to an unacceptable health risk.</p>
Management Actions	<p>There seems to be a mixture of asbestos and non-asbestos panelling to the walls. Assume all wall panels contain asbestos, unless specifically sampled. May remain in-situ until replacement is required. Manage as per Asbestos Management Plan. Administrative – Follow safe work procedures during removal and maintenance. Personal protective equipment – P2 facemask and coveralls required when working on material.</p>

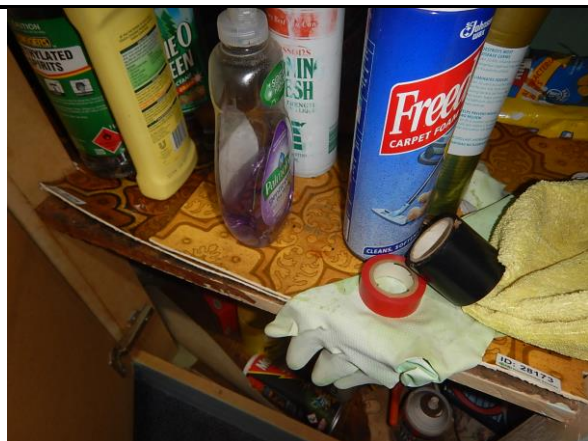
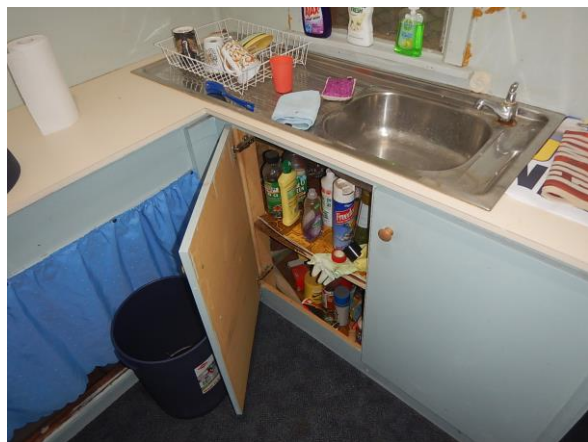
ID 3:- Patterned Vinyl Material and Backing Layer (Asbestos Detected)	
Material	Chrysotile asbestos detected.
Lab No.	Eurofins ARL Lab No. 21-08932-4.
QED Sample No.	ID: 28173.
Locations	Internal – Kitchen cupboard shelf lining.
Condition	Fair to poor, Friable
Signage	None.
Potential for Disturbance	Medium.
Risk	<p>IMMEDIATE ACTION REQUIRED. The ACM are friable but are in a stable condition. The ACM are accessible. Serious consideration should be given to their removal. If removal is not immediately practicable, short-term control measures, such as sealing and enclosure, may be able to be used until removal is possible.</p>
Management Actions	<p>Label immediately. The ACM is friable and damaged. This material should be planned for removal as soon as practical. May remain in-situ until replacement is required. May be disturbed only by a contractor holding a Class A Asbestos Removal License. Manage as per Asbestos Management Plan. Administrative – Follow safe work procedures during removal and maintenance. Personal protective equipment – P3 full face powered air respirator and coveralls required during removal of material.</p>

ID #	Product	Location
3	Patterned Vinyl Material and Backing Layer.	Internal – Kitchen cupboard shelf lining.
<i>Recommendations: Material is friable and damaged. The ACM should be removed as soon as practical.</i>		
5	Loose Fibre Cement Panel/debris.	External – Underneath original section of building.
<i>Recommendations: This material is non-friable and doesn't pose a significant risk to persons in the area; however, this debris should be removed when practical.</i>

1. ID# 3 & 5 require removal. ID# 3 is significantly more urgent than ID#5. Refer to Management Actions for further information.
2. All other remaining materials identified may remain in situ until requiring replacement although, where practicable, asbestos containing materials should be removed, consistent with the Federal Government's stated ultimate goal of the prohibition of asbestos, which is for "all workplaces to be free of asbestos".

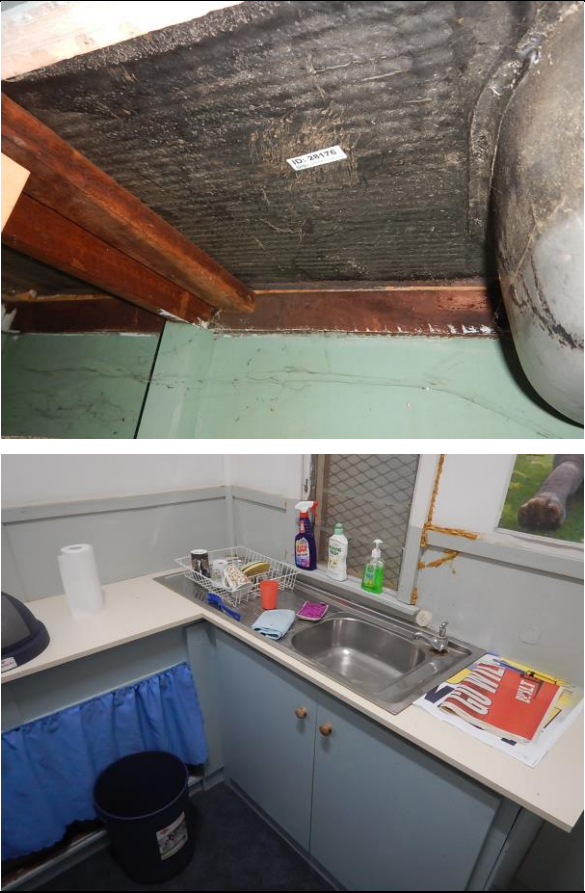
ID 4:- Under Sink Membrane (Asbestos Detected)

Material	Chrysotile asbestos detected.	
Lab No.	Eurofins ARL Lab No. 21-08932-7.	
QED Sample No.	ID: 28176.	
Locations	Internal – Kitchen, sink unit.	
Condition	Good, intact, non-friable.	
Signage	None.	
Potential for Disturbance	Low.	
Risk	<p>The ACM are not friable and are in stable condition. Ensure that they remain clearly labelled and regularly inspect to ensure they are not deteriorating or otherwise contributing to an unacceptable health risk.</p>	
Management Actions	<p>Label when practical. May remain in-situ until replacement is required. Manage as per Asbestos Management Plan. Administrative – Follow safe work procedures during removal and maintenance. Personal protective equipment – P2 facemask and coveralls required when working on material.</p>	
References (See Appendices)	<p>Safe Work Australia, Code of Practice: How to Manage and Control Asbestos in the Workplace. Safe Work Australia, Code of Practice: How to Safely Remove Asbestos Appendix E—Examples of asbestos removal work Removing bituminous (malthoid) products</p>

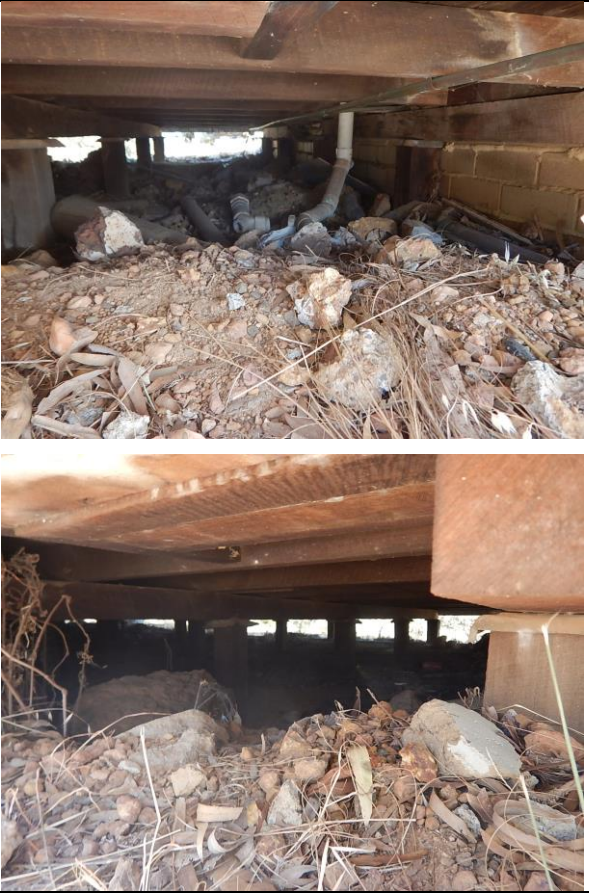
ID 5:- Loose Fibre Cement Panel/Debris (Suspected Asbestos Containing Material)

Material	Suspected asbestos containing material.	
Lab No.	Unable to obtain suitable sample [unable to access].	
QED Sample No.	ID: Observed.	
Locations	External – Underneath original section of building.	
Condition	Fair, intact, non-friable.	
Signage	None.	
Potential for Disturbance	Low.	
Risk	<p>The ACM are not friable and are in stable condition. Ensure that they remain clearly labelled and regularly inspect to ensure they are not deteriorating or otherwise contributing to an unacceptable health risk.</p>	
Management Actions	<p>The ACM should be planned for removal, including any associated debris. May remain in-situ until replacement is required. Manage as per Asbestos Management Plan. Administrative – Follow safe work procedures during removal and maintenance. Personal protective equipment – P2 facemask and coveralls required when working on material.</p>
