ASBESTOS REGISTER

Forrestfield Bowling Club, Morison Road & Hartfield Road, Forrestfield, WA

Report ID: **34726Br0**

Prepared for: **City of Kalamunda**

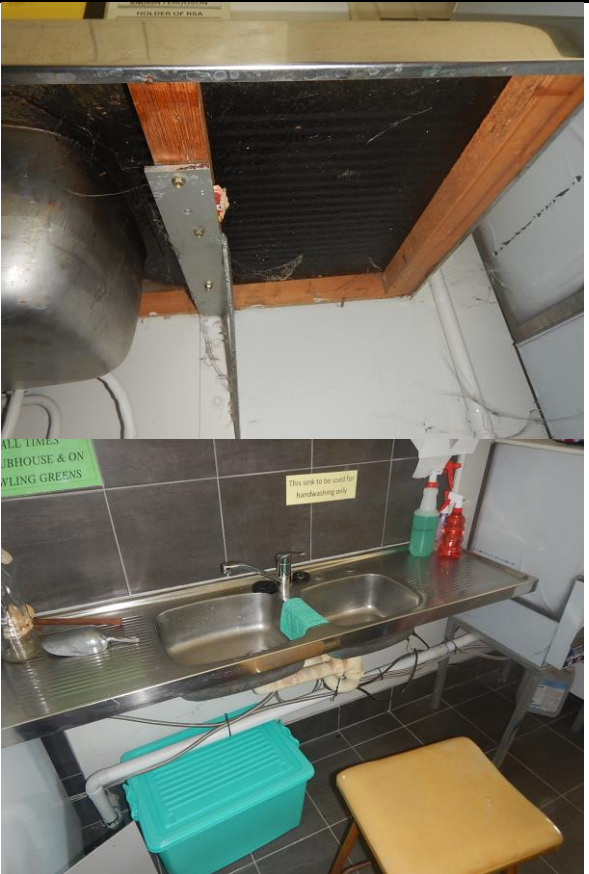
ID 1:- Under Sink Membrane (Radiant) (Asbestos Detected)

Material	Chrysotile asbestos detected.	
Lab No.	Greencap Report No. 47008.	
QED Sample No.	ID: 28245.	
Locations	Internal – Main function room, sink unit.	
Condition	Good, intact, non-friable.	
Signage	None.	
Potential for Disturbance	Low.	
Risk	<p>The ACM are not friable and are in stable condition. Ensure that they remain clearly labelled and regularly inspect to ensure they are not deteriorating or otherwise contributing to an unacceptable health risk.</p>	
Management Actions	<p>Label when practical.</p> <p>May remain in-situ until replacement is required.</p> <p>Manage as per Asbestos Management Plan.</p> <p>Administrative – Follow safe work procedures during removal and maintenance.</p> <p>Personal protective equipment – P2 facemask and coveralls required when working on material.</p>	
References (See Appendices)	<p>Safe Work Australia, Code of Practice: How to Manage and Control Asbestos in the Workplace.</p> <p>Safe Work Australia, Code of Practice: How to Safely Remove Asbestos</p> <p>Appendix E—Examples of asbestos removal work</p> <p>Removing bituminous (malthoid) products</p>

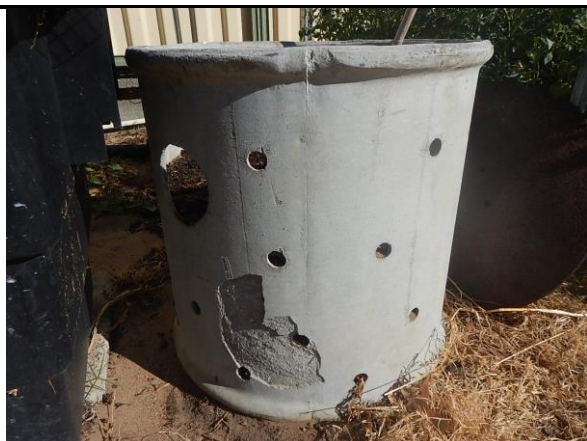
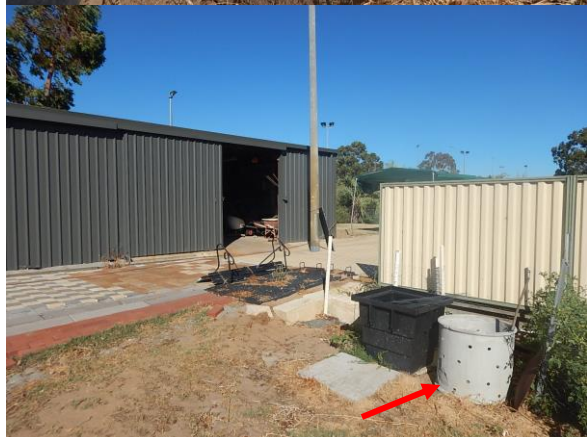
ID 2:- Fibre Cement Soak Well/Large Pipe (Asbestos Detected)	
Material	Chrysotile asbestos detected.
Lab No.	Greencap Report No. 47008.
QED Sample No.	ID: 28246.
Locations	External – Adjacent shed, loose/stored (used as flower bed).
Condition	Fair, unsealed, non-friable.
Signage	None.
Potential for Disturbance	Medium.
Risk	<p>The ACM are not friable and are in stable condition. However, the material is being used for a different purpose. Material should be removed, if this is not practical at this time, ensure the material remains clearly labelled and regularly inspect to ensure they are not deteriorating or otherwise contributing to an unacceptable health risk.</p>
Management Actions	<p>Material should not be used for any purpose; being used as a flower bed has an inherent risk of disturbance. Material should be planned for removal as soon as practical. May remain in-situ until replacement is required. Manage as per Asbestos Management Plan. Administrative – Follow safe work procedures during removal and maintenance. Personal protective equipment – P2 facemask and coveralls required when working on material.</p>

ID #	Product	Location
2	Fibre Cement Soak Well/Large Pipe.	External – Adjacent shed, loose/stored (used as flower bed).
<i>Recommendations: Material is unsealed and being used for a purpose it was not designed for. Removal of this material should occur as soon as practical.</i>

1. ID#2 requires removal as soon as practical. Refer to Management Actions for further information.
2. All remaining materials identified may remain in situ until requiring replacement although, where practicable, asbestos containing materials should be removed, consistent with the Federal Government's stated ultimate goal of the prohibition of asbestos, which is for "all workplaces to be free of asbestos".

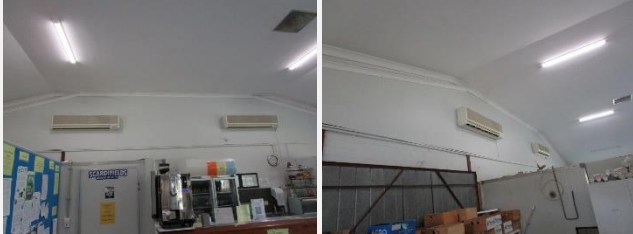
Item Description	Lab No.	Location	Photo	Comments
Upper Wall Panelling	Greencap Report No. 47008. QED ID: 28248	Main function room, upper wall behind the bar.

No asbestos detected. *Note: the sample taken was a composite of the main hall upper wall panelling, storeroom ceiling and bag store wall panelling.
Bag Store Wall Panelling	Greencap Report No. 47008. QED ID: 28248	Main function room, walls surrounding the bog store.

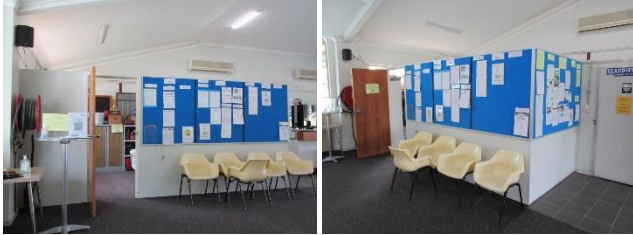
No asbestos detected. *Note: the sample taken was a composite of the main hall upper wall panelling, storeroom ceiling and bag store wall panelling.
Bar Store Ceiling Panelling	Greencap Report No. 47008. QED ID: 28248	Storeroom ceiling behind the bar

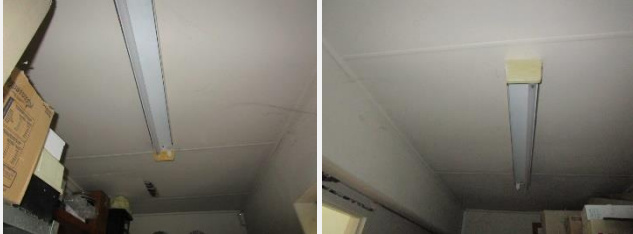
No asbestos detected. *Note: the sample taken was a composite of the main hall upper wall panelling, storeroom ceiling and bag store wall panelling.
Water Tank - Electrical Mounting Board	Greencap Report No. 47008. QED ID: 28247	Water tank retic sub board

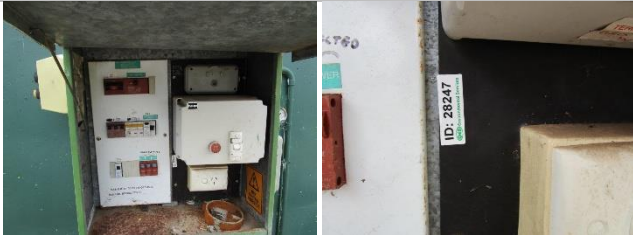
No asbestos detected.
