ASBESTOS REGISTER

Reid Oval Changerooms, Morrison Road, Forrestfield, WA

Report ID: **34732Br0**

Prepared for: **City of Kalamunda**

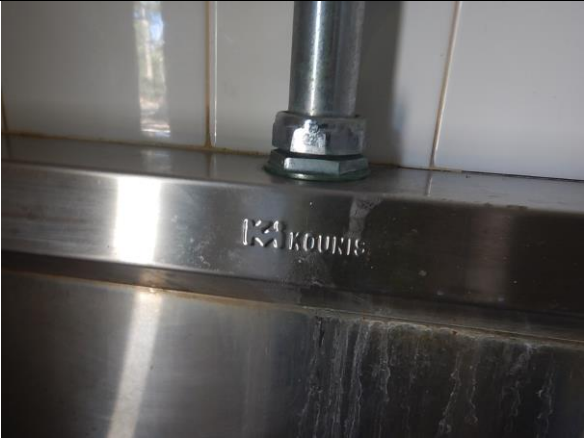
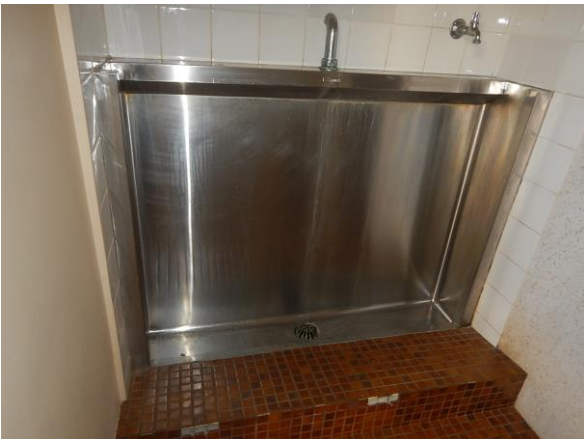
ID 1:- Urinal Backing Membrane (Kounis) (Suspected Asbestos Containing Material)

Material	Suspected asbestos containing material.	
Lab No.	Unable to sample (encapsulated)	
QED Sample No.	ID: N/A.	
Locations	Internal - Male toilets, urinal.	
Condition	Encased, intact, non-friable.	
Signage	Unable to adequately label.	
Potential for Disturbance	Low.	
Risk	<p>The ACM are not friable and are in stable condition. Ensure that they are regularly inspected to ensure they are not deteriorating or otherwise contributing to an unacceptable health risk.</p>	
Management Actions	<p>May remain in-situ until replacement is required. Manage as per Asbestos Management Plan. Administrative – Follow safe work procedures during removal and maintenance. Personal protective equipment – P2 facemask and coveralls required when working on material.</p>	
References (See Appendices)	<p>Safe Work Australia, Code of Practice: How to Manage and Control Asbestos in the Workplace. Safe Work Australia, Code of Practice: How to Safely Remove Asbestos Appendix E—Examples of asbestos removal work Removing bituminous (malthoid) products</p>

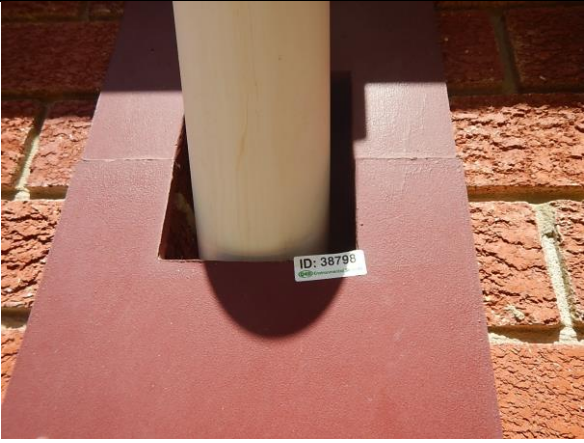
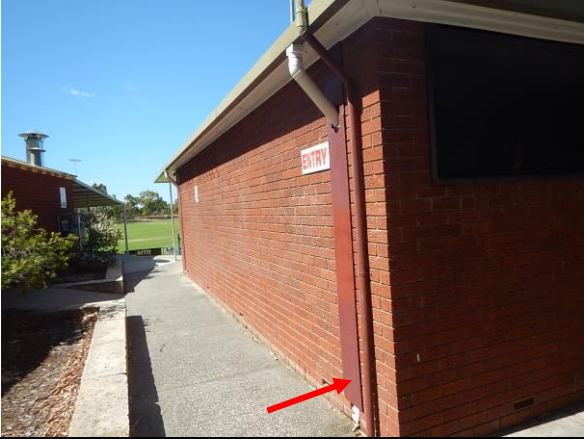
ID 2:- Fibre Cement Panelling (Suspected Asbestos Containing Material)

Material	Suspected asbestos containing material.	
Lab No.	Unable to obtain suitable sample.	
QED Sample No.	ID: Observed.	
Locations	External – Down pipe covering panels.	
Condition	Good, sealed, non-friable.	
Signage	None.	
Potential for Disturbance	Low.	
Risk	<p>The ACM are not friable and are in stable condition. Ensure that they remain clearly labelled and regularly inspect to ensure they are not deteriorating or otherwise contributing to an unacceptable health risk.</p>

Management Actions	<p>Label when practicable. May remain in-situ until replacement is required. Manage as per Asbestos Management Plan. Administrative – Follow safe work procedures during removal and maintenance. Personal protective equipment – P2 facemask and coveralls required when working on material.</p>	
References (See Appendices)	<p>Safe Work Australia, Code of Practice: How to Manage and Control Asbestos in the Workplace. WHS Appendix G—Recommended safe working practices Safe work practice 1—Drilling of ACM Safe work practice 2—Sealing, painting, coating and cleaning of asbestos cement products Safe Work Australia, Code of Practice: How to Safely Remove Asbestos Appendix E—Examples of asbestos removal work Asbestos cement products</p>

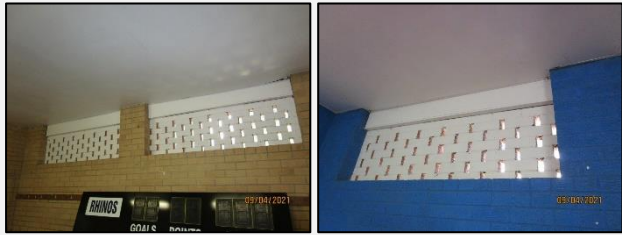
Item Description	Lab No.	Location	Photo	Comments
Window infill panels	Eurofins ARL Lab No. 21-10098-66 QED ID: 28257	Panels above windows, change rooms.

No asbestos detected. Organic Fibres detected
